FAILURE ANALYSIS OF A FRACTURED CONNECTING ROD

ABSTRACT

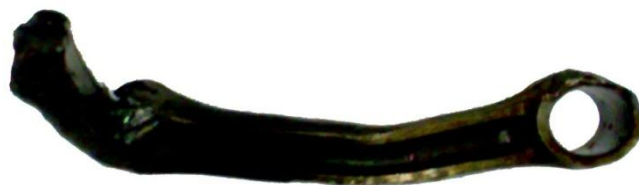
Fig-1. Failure on Connecting Rod

However, specifically describing such a failure, it is important to point out at the different reasons for this failure such as fatigue near a physical defect in the rod, the overheating of the engine, cracking, lubrication failure in a bearing which is usually caused by inaccurate or faulty maintenance, failure of the rod bolts which is due to defect, improper tightening ,and re-use of already used (stressed) bolts where not recommended. Figure 1 shows the failure on connecting rod (Biancolini 2003 and Su Young 2006).

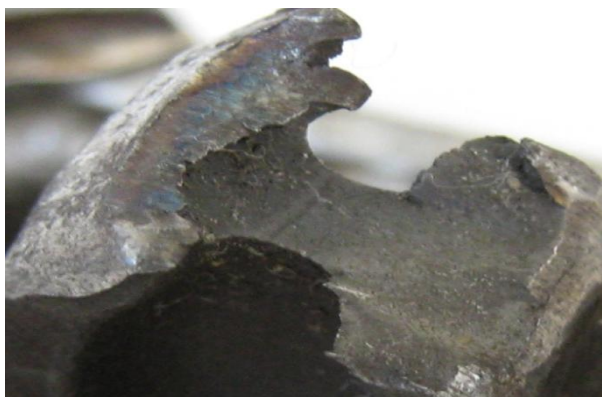
The cross-section of the fractured surface is shown in Figure 4, and the rod's microstructure is shown in Figure 5. A section through the crack origin was adopted, mounted, polished and etched in 4% nital (Nitric acid 1-10ml + Ethanol 100ml) and 0.5% hydrofluoric acid in water. Microscopic examination in Figure 5 revealed a microstructure of a ductile iron specimen with little porosity

Fig-4. Fractured surface at the end of connecting rod

Each crack made the crack progress by one striation after an initial propagation and therefore, the rupture occurred at any critical crack size. Moreover, the striations of the fractured surface under consideration were not seen to be clear and reliable enough as to determine the initial point. Thus, based on the plastic straining marks that were detected and metallographic testing, it can be summed up that the occurrence of this fracture was due to tiny plastic deformation that preceded the crack opening, which finally, caused this fracture.

Based on the results of the experiments obtained by analyzing the finite element in the present study, it can be concluded that the occurrence of the connecting rod failure was due to the fatigue crack growth mechanism which came as a result of higher stress being combined with the porosity (manufacturing defect) in initiation and growth of a fatigue crack followed by catastrophic failure. Thus, it can be recommended that materials with good mechanical properties should be selected, and they should be free from manufacturing defects. Finally, lubrication engine system should be regularly checked, and all these are highly recommended to ensure long life connecting rod.

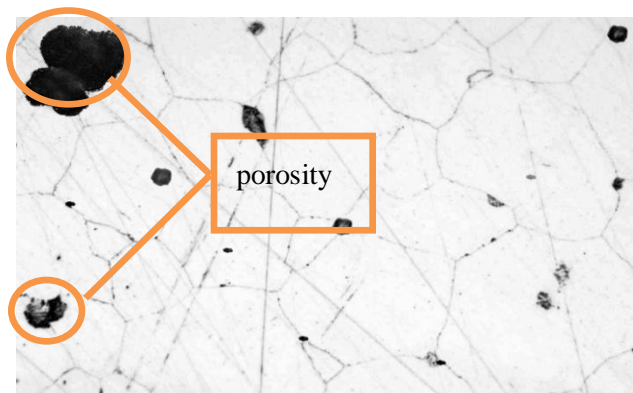
Fig-5. Metallographic of casting defect of the connecting rod

Based on the results obtained from analyzing the finite element, it can be noticed that the connecting rod subjected into diverse loads led to some deformation during the compression and power stroke. The results also revealed that there is a repetition of the loading with every crankshaft revolution, so this means that it supported the fatigue load. Due to this loading, each casting defect is potential to develop itself as the initial point for fatigue-crack initiation.
