International Journal of Remote Sensing

Detection of collapsed buildings caused by the 1999 Izmit, Turkey earthquake through digital analysis of post-event aerial photographs

M. TURKER* and B. T. SAN

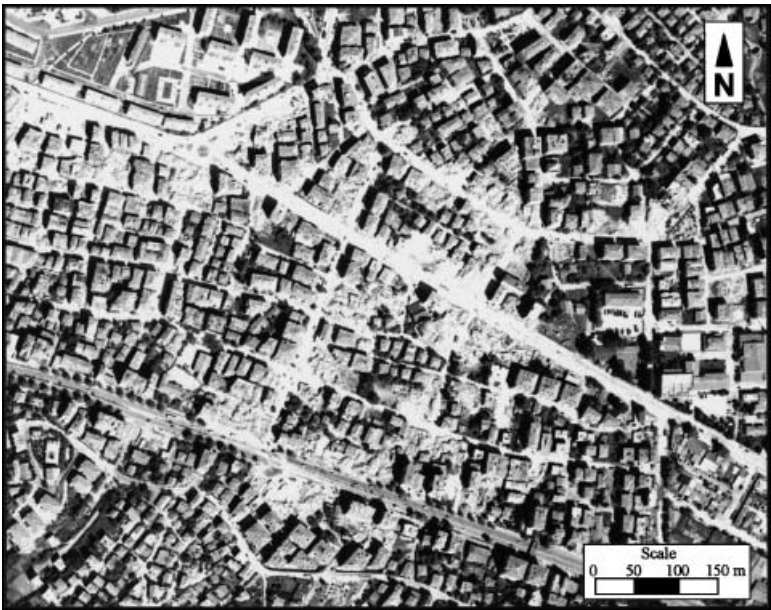
Figure 2. The post-earthquake digital orthophoto of the selected urban area.

In September 1999, General Command of Mapping (GCM) took 4000 black and white aerial photographs (1 : 16 000 scale), which cover about 12 000 km² in the region, to determine the damages caused by the earthquake, to use them in regional and city planning, and to rebuild new urban areas. GCM is a national mapping agency of Turkey in charge of the production and revision of 1 : 25 000 and smaller-scale topographic maps for both national defence and development purposes. GCM scanned the aerial photographs at 21 μm resolution using a Zeiss Scai photogrammetric scanner and produced approximately 1300 (1 : 5000 scale) digital orthophotos with 0.5 m resolution. The digital orthophoto corresponding to the study area was therefore obtained from GCM to perform digital processing and analysis operations for the damage detection. In addition to the digital orthophoto, one

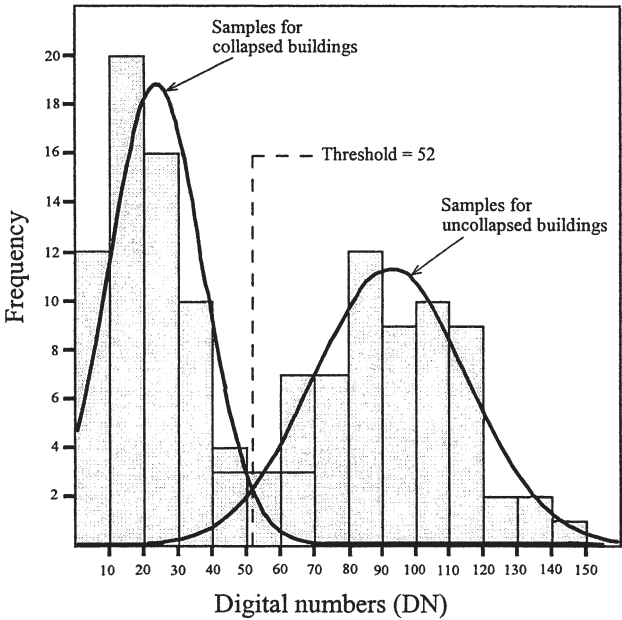
Figure 3. The distribution curves for the samples collected from the edge pixels of collapsed and uncollapsed buildings.

A critical element of the edge detection procedure was deciding where to place a threshold boundary to extract those pixels corresponding to shadow edges and to eliminate the noisy pixels from further processing. To find the optimum threshold, 130 well-distributed samples were selected from the edge pixels of 40 buildings. An equal amount of samples (65) was collected from the edge pixels of 20 collapsed and 20 uncollapsed buildings. When collecting the samples care was taken to select minimum 1 and maximum 4 samples from each of the selected buildings. For collapsed buildings, the mean value and standard deviation were computed as 23.5 and 13.5 (8 bits) respectively. The low mean value would indicate the absence of the cast shadows due to collapse. For uncollapsed buildings, the mean value and standard deviation were found to be 92.40 and 22.88, respectively. The high mean value computed for uncollapsed buildings would be considered due to cast shadows. The distribution curves for the samples collected are illustrated in figure 3. By analysing figure 3 the threshold boundary was identified as 52, which is the intersection of the two curves. Therefore, pixels with a DN value of 52 and below were considered to represent the shadow edges of those buildings collapsed due to earthquake. Similarly, those pixels with a DN value above 52 were accepted as belonging to shadow edges of uncollapsed buildings. The digital orthophoto, the Prewitt edge-filtered image, and the thresholded edge image of a highly damaged urban area are illustrated in figure 4(a), (b) and (c), respectively, with the vector

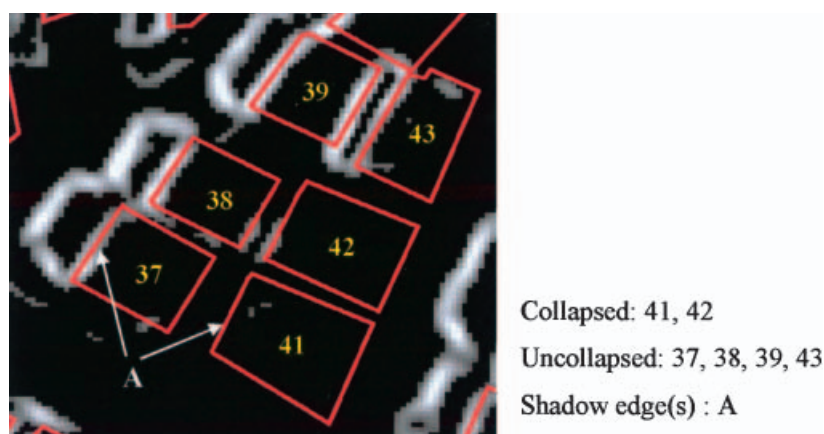
Figure 7. A thresholded edge image of a small area with the vector-building polygons overlaid.

The building polygons were retrieved one-by-one through a database query. For each polygon, the shadow-casting edges were identified by using above given logic. These edges were converted into a raster object and overlaid on the thresholded edge image. The agreement was then measured between the shadow-producing edges of each building polygon and the thresholded edge image. To do this, a pixel count was initiated to determine the percentage of shadow edge pixels. Ideally, the shadow edges of collapsed buildings should contain low percentages. Similarly, the shadow edges of uncollapsed buildings should contain high percentages of shadow edge pixels. In reality, these may not be the cases, however. Figure 7 illustrates the thresholded edge image of a small area with the vector building polygons overlaid. A close agreement is evident between the shadow-casting edges of uncollapsed buildings (numbers 37, 38, 39 and 43 in figure 7) and the corresponding shadow edge pixels. On the contrary, the absence of shadow information indicates that the building is collapsed (numbers 41 and 42 in figure 7).

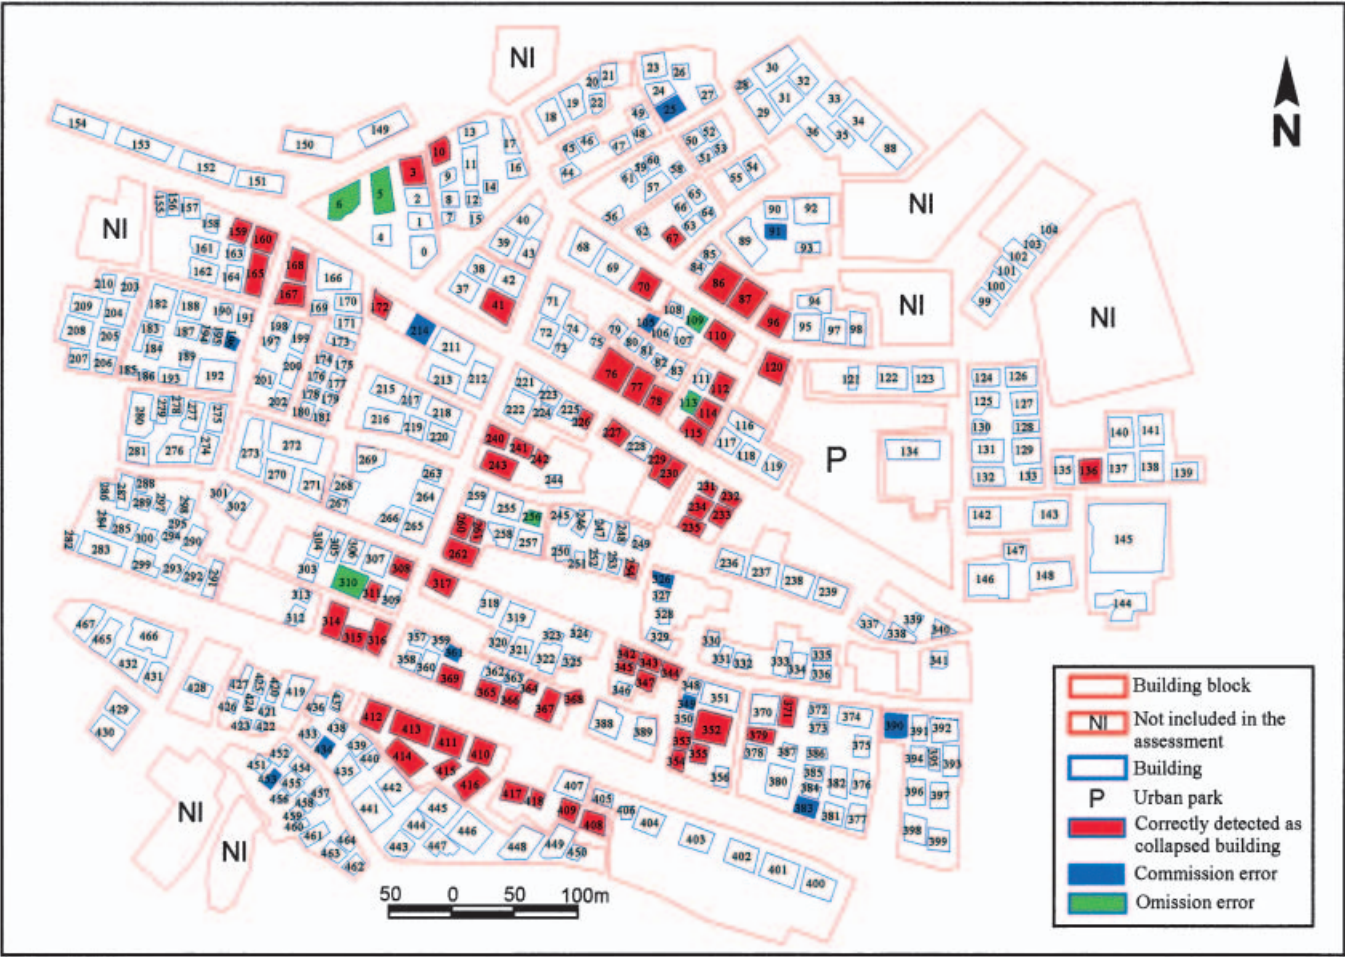
Figure9. Illustration of the results of the analyses.

A further investigation was carried out to determine what might have caused those collapsed and uncollapsed buildings to deviate from reference data. The condition of each of the wrongly categorized buildings was carefully inspected on the digital orthophoto through visual analysis. It was found that the approach did not work properly in several cases. In the first case, an uncollapsed building casts shadows on a closely located other building. Therefore, the shadow-casting edges of the building polygon do not match with the corresponding shadow edges. For example, the uncollapsed buildings numbers 25, 91, 195, 349, 361, 383, 390, 434 and

453 were erroneously detected as collapsed due to this reason. A similar confusion was also observed for building 214, which was wrongly categorized as collapsed although the reference data suggest that this building is uncollapsed. It is evident on the building polygon layer that there is no closely located building on which building 214 can cast a shadow. However, when we carefully checked the digital orthophoto we observed that there is a building located very closely to building 214. It appears that this building was constructed between the date of the compilation of the maps (1998), which is before the earthquake, and the date of aerial photo acquisition (1999), after the earthquake.

In the second case, the vegetation near the shadow casting edges of an uncollapsed building causes confusion. When compared with the brighter tone of the collapsed buildings, the vegetated areas have a much lower reflectance and appear darker than the surrounding objects. Therefore, the edge pixels generated by the Prewitt edge-detection filter correspond to sharp changes in DN values between the collapsed building and the vegetation near the building. This causes the collapsed buildings to be labelled incorrectly as uncollapsed. For example, it is clearly evident on reference data that building 310 is collapsed. However, this building was erroneously labelled uncollapsed due to the above reason. The confusion caused by the vegetation was also observed in the opposite direction. Buildings 105 and 326 were detected as collapsed although they were uncollapsed. The investigation showed that the Prewitt edge-detection filter did not accentuate the shadow casting edges of these buildings. It was observed that the computed percentage value fell below the preset threshold of 50% and therefore these two buildings were erroneously labelled collapsed.

In the third case, the building does not collapse completely and therefore casts shadows. Although the width of the shadows along the Sun's illumination direction is narrower than that of uncollapsed buildings, these shadows cause the wrong categorization of the building. For example, the reference data suggest that building 256 did not collapse completely. However, because this partially collapsed building casts shadows, it was therefore erroneously labelled uncollapsed. Similarly, building 113 was improperly labelled uncollapsed. The investigation showed that the rubble of this building produced shadows which seem to have caused the erroneous labelling of the building.
