# Hacking the Oce Colorwave printer: when a quick security assessment determines the success of a Red Team exercise.

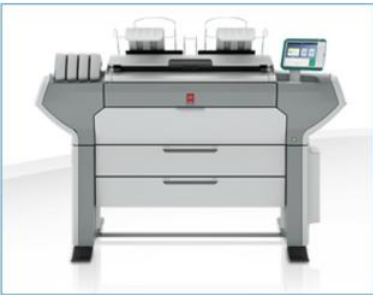
We selected the first URL in the list (a local IP address) and visited that. It was the web interface of the Oce Colorwave 500 printer, a big boy weighting more than 250 kilograms (see picture below).
