Willamette National Forest  
**Burned Area Emergency Response Summary – Holiday Farm Fire**  
October 30, 2020

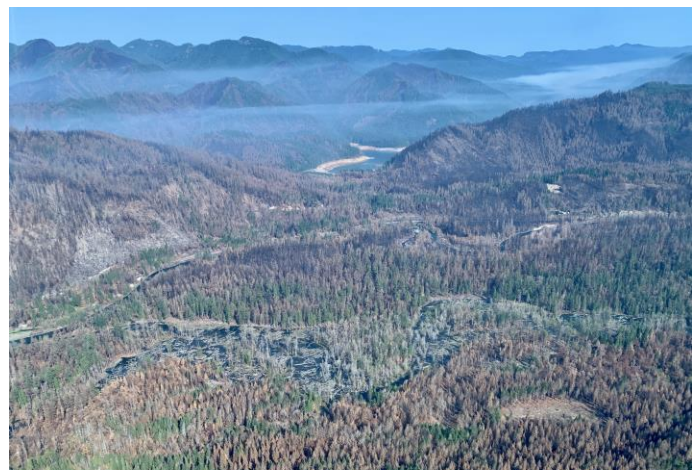
*Figure 1. Mosaic of low, moderate and high SBS – South Fork McKenzie River/Blue River area.*

Long-term soil productivity was identified as a critical value with a high risk of damage or loss. However, no treatments are prescribed to mitigate impacts. Based on modeling across similar burned areas in western Oregon during the 2020 fire season, the reduction in soil loss achievable by techniques such as aerial mulching would be nominal, and treatments would not be cost-effective. Post-fire precipitation events early in the wet season have already accelerated soil loss on erosion-prone hillslopes, further reducing the prospective effectiveness of land treatments to reduce erodibility. Allowing for natural recovery is the recommended course of action.

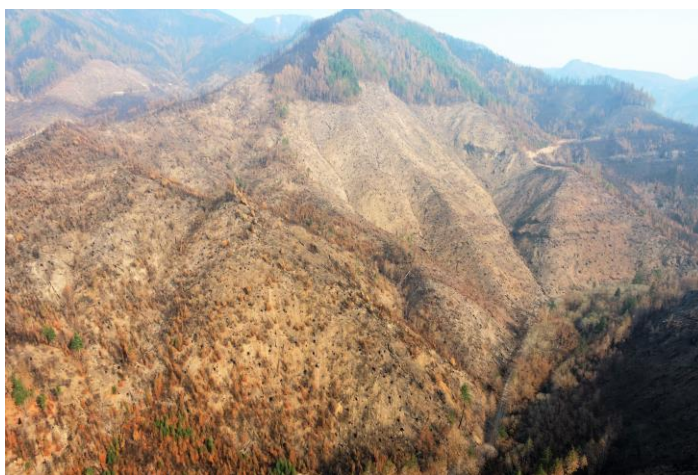
*Figure 2. Debris-flow prone slopes in Quartz Creek drainage.*

Our observations and analysis conclude that there is an elevated risk of instability in the form of rockfall and debris flows across much of the burned area. Specific areas with rockfall hazard were identified that in the Highway 126 corridor, on roads accessing Cougar and Blue River dams and reservoirs, and on a forest road accessing a communications site. Elevated debris flow hazard was identified on a number of steep canyon hillslopes where SBS is high and moderate, including in the Highway 126/McKenzie River corridor, in Gate Creek, Elk Creek, Cone Creek, Quartz Creek, and above Blue River Reservoir. The cumulative risk of various types of slope instability, sediment bulking, and channel flushing is high along many slopes and drainages in and below the burned area following the Holiday Farm Fire. Based on this, special attention and caution is recommended in areas where people are living, traveling through, working, or recreating in or below burned areas during and after storm events.

In order to reduce risk to life and safety, we recommend to coordinate warning notifications with the National Weather Service, post warning signs, and enforce administrative closures, especially if rainfall intensities would reach a threshold of 0.75-inch/hour in short duration storms. Cooperation and coordination with partner agencies such as Lane County and the Oregon Department of Transportation is recommended to help mitigate risk along the important transportation corridors in the burned area.

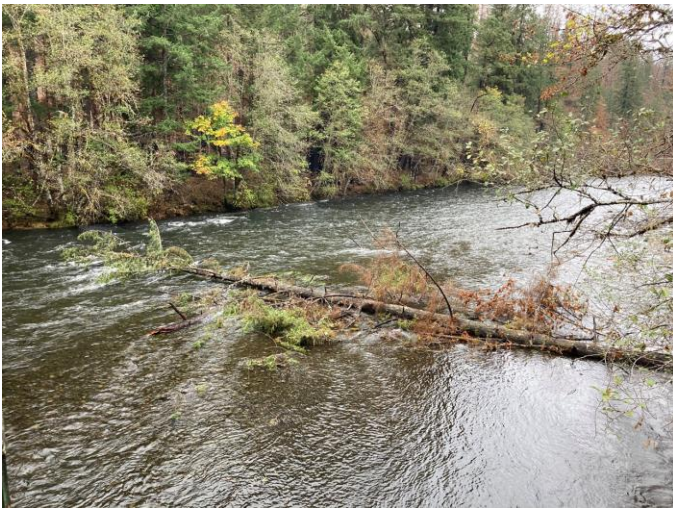
*Figure 3. McKenzie River woody debris*

Large woody debris available for recruitment into stream channels and valley bottom fish-bearing streams has increased greatly because of the Holiday Farm Fire. Increases in large channel wood will have a long-term benefit on wood loading, geomorphic complexity, and habitat quality in Critical Habitat. In the short term, increased wood delivery to the mainstem McKenzie River is likely to present challenges to recreational boating, a major driver of the local economy. Limited repositioning of channel wood is proposed as needed to protect boater safety while retaining habitat benefits that large wood provides.

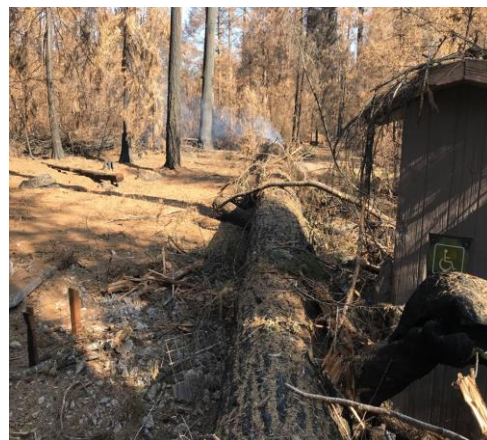
The Holiday Farm burned area and immediate vicinity include 3 campgrounds, 2 boat launches, 1 trail, 1 Wild and Scenic river, and 2 reservoirs, most of which experience year-round use. Of these, one campground, one trail and one boat launch were heavily damaged, with nearly total tree mortality and infrastructure loss. We recommend closure and decommissioning of the damaged campground and trail, hazard warning signage at the boat launch and other river access sites, and monitoring of conditions at one campground (storm inspection and response).

*Figure 4. Delta Campground Vault Toilet*
