SPECIAL CRASH INVESTIGATIONS

CASE NO: CR14063

ON-SITE AMBULANCE CRASH INVESTIGATION

**VEHICLE: 2012 FORD E-350 TYPE II AMBULANCE
AMBULANCE BODY: WHEELED COACH CRUSADER PLUS**

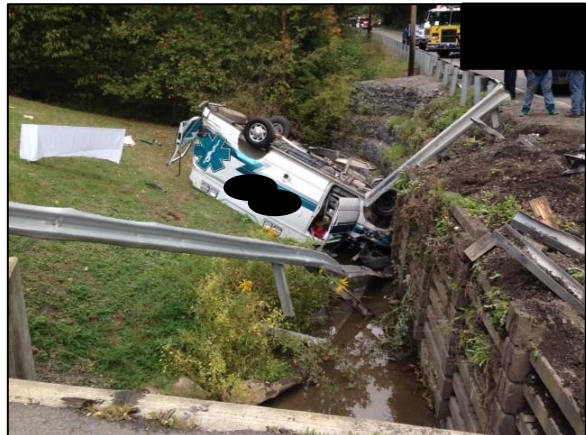
Figure 1: On-scene image looking east at the final rest position of the ambulance. (Image supplied by an internet news service.)

This on-site ambulance crash investigation focused on the multiple-event crash of a 2012 Ford E-350 Type II ambulance (**Figure 1**) and the injury sources to the four crew members and patient within the vehicle. The ambulance was transporting a 62-year-old male in cardiac arrest to the hospital at the time of an intersection crash with a 2012 Jeep Grand Cherokee. The front plane/right corner of the ambulance struck and then engaged the left plane/forward aspect of the Jeep. After separating from the Jeep, the ambulance departed the roadway, impacted and penetrated a guardrail, and rolled over.

The ambulance rolled two-quarter turns as it fell off a 30 m (10 ft) high retaining wall coming to rest on its roof. The emergency lights and siren on the ambulance were active during the transport.

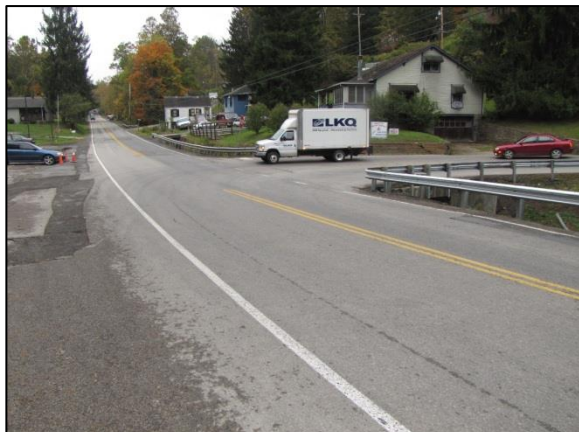
Figure 2: Overall west-looking (lookback) view depicting the configuration of the intersection.

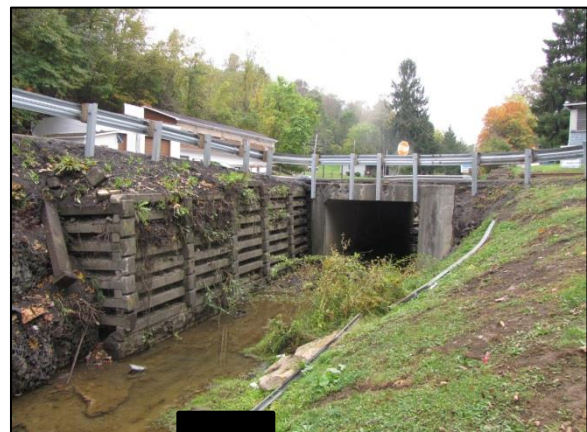
Figure 3: West-looking view toward the culvert and retaining wall from the area of the ambulance's final rest position.

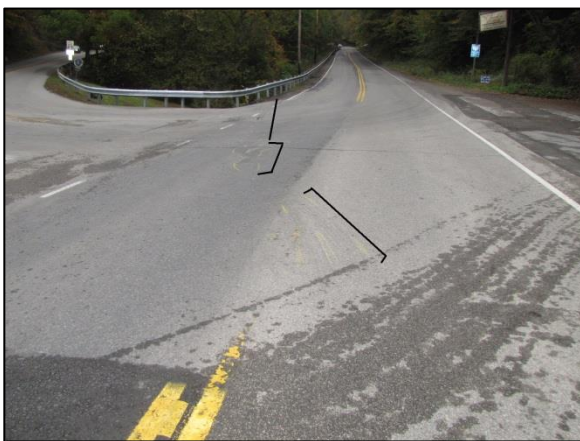
The vehicle-to-vehicle engagement cut the sidewall of the ambulance's front right tire. The tire aired out and the rim contacted the road surface. As the ambulance separated from the impacts to the left, it traveled through the westbound lane and departed the north side of the road at the apex of the northeast intersection corner. This trajectory was evidenced by the 17 m (55.8 ft) long intermittent tire and gouge mark (**Figures 4 and 5**).

Figure 4: East looking view of the ambulance's tire marks documented at the time of the SCI scene inspection.

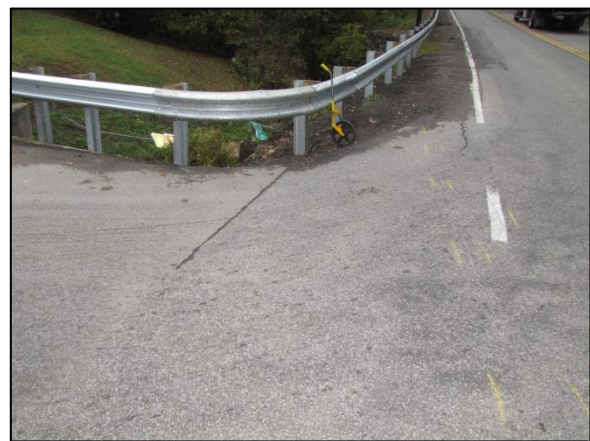
Figure 5: East looking view of the ambulance's right front tire mark tire and the replaced guardrail at the apex of the intersection.

The ambulance impacted and penetrated the guardrail (Event 3, **Figure 5**) that protected the retaining wall and steep 3 m (10 ft) drop-off to the roadside creek. Eight guardrail posts were displaced by this impact. The principle direction of force was in the 12 o'clock sector. The impact force resulted in the actuation of the safety belt pretensioners and the deployment of the frontal air bags in the ambulance. The ambulance then initiated a fall-over from the end of the retaining wall and rolled over two quarter-turns (Event 4) coming to rest on its roof. The vehicle was oriented in a north/south direction. The engine compartment of the overturned ambulance was in the shallow creek. The Jeep came to rest at the mouth of the intersection, straddling the centerline of the primary roadway. The EDR-recorded longitudinal and lateral delta-V's of the Jeep were +7 km/h (+4.3 mph) and +13 km/h (+8.1 mph) at 134 milliseconds after AE.

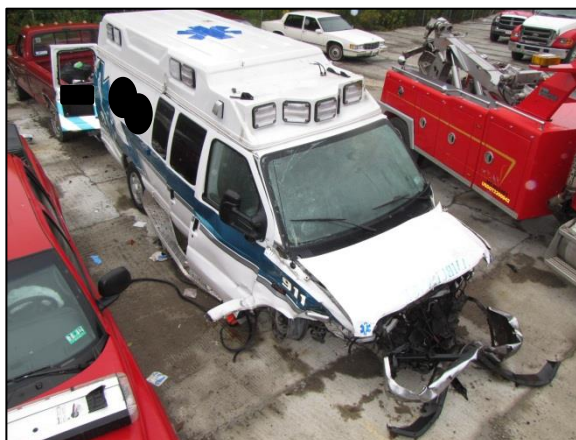
The 2012 Ford E-350 chassis (**Figure 6**) was identified by the Vehicle Identification Number (VIN): 1FDSS3EL7CDxxxxxx and was manufactured as an incomplete vehicle in June 2012. The digital odometer reading was 73,401 km (45,609 mile). The Super Duty, extended van was built on a 351 cm (138 in) wheelbase and was equipped with the Type II ambulance prep package. The rear-wheel drive vehicle had a Gross Vehicle Weight Rating (GVWR) of 4,309 kg (9,500 lb) with a front axle and rear axle rating of 1,905 kg (4,200 lb) and 2,760 kg (6,084 lb), respectively. The powertrain consisted of a 5.4-liter V-8 engine linked to a 5-speed automatic transmission. The vehicle manufacturer's recommended tire size was LT245/75R16 front and rear, with cold tire pressures of 414 kPa (60 PSI) front and 552 kPa (80 PSI) rear. The left front tire was a Firestone Transforce HT tire of the recommended size. The rear tires were Cooper Discoverer A/T tires of the recommended size. The front tire was missing. Specific tire data measured at the time of the SCI inspection was as follows:

Figure 6: Overhead front right oblique view of the Ford Type II ambulance.

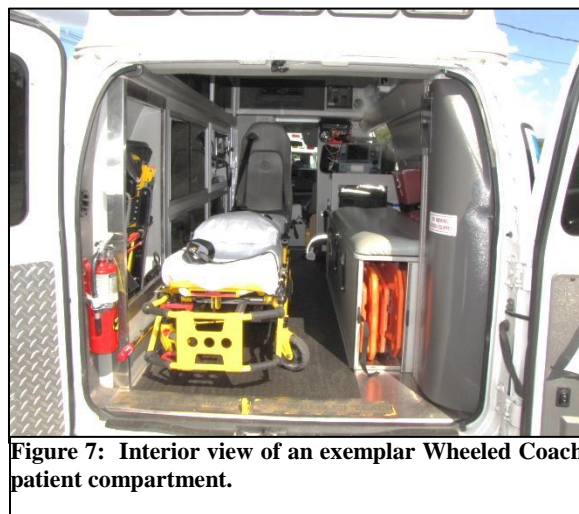
The Crusader Plus model patient compartment of the ambulance was manufactured by Wheeled Coach Industries of Winter Park, Florida and was installed on the Ford chassis in November 2012. The vehicle was received by the ambulance company in December 2012. **Figure 7** is an interior view of a similarly equipped Wheeled Coach Crusader Plus Type II ambulance ordered by the ambulance company at the same time as the focus vehicle. The patient compartment consisted of the typical Type II interior layout with a raised fiberglass roof. The layout included: double-rear entry doors for cot loading, an inward-facing three-passenger bench seat along the right side, a rear-facing Attendant's seat against the bulkhead immediately forward of the cot, double right side entry doors, multiple cabinets for storage and a pass-through to the cab compartment of the van with a sliding door. A custom cabinet and shelf was located at the forward aspect of the inward-facing bench. This unit measured 41 cm x 41 cm x 46 cm (16 in x 16 in x 18 in), width x height x depth. A 40 cm x 46 cm (15.8 in x 18 in), length x depth, area at the forward aspect of the bench seat was designed for bio-waste and sharps containers that were located under and enclosed within the bench.

Figure 7: Interior view of an exemplar Wheeled Coach patient compartment.

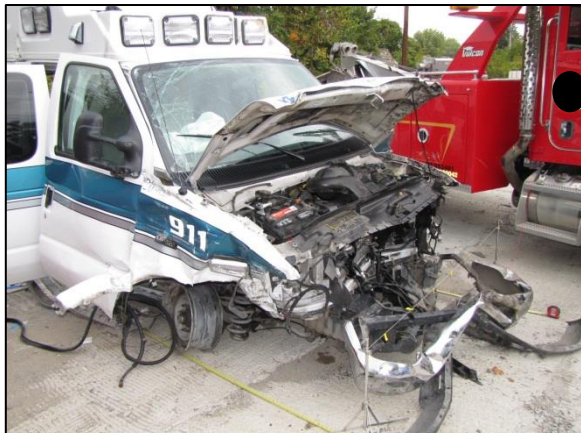
The front, right, top and left planes of the ambulance sustained exterior damage as a result of the multiple event crash sequence. The front plane sustained overlapping damage attributable to the Event 1 impact with the Jeep and the guardrail impact Event 3. Although not evident at the bumper level due to the overlap, the damage identified during the exterior inspection of the Jeep indicated the engagement of the ambulance began at its front right corner (**Figure 8**). The hood exhibited direct contact damage beginning 68 cm (26.8 in) right of center extending 17 cm (6.7 in) to its right edge. This damage pattern wrapped onto the right plane and extended rearward to

the mid-aspect of the right front door. The elevation of the contact damage extended 117 cm (46 in) above the ground consistent with the height of the Jeep's left plane damage. Longitudinal abrasions indicative of the vehicle-to-vehicle engagement was noted to the right fender of the ambulance. A contact abrasion to the housing of the ambulance's side mirror (front aspect) was associated to an abrasion on the Jeep's left front window glazing. The vehicles' interaction cut the front right tire and deformed the wheel rim of the ambulance. The front right rim contacted and gouged the roadway. The Collision Deformation Classification (CDC) assigned to this damage pattern was 12FRAE6.

Figure 8: Front right oblique view depicting the ambulance damage.

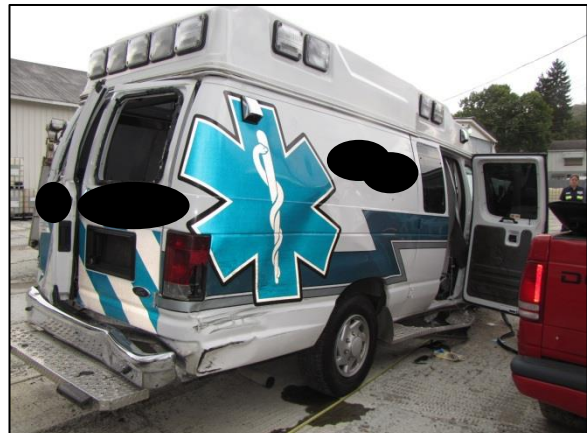
Figure 9: Right rear oblique view depicting the sideslap damage to the ambulance.

A 112 cm (44 in) region of sideslap damage (Event 2) was located on the right plane beginning at the right rear corner and extending forward (**Figure 9**). The pattern extended vertically 117cm (46 in). The maximum lateral crush measured less than 3 cm (1.0 in). Longitudinal abrasions flowing front-to-rear from impact with the Jeep were noted throughout the area. The taillight lens was fractured and the right end of the rear bumper was deformed rearward. The CDC of this damage pattern was 03RBEW1.

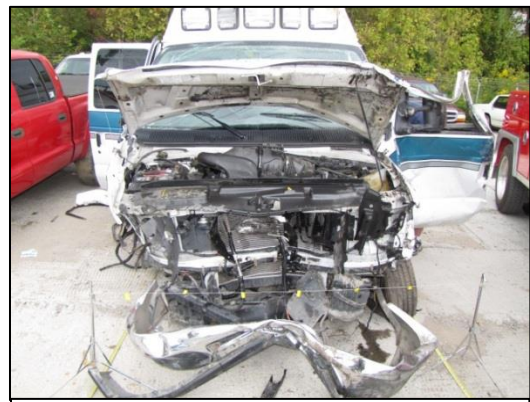
The direct contact damage on the front plane, due to the guardrail impact (Event 3), extended from bumper corner-to-bumper corner across the entire 173 cm (68 in) front plane (**Figure 10**). The deformed front bumper had separated from its frame rail mounts and was loosely hanging. Longitudinal crush was measured to the lower radiator support and was as follows: C1 = 0, C2 = 0, C3 = 13 cm (5.1 in), C4 = 8 cm (3.1 in), C5 = 4 cm (1.6 in), C6 = 17 cm (6.7 in). The residual deformation of the left frame-end measured 6 cm (2.5 in). The right frame

Figure 10: Front view of the ambulance damage.

end was undeformed. The CDC of this damage pattern was 12FDEW2. Due to the yielding properties of this impact, its analysis was beyond the scope of the WinSMASH program.

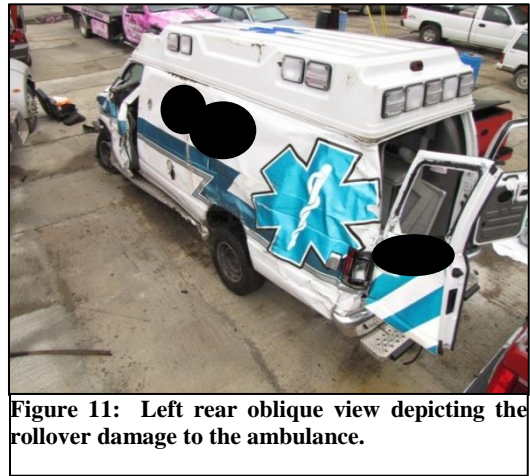
The left and top planes sustained body panel abrasions and deformation related to the two-quarter turn rollover event. The rollover event initiation was considered a fall-over. The aft aspect of the left panel sustained impact damage from ground contact (**Figure 11**). The damaged region began at the left rear corner and extended forward to the left rear axle area. Overlapping damage from recovery operations extended along the entire length of the left plane. The top plane was abraded by the overturn. The fiberglass roof remained attached and was intact. The CDC of the rollover damage was 00TDDO1.

Figure 11: Left rear oblique view depicting the rollover damage to the ambulance.

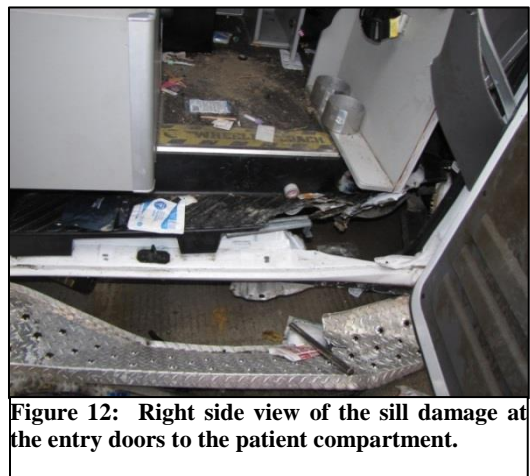
The left wheelbase was reduced 8 cm (3 in). The right wheelbase was reduced 38 cm (15 in). This reduction was attributed contact with multiple guardrail support posts. These posts also engaged the ambulance body along the right sill (**Figure 12**). The sill was torn rearward to a point 51 cm (20 in) aft of the B-pillar. The left front door remained closed during the crash and was forced open by the first on-scene bystander. The right door remained latched, but the frame separated from its mounting points due to guardrail support post impacts. The right and rear doors of the ambulance were jammed shut and forced open during the emergency response.

Figure 12: Right side view of the sill damage at the entry doors to the patient compartment.

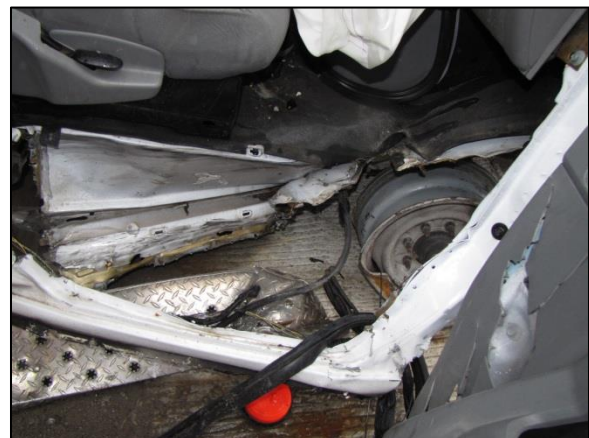
During the impact with the guardrail, the support posts penetrated the right occupant compartment at the right edge of the toe pan (**Figure 13**) and then continued along the right sill to B-pillar. The lower aspect of the door frame deformed outward creating a 41 cm (16 in) gap at the A-pillar and a 28 cm (11 in) gap at the B-pillar.

Figure 13: View of the front right interior and the damage to the right sill and door frame of the ambulance.

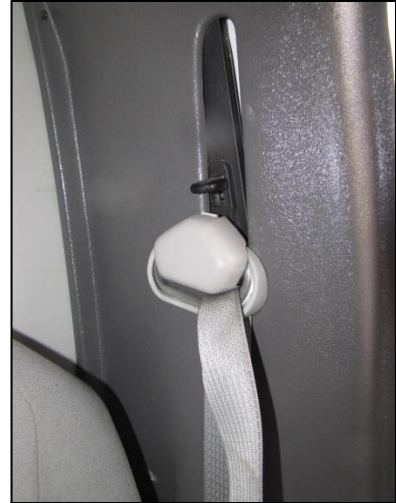
The driver's safety belt was found in an extended position at the time of the SCI inspection. The length of the webbing measured 180 cm (71 in) from the floor anchor to the D-ring. A small crease in the webbing, related to the location of the buckled latch plate, was observed 104 cm (41 in) above the anchor. The shoulder portion of the webbing was gathered and jammed in the forward aspect of the D-ring as a result of driver loading (**Figure 14**). Examination of the latch plate revealed evidence of historical wear. However, this vehicle was driven by multiple drivers; therefore, the latch plate wear could not be attributed to just the focus driver. The buckle pretensioner was actuated reducing the height of the buckle 95 mm (3.7 in). The driver was restrained by the safety belt based on the observations of the SCI inspection. This determination was consistent with the recorded EDR data.

Figure 14: Interior image depicting the condition of the ambulance driver's safety belt at the D-ring.

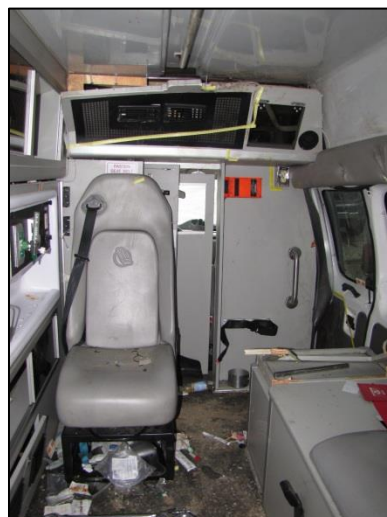
displacement of the unrestrained occupants about the compartment's interior. The occupants responded primarily to the guardrail impact and rollover (Events 3 and 4) and were displaced into the forward wall, coming to rest on top of one another on the roof. The left, back and right wall of the patient compartment was free of occupant contact evidence and/or damage.

Figure 15: View into the patient compartment of the ambulance looking forward.

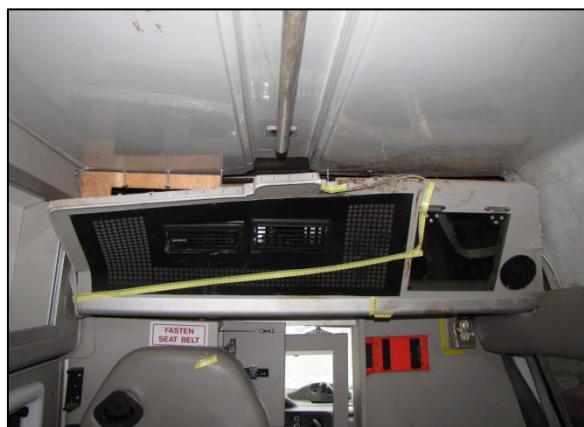
The upper aspect of the forward wall was contacted by the occupant across its entire 120 cm (47 in) width. The panel housing the heating, ventilation and air conditioner (HVAC) vents was displaced and deformed (**Figures 15 and 16**). Blood evidence was noted at the center and right aspects. An isolated 5 cm (2 in) diameter dent to the apex of the forward panel was located at the right center aspect. The cover of the 115-volt electrical outlet was dented with associated blood evidence. The vinyl upholstery on the upper aspect of the rear-facing attendant's seat was scuffed and torn from occupant loading. The upholstery and padding surrounding belt guide/D-ring for displaced. A large area of post-crash blood evidence was noted to the padding that was applied to the forward right entry door to the patient compartment.

Figure 16: Close-up view of the occupant contacts at the upper aspect of the patient compartment's forward wall.

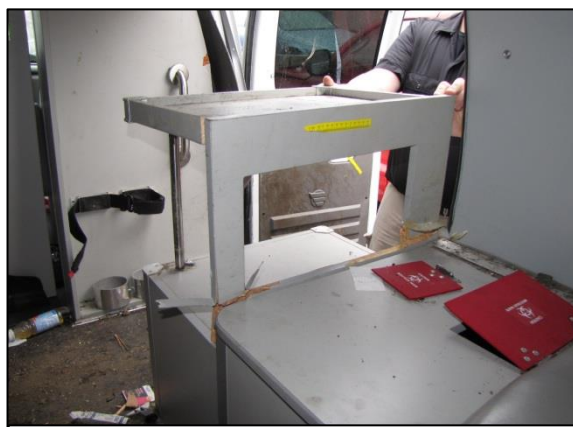
Figure 17: Image depicting the fractured custom shelf unit at the forward aspect of the patient compartment bench seat.

The custom cabinet and shelf (located at the forward aspect of the inward-facing bench) was fractured by the displaced Paramedic occupant (**Figure 17**). The unit was manufactured of 2 cm (0.75 in) plywood finished with Formica bonded with glue and wooden pegs. This shelf unit housed the cardiac monitor and various supplies that were in use at the time of the crash. The right upper arm and flank of Paramedic contacted and fractured the shelf. The fracture of her

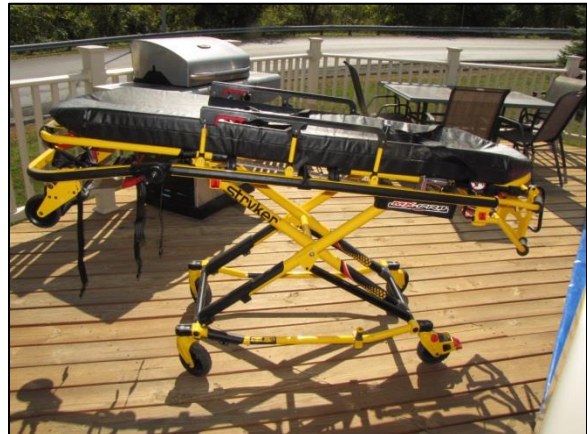
The patient was being transported on a Stryker Model 6082 MX-Pro R3 cot (**Figure 18**). The manually-operated cot was rated for an occupant load of 295 kg (650 lb). The cot did not appear to be damaged or deformed. The X-frame raised and lowered without binding. The IV poles and side rails were undamaged. The locking pin attached to the right longitudinal frame member did not appear to be loaded or deformed.

Figure 18: Right side view of the ambulance cot.

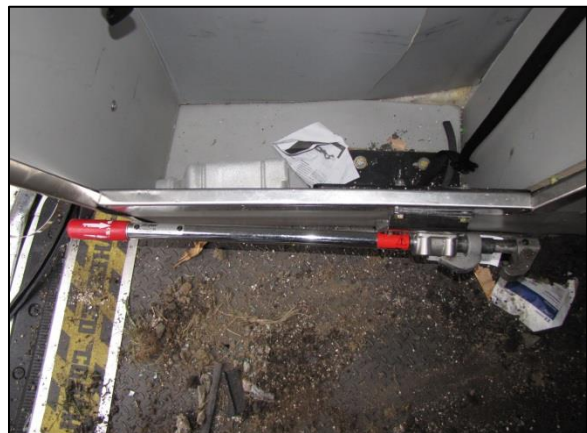
At inspection, the rail clamp was not functional and appeared deformed. The clamp was mounted to the lower wall that formed the stair chair enclosure at the left rear of the patient

Figure 19: Image of the ambulance cot rail clamp fastener.

compartment. This area had sustained induced deformation as a result of ground contact during the rollover and likely rendered the clamp inoperative.

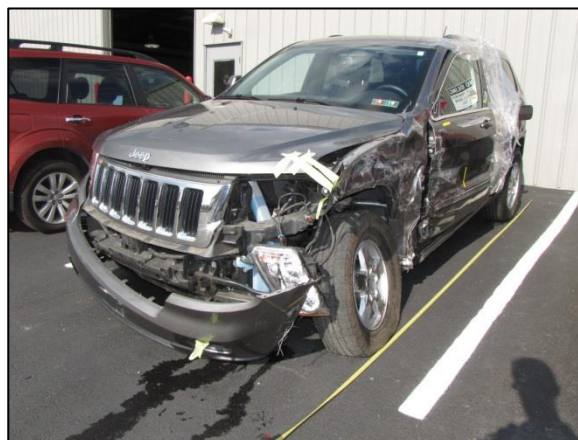
The 2012 Jeep Grand Cherokee (**Figure 20**) was identified by the Vehicle Identification Number (VIN): 1C4RJFAG5CCxxxxxx. The digital odometer reading was 71,334 km (44,326 miles). The rear-wheel drive sport utility vehicle was built on a 292 cm (115 in) wheelbase and was equipped with the Laredo trim package. The Jeep had a GVWR of 2,948 kg (6,500 lb) with a front axle and rear axle rating of 1,452 kg (3,200 lb) and 1,678 kg (3,700 lb), respectively. The powertrain consisted of a 3.6-liter V-6 gasoline engine linked to a 5-speed automatic transmission. Additional features included Traction Control, Electronic Stability Control (ESC), and a Tire Pressure Monitoring System (TPMS). The brakes were front/rear disc with electronic brakeforce distribution and emergency brake assist. The vehicle manufacturer's recommended tire size was P245/70R17 front and rear, with cold tire pressures of 228 kPa (33 PSI). All four tires were Goodyear Fortera HL tires of the recommended size. Specific tire data measured at the time of the SCI inspection was as follows:

Figure 20: Front left oblique view of the Jeep Grand Cherokee.

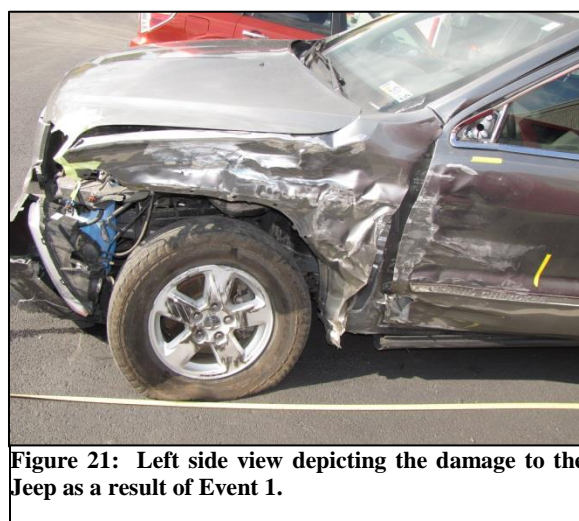
The Jeep sustained two regions of impact damage to its left plane that were directly related to Events 1 and 2. The impact damage related to Event 1 began at the mid-aspect of the left front door 175 cm (68.8 in) forward of the rear axle reference point and extended forward 193 cm (76 in) to the front left corner (**Figure 21**). The door plane and left fender exhibited longitudinal abrasions consistent with the right plane/forward aspect damage identified on the ambulance. The left fender separated in the impact preventing lateral crush documentation. The estimated maximum crush within the contact pattern was approximately 8 cm (3 in) at the front left corner. The vehicle's structural support inboard of the fender was not damaged. The front bumper fascia was separated at its left aspect. The sidewall of the left front tire was punctured and direct contact damage was noted to the left front wheel rim. An abrasion was noted to the left front door frame and left front window glazing caused by contact from the housing of the ambulance's right mirror. The CDC assigned to this damage pattern was 08LYAW2.

Figure 21: Left side view depicting the damage to the Jeep as a result of Event 1.

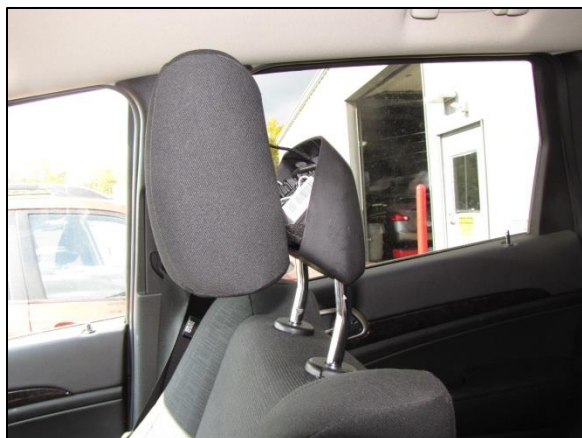
Both the driver's and front right passenger's AHR actuated as a result of the crash (**Figure 22**). The padded portion of the restraint translated forward to help protect the occupant's head and neck from excessive rearward acceleration and motion. The manufacturer's literature stated that this spring-loaded device was actuated by the electronic release of the latch mechanism internal to the device and was controlled by the Air Bag control Module during a rear-impact event. The AHR could be manually reset and was reusable.

Figure 22: View depicting the actuated active head restraint in the Jeep.

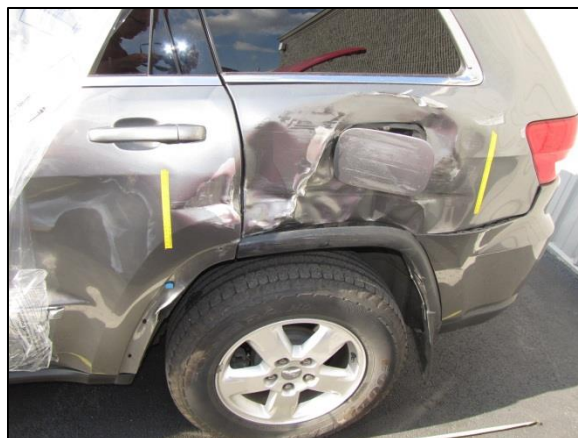
Figure 23: Left view depicting the sideslap damage to the Jeep.

A region of sideslap damage (Event 2) on the left quarter-panel surrounded the right rear wheel opening (**Figure 23**). The direct contact damage began 46 cm (18.2 in) aft of the right rear axle and ended 35 cm (13.8 in) forward of the axle reference. The maximum crush within the region was 5 cm (2 in). The CDC describing this damage pattern was 09LZEW1.

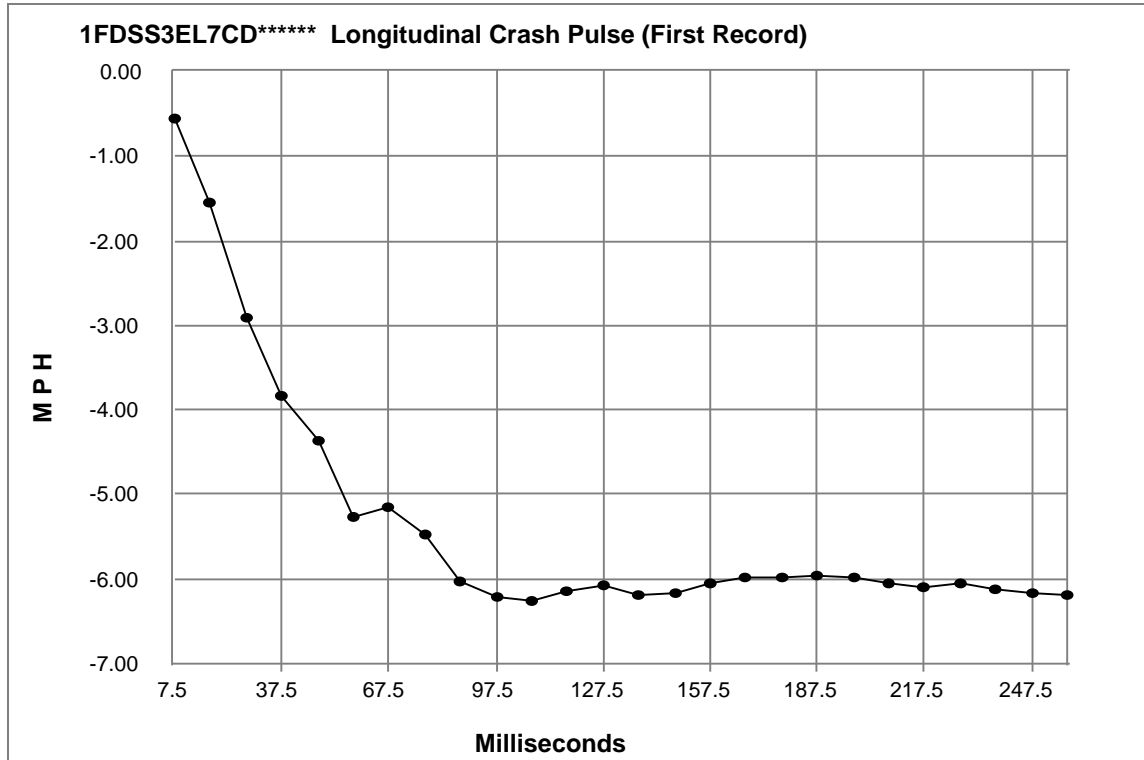
Longitudinal Crash Pulse (First Record)

Time (msec)	Delta-V, longitudinal (MPH)	Delta-V, longitudinal (km/h)
7.5	-0.55	-0.89
17.5	-1.54	-2.47
27.5	-2.90	-4.67
37.5	-3.84	-6.17
47.5	-4.36	-7.02
57.5	-5.27	-8.47
67.5	-5.15	-8.29
77.5	-5.48	-8.81
87.5	-6.02	-9.69
97.5	-6.21	-9.99
107.5	-6.26	-10.08
117.5	-6.15	-9.89
127.5	-6.08	-9.78
137.5	-6.19	-9.97
147.5	-6.16	-9.91
157.5	-6.05	-9.73
167.5	-5.97	-9.61
177.5	-5.98	-9.63
187.5	-5.97	-9.61
197.5	-5.99	-9.64
207.5	-6.06	-9.76
217.5	-6.09	-9.80
227.5	-6.06	-9.75
237.5	-6.12	-9.85
247.5	-6.16	-9.92
257.5	-6.19	-9.96

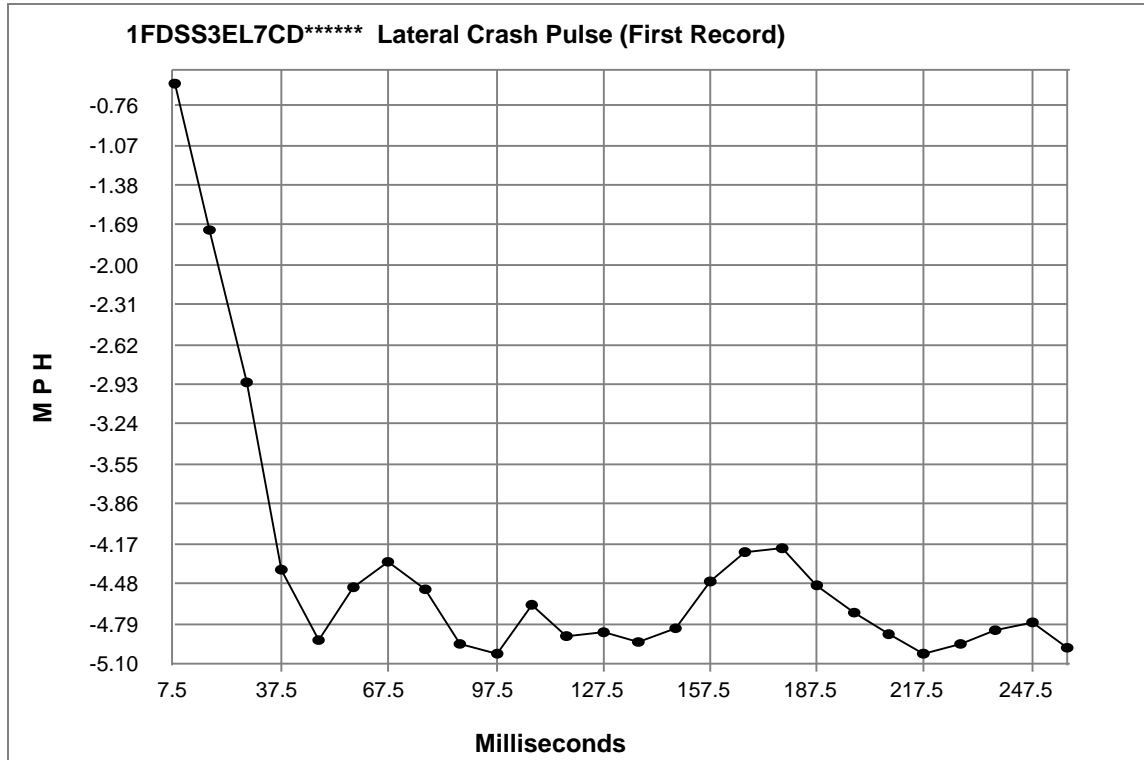
Lateral Crash Pulse (First Record)

Time (msec)	Delta-V, lateral (MPH)	Delta-V, lateral (km/h)
7.5	-0.59	-0.95
17.5	-1.73	-2.79
27.5	-2.92	-4.70
37.5	-4.36	-7.02
47.5	-4.92	-7.92
57.5	-4.51	-7.26
67.5	-4.31	-6.94
77.5	-4.52	-7.27
87.5	-4.95	-7.97
97.5	-5.02	-8.08
107.5	-4.64	-7.47
117.5	-4.88	-7.85
127.5	-4.85	-7.81
137.5	-4.93	-7.93
147.5	-4.83	-7.77
157.5	-4.46	-7.18
167.5	-4.23	-6.81
177.5	-4.21	-6.77
187.5	-4.49	-7.22
197.5	-4.70	-7.56
207.5	-4.87	-7.84
217.5	-5.03	-8.09
227.5	-4.94	-7.95
237.5	-4.84	-7.78
247.5	-4.78	-7.69
257.5	-4.97	-8.00

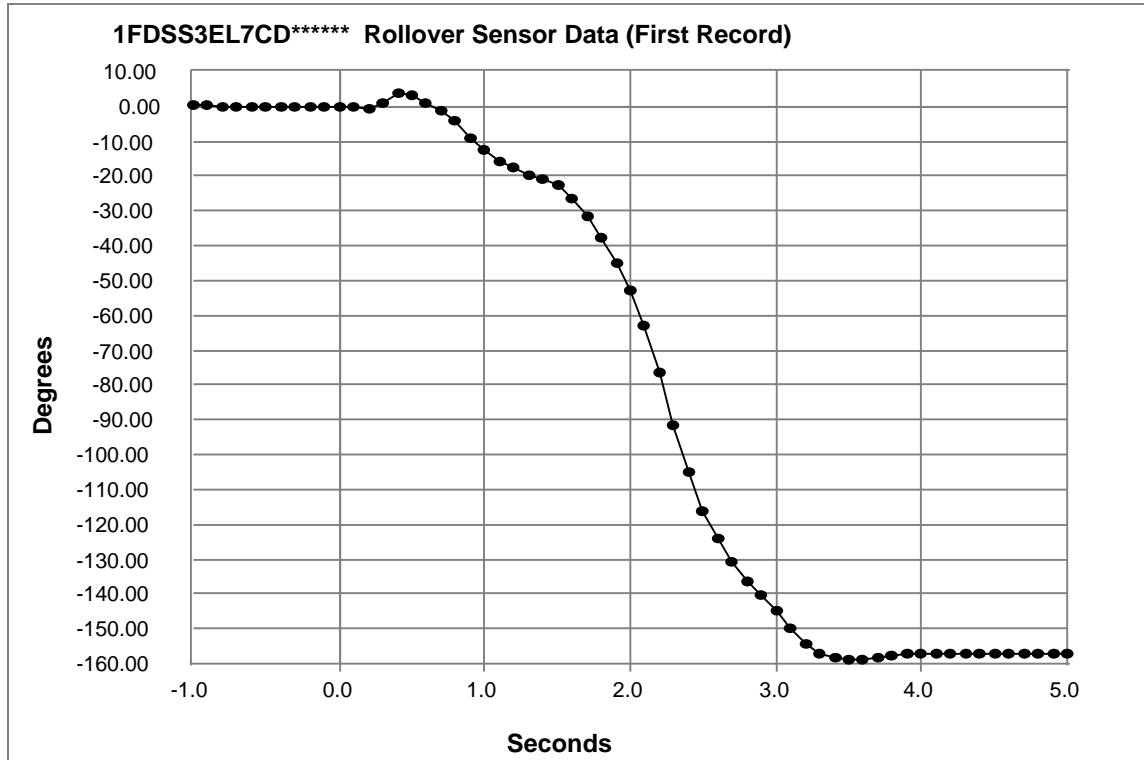
Rollover Sensor Data (First Record)

Time (sec)	Vehicle roll angle (degrees)
-1.0	0.32
-0.9	0.26
-0.8	0.15
-0.7	-0.11
-0.6	-0.25
-0.5	-0.26
-0.4	-0.26
-0.3	-0.19
-0.2	0.04
-0.1	0.14
0.0	0.05
0.1	-0.38
0.2	-0.58
0.3	1.14
0.4	3.7
0.5	3.1
0.6	0.76
0.7	-1.23
0.8	-4.31
0.9	-8.92
1.0	-12.68

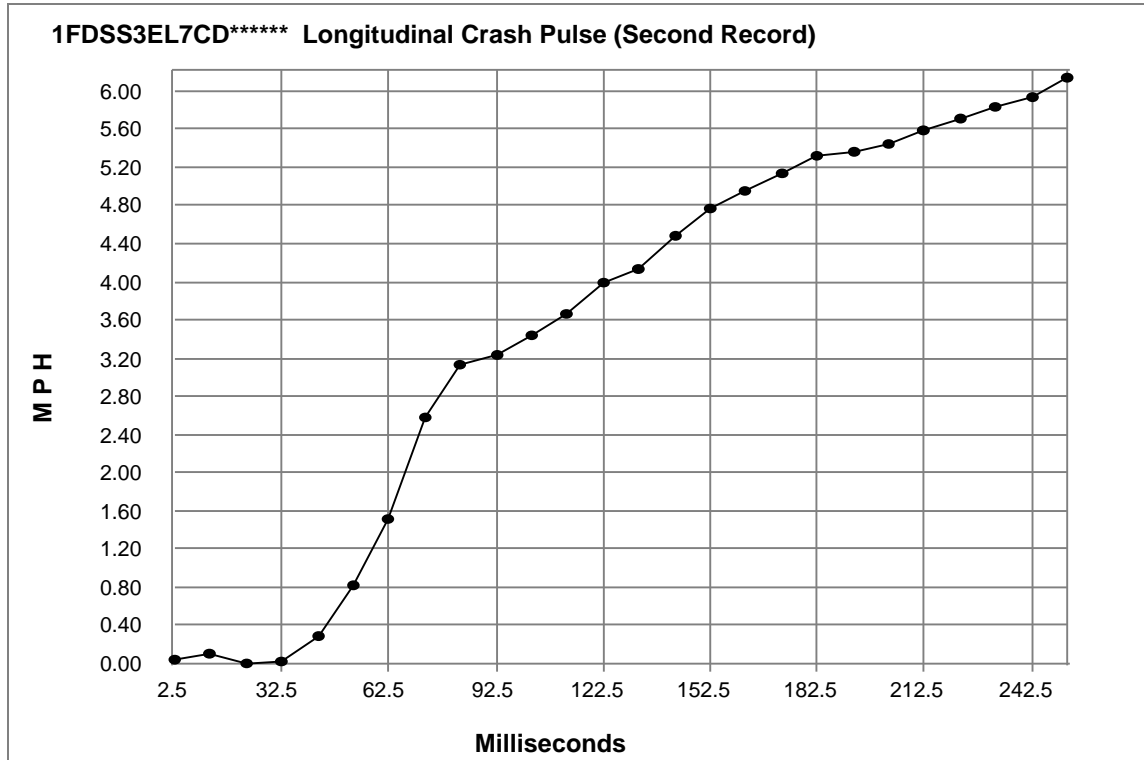
Longitudinal Crash Pulse (Second Record)

Time (msec)	Delta-V, longitudinal (MPH)	Delta-V, longitudinal (km/h)
2.5	0.05	0.07
12.5	0.11	0.18
22.5	0.00	0.01
32.5	0.01	0.02
42.5	0.29	0.47
52.5	0.82	1.32
62.5	1.51	2.44
72.5	2.59	4.16
82.5	3.13	5.04
92.5	3.24	5.21
102.5	3.44	5.53
112.5	3.65	5.88
122.5	4.00	6.44
132.5	4.13	6.65
142.5	4.49	7.22
152.5	4.77	7.68
162.5	4.95	7.97
172.5	5.13	8.26
182.5	5.32	8.56
192.5	5.36	8.63
202.5	5.44	8.75
212.5	5.58	8.98
222.5	5.72	9.20
232.5	5.84	9.39
242.5	5.94	9.55
252.5	6.14	9.89

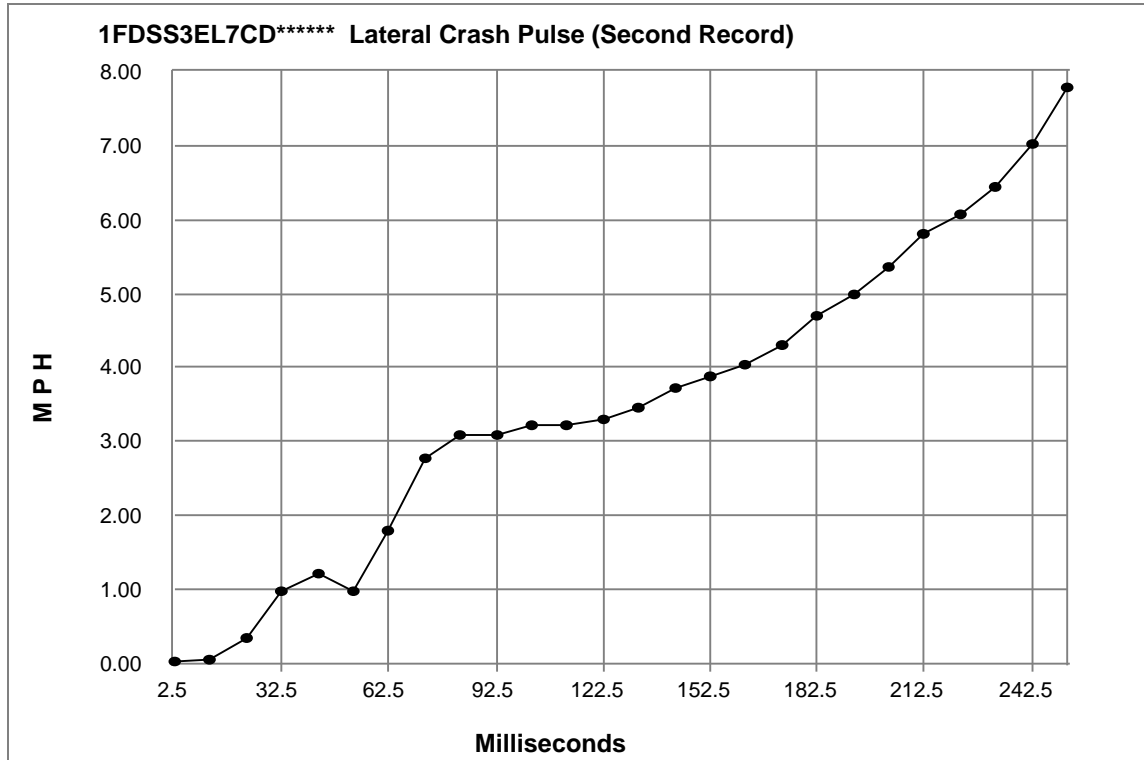
Lateral Crash Pulse (Second Record)

Time (msec)	Delta-V, lateral (MPH)	Delta-V, lateral (km/h)
2.5	0.01	0.02
12.5	0.05	0.08
22.5	0.34	0.55
32.5	0.98	1.58
42.5	1.21	1.95
52.5	0.98	1.58
62.5	1.79	2.88
72.5	2.78	4.47
82.5	3.10	4.98
92.5	3.08	4.95
102.5	3.23	5.20
112.5	3.22	5.19
122.5	3.31	5.32
132.5	3.47	5.58
142.5	3.73	6.01
152.5	3.87	6.23
162.5	4.03	6.49
172.5	4.29	6.91
182.5	4.69	7.56
192.5	4.98	8.01
202.5	5.37	8.64
212.5	5.80	9.34
222.5	6.08	9.79
232.5	6.45	10.38
242.5	7.03	11.32
252.5	7.78	12.53

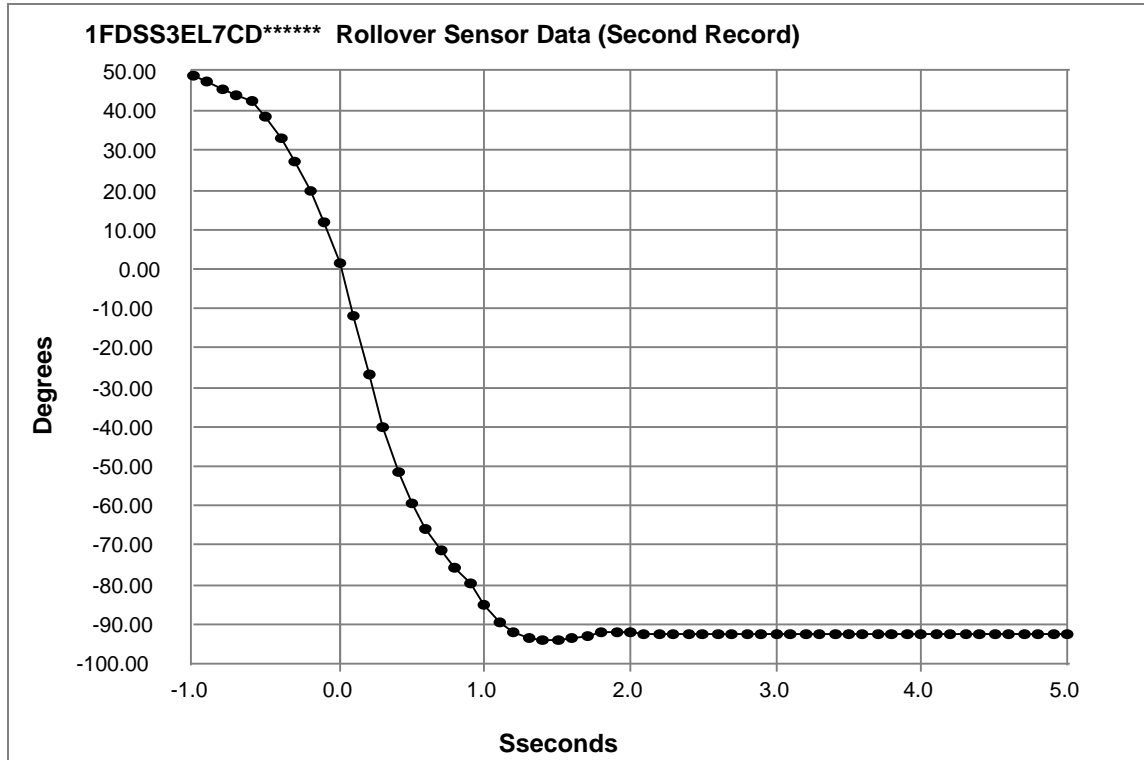
Rollover Sensor Data (Second Record)

Time (sec)	Vehicle roll angle (degrees)
-1.0	49.25
-0.9	47.44
-0.8	45.38
-0.7	43.9
-0.6	42.36
-0.5	38.57
-0.4	33.35
-0.3	27.37
-0.2	19.99
-0.1	11.87
0.0	1.68
0.1	-11.65
0.2	-26.6
0.3	-40.08
0.4	-51.49
0.5	-59.29
0.6	-65.98
0.7	-71.36
0.8	-75.52
0.9	-79.78
1.0	-85.02

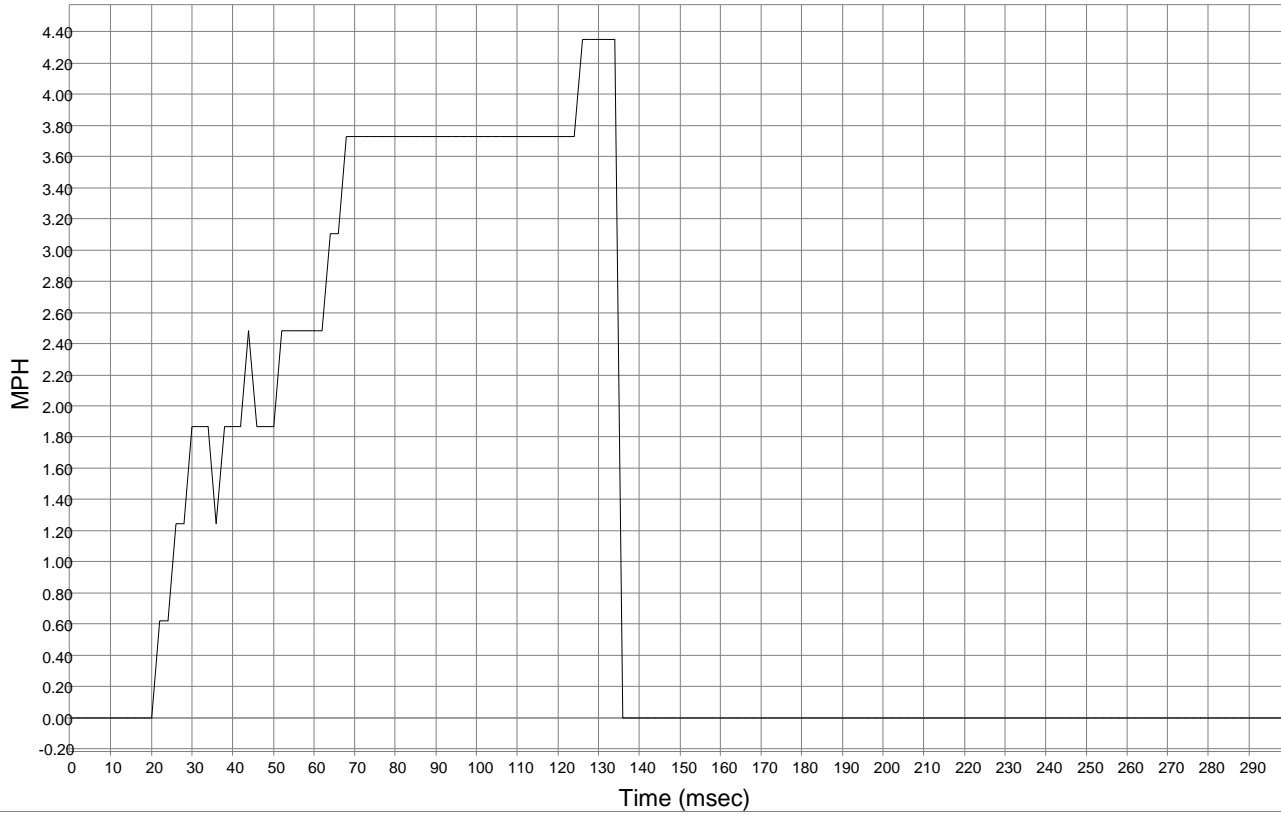
Longitudinal Crash Pulse (Most Recent Event)

Time (msec)	Delta-V, Longitudinal (MPH [km/h])
0	0.0 [0]
2	0.0 [0]
4	0.0 [0]
6	0.0 [0]
8	0.0 [0]
10	0.0 [0]
12	0.0 [0]
14	0.0 [0]
16	0.0 [0]
18	0.0 [0]
20	0.0 [0]
22	0.6 [1]
24	0.6 [1]
26	1.2 [2]
28	1.2 [2]
30	1.9 [3]
32	1.9 [3]
34	1.9 [3]
36	1.2 [2]
38	1.9 [3]
40	1.9 [3]
42	1.9 [3]
44	2.5 [4]
46	1.9 [3]
48	1.9 [3]
50	1.9 [3]
52	2.5 [4]
54	2.5 [4]
56	2.5 [4]
58	2.5 [4]
60	2.5 [4]
62	2.5 [4]
64	3.1 [5]
66	3.1 [5]
68	3.7 [6]
70	3.7 [6]
72	3.7 [6]
74	3.7 [6]
76	3.7 [6]
78	3.7 [6]
80	3.7 [6]
82	3.7 [6]
84	3.7 [6]
86	3.7 [6]
88	3.7 [6]
90	3.7 [6]
92	3.7 [6]
94	3.7 [6]
96	3.7 [6]
98	3.7 [6]
