3C9 Failure of Engineering Materials Lab Report

Louis Zeng (lz406)

Fitzwilliam College, February 2021

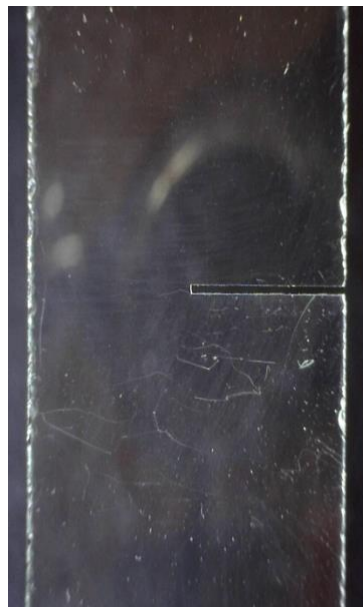
(Middle) Strip specimen cut from PMMA sheet.

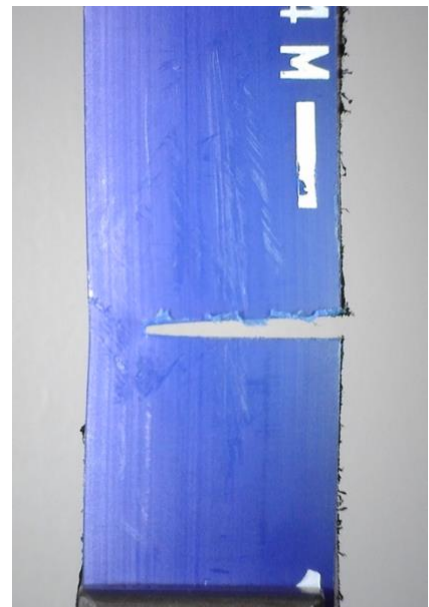
(Right) Strip specimen cut from MDPE pipe.

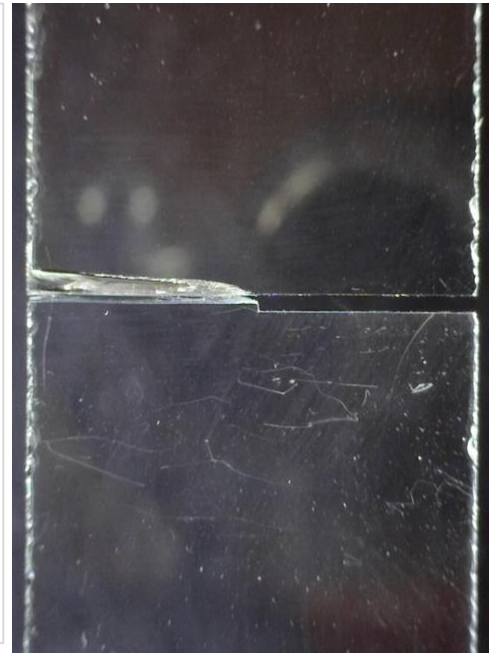
In the experiment, both the load-extension graph of PMMA (shown left) and their behaviours in axial tensile testing (shown right) suggest linear elastic fracture mechanics (fast fracture) applies to PMMA specimens.

- In the left graph, PMMA displacements increase linearly until sudden failures.
- From Table 1 above, when failures happen, PMMA specimens have very small failure extensions.
- In the right photo, the edge crack in the specimen expands quickly (coincides with sudden plunge in the load-extension graph), lead to its failure.

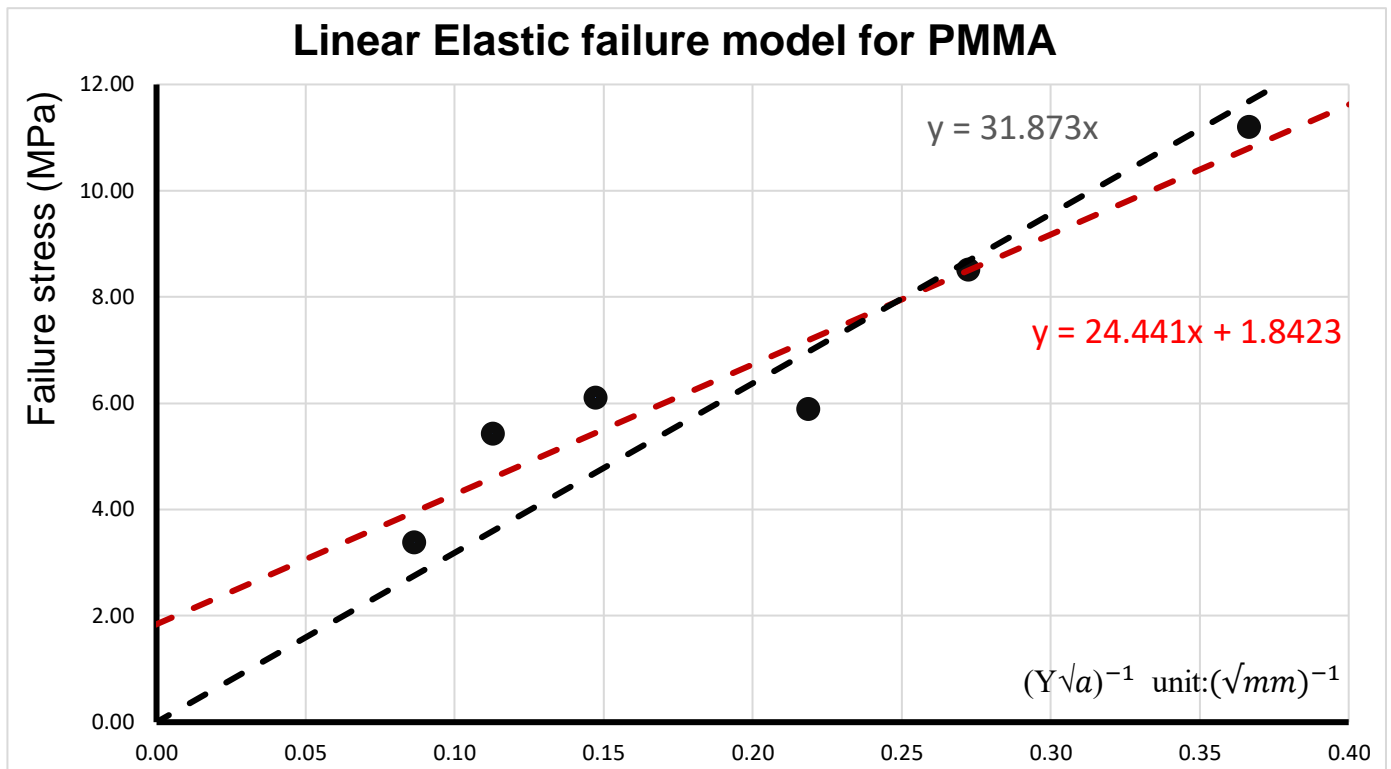
Failure stress σ_f ---- $(Y\sqrt{a})^{-1}$ graph for PMMA specimens is plotted as above.

If Linear Elastic fracture mechanics applies for PMMA, we would expect a straight line with slope $K_c/\sqrt{\pi}$ (black line) which goes through the origin. However, the best fit linear relationship between σ_f and $(Y\sqrt{a})^{-1}$ given by Excel is the red line $\sigma_f = 24.441(Y\sqrt{a})^{-1} + 1.8423$ which doesn't go through the origin.

And it can be observed from the plots that the data aren't perfectly located on the red line (best fit) nor the black line (expected when material is perfectly linear elastic).

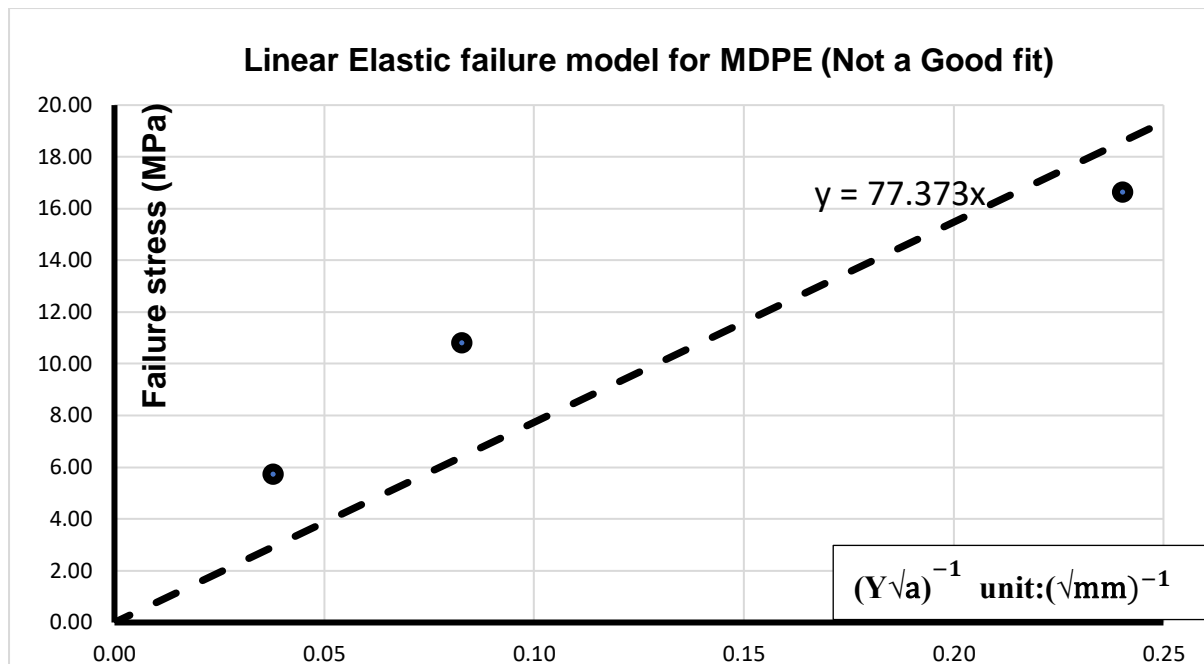
Just for entirety, failure stress σ_f ---- $(Y\sqrt{a})^{-1}$ graph for MDPE specimens is plotted as above.

While it can be seen that data doesn't fit well on a straight line that goes through the origin; but the results from only 3 data sets is not conclusive.

But we can say that fractures on MDPE are unlikely resulted by linear elastic failure.
