ชื่อโครงการ : **Repair Caterpillar G3516NA Gas
Engine water ingested**

บริษัท : **PTTEP**

Project Type	Maintenance
Business Line	Exploration & Production
Operational Function	Maintenance and Inspection
Operational Unit	Bongkot Well Head Platform 06
Equipment Type	Gas Engine
Product Group	Booster Compressor

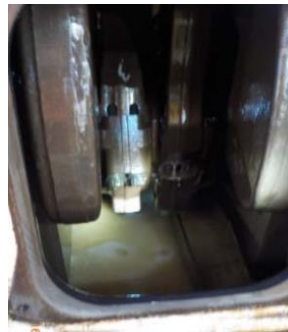
3.1	Detail	<p>WP06 was tripped with water surge tank low level function, and found lube oil mixed with cooling water. Later, during cylinder block pressurize test, it was found cooling water droplets seeping between gear cluster, inside flywheel housing, rear end. Thus, WP06 gas engine was decided to replace plug O-ring instead of remove engine to overhaul onshore, which is very high cost.</p>

Figure 1: Lube oil mixed with cooling water inside engine crankcase

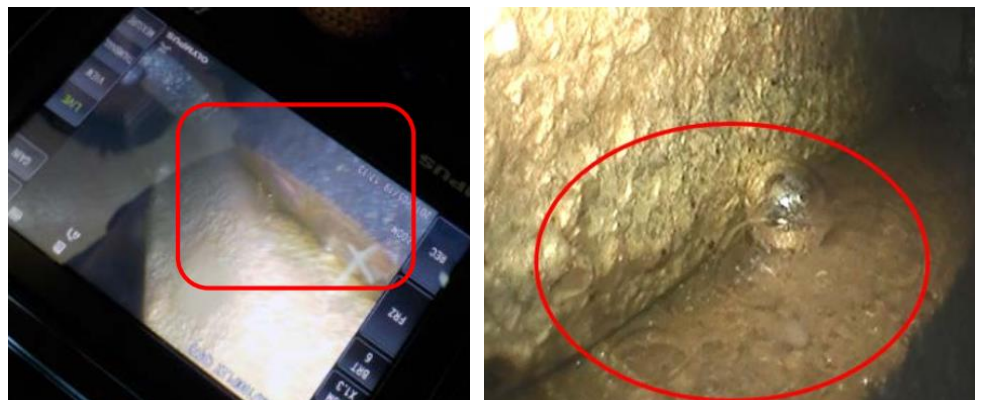
In this case, it was leak at water manifold plug as shown in figure 3, while figure 4 shown combined water path of cylinder liner and manifold plug.

Figure 3: Water droplets seeping at gear cluster rear end during pressure test

Finally, WP06 has decided to replace manifold plug O-rings onsite to be extend engine change out to meet target at 72,000 running hour (currently is 57,378 hrs base on Jul 4th 2019), and minimize operational cost.

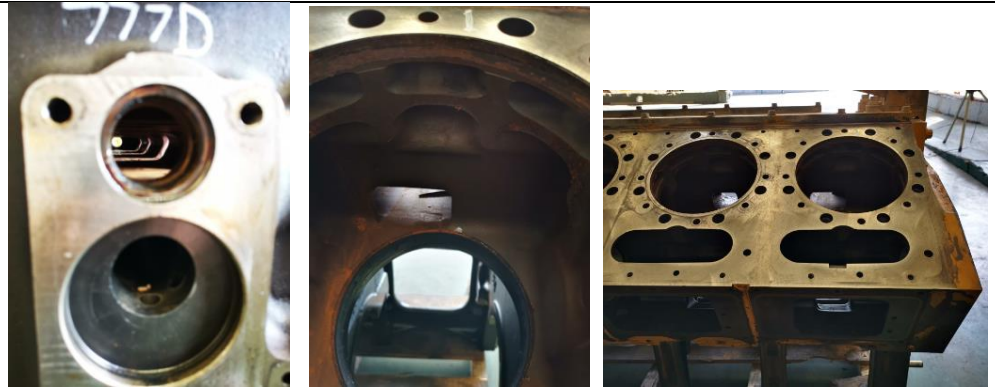
Figure 4: Path connecting between manifold plug and cylinder liner in cylinder block

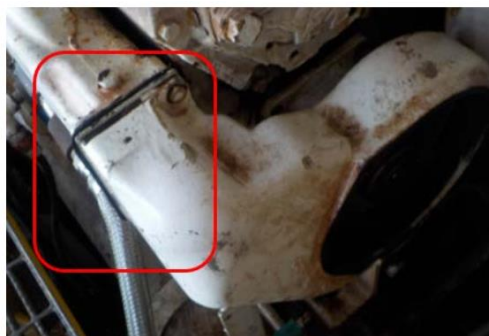
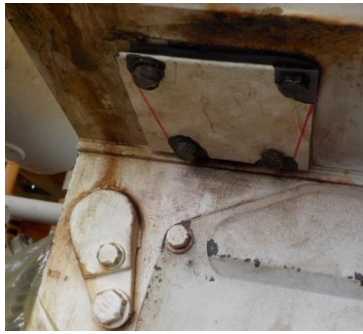
To find out leaking point, it is required cylinder block pressure test up to 70 psi. Figure 5 shown spade point with rubber gasket.

Figure 5: Spade points for pressure test

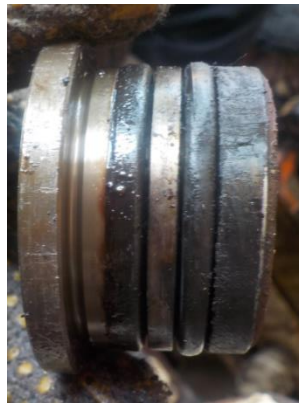
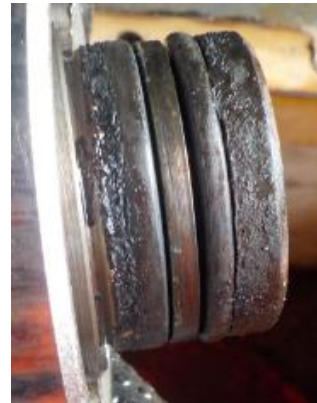
Condition of manifold plug O-rings after removal found deteriorated O-rings display in figure 6.

Figure 6: Plug O-rings condition front and rear respectively
