Temporary Clamp Management e-TCM (Shark tank winner 2020)

Temporary Clamp Management (eTCM)

Implement Location
X-MN/X-OP/ T-II/TP-PO

Clamp is the best repair method for a maintenance engineer which prefers to repair any leakages to prevent an expensive and unwanted shutdown. However, its improper management can make a lack of monitoring and tracking of online leak sealing points causing an effect on its maintenance plan, trouble, and finally met the incident. So, this system is able to provide the leak sealing location mapping and risk assessment leading to effective maintenance planning, inspection and monitoring.

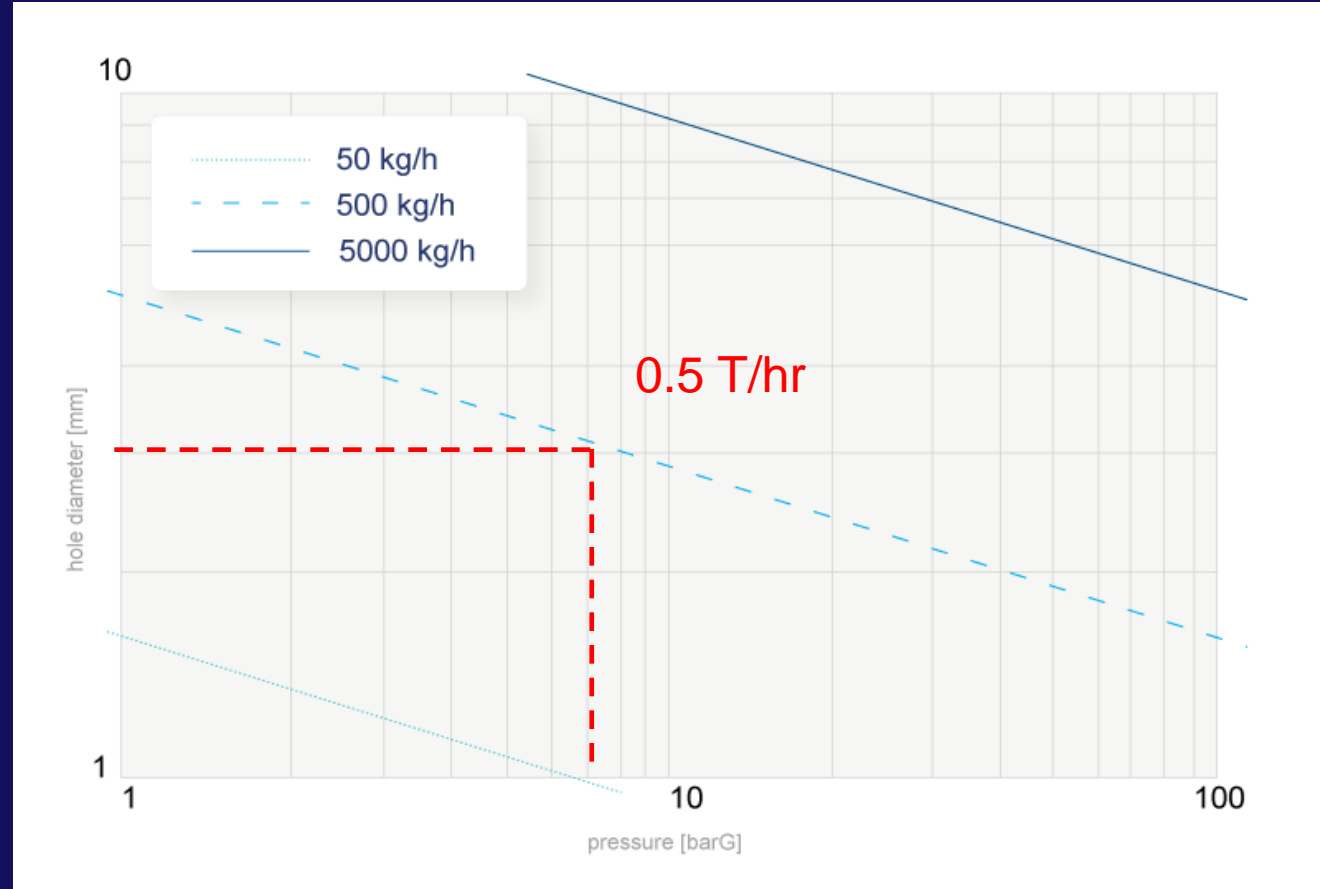
Fig. Release rate as a function of pressure and hole diameter
for a liquid with density of 650 kg/m³

1. Hole size 3 mm at Pressure 7 Barg release rate at	0.5	T/hr
2. Naphtha* price is	370	US/T
3. Then 24 hr leak, calculated (0.5x370x24)	4,440	US/ Day
4. Convert to Baht (30.02 Baht/US)	133,289	Baht/Day
From historic of PTTGC, the number of HC clamps are	250	Clamps/yr
- Saving 250x133,289 =	33.32	MB/year
- Safety factor 50%	<u>16.66</u>	<u>MB/year</u>

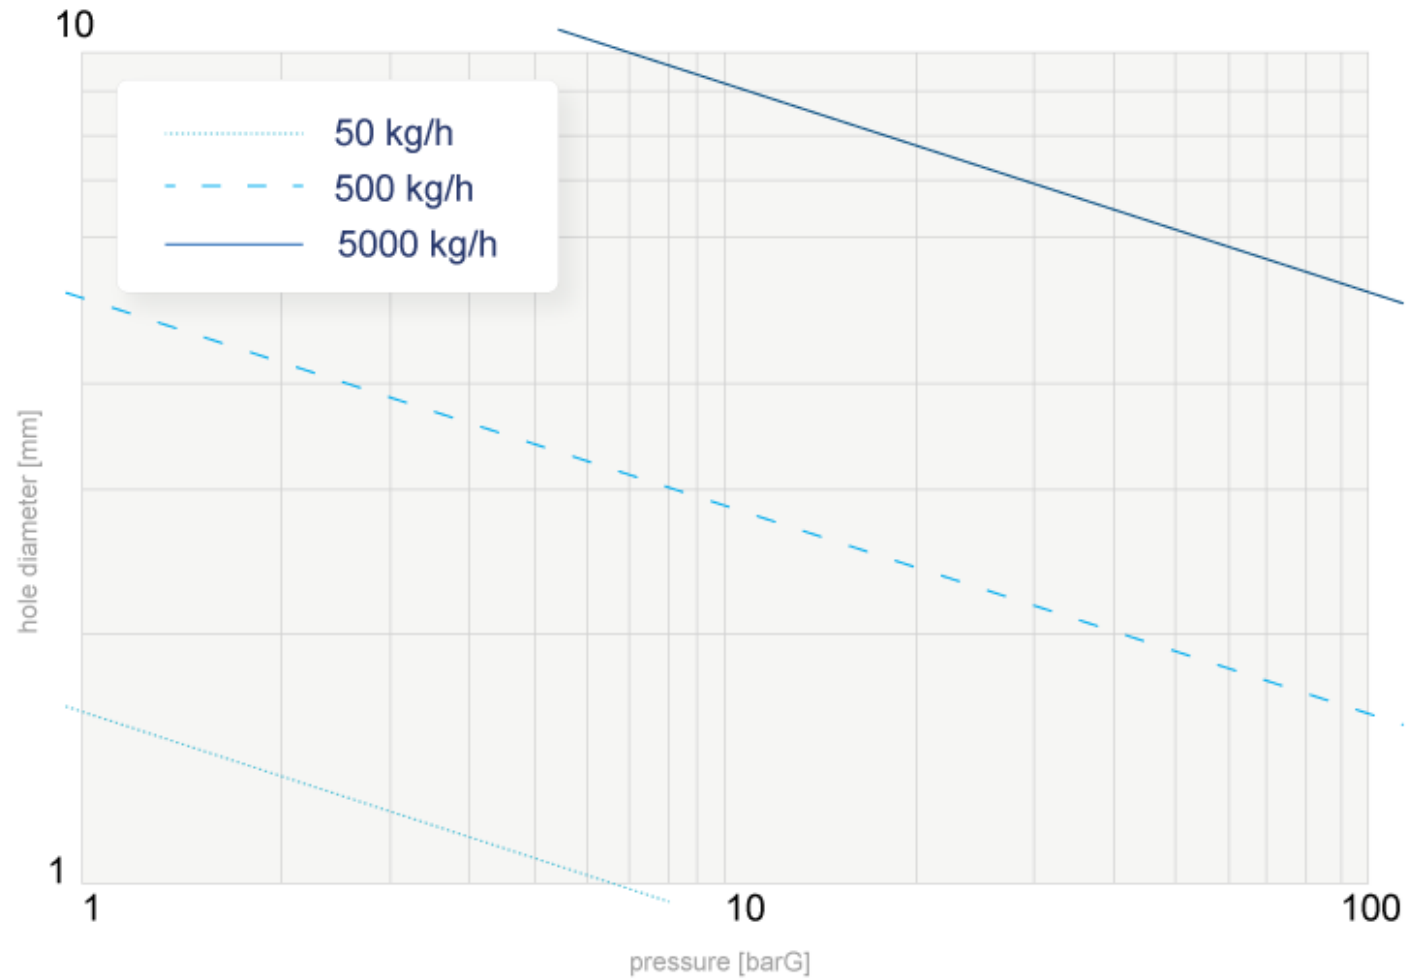
Fig. Release rate as a function of pressure and hole diameter for a liquid with density of 650 kg/m³

Table: Release Hole Sizes and Areas Used in Consequence Analyses

Release Hole Number	Release Hole Size	Range of Hole Diameters (mm)	Release Hole Diameter, d_n (mm)
1	Small	0 – 6.4	$d_1 = 6.4$
2	Medium	> 6.4 – 51	$d_2 = 25$
3	Large	> 51 – 152	$d_3 = 102$
4	Rupture	> 152	$d_4 = \min [D, 406]$

***Referred from API RP 581 Risked Based Inspection Methodology
