VOITH Gear Box SG ESP Bearing Damage (Unplan SD 12 Days)

By Kitipon Nusong

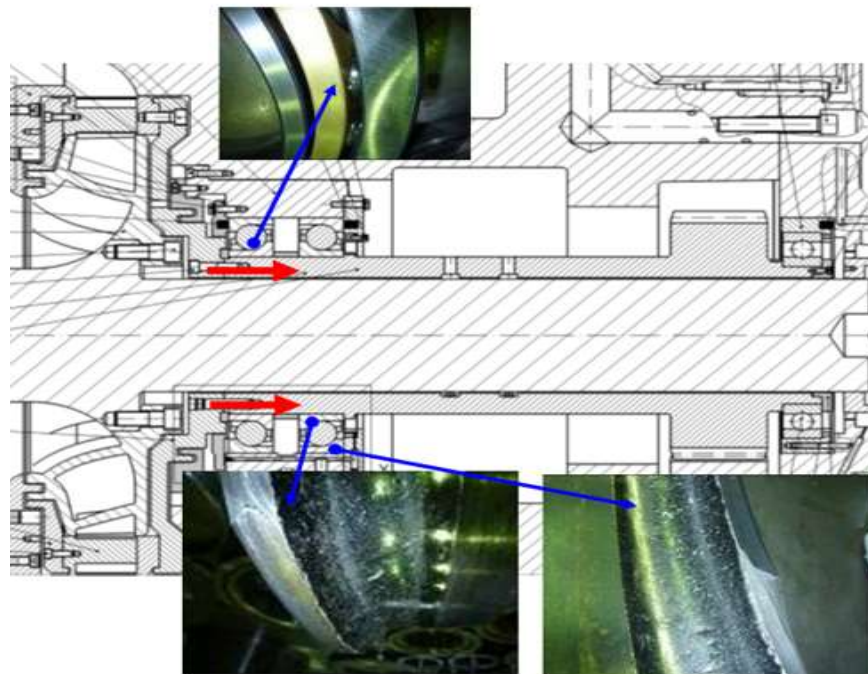
Abnormal raceway is clear indication of too high axial thrust

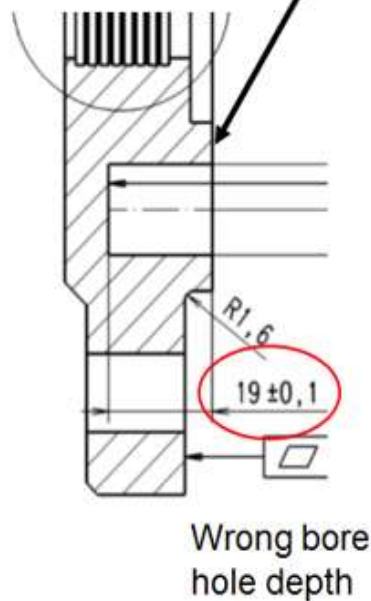
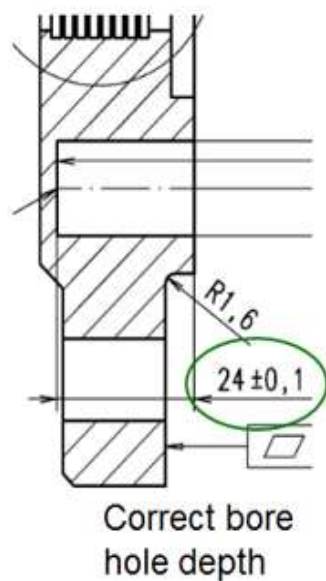
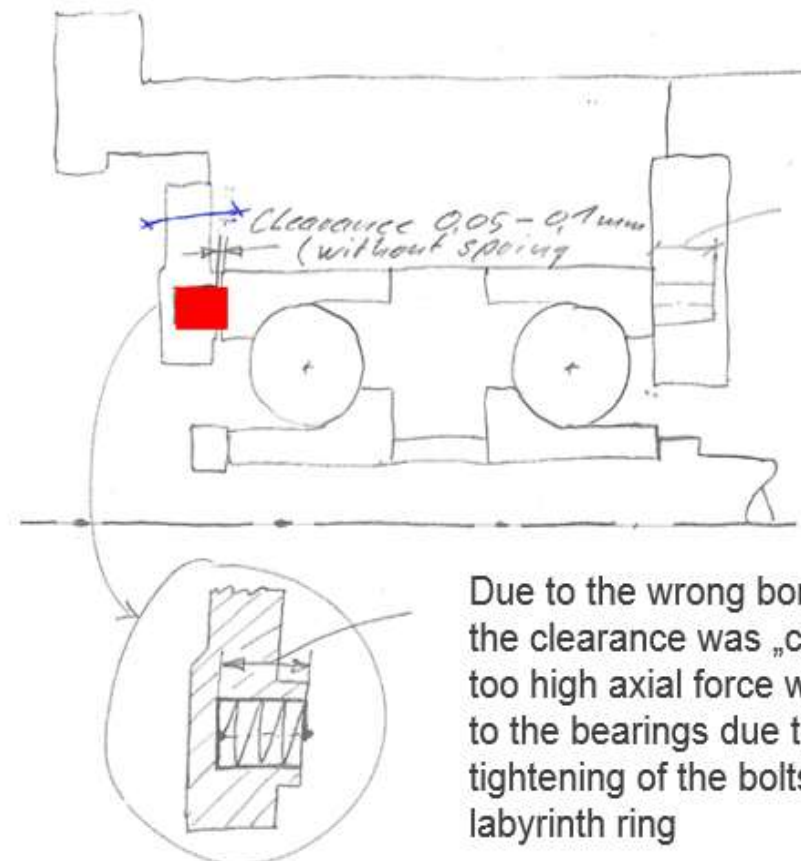
This surface is machined to adjust the axial bearing clearance. Therefore the bore hole depth can become smaller than 19 mm

Due to the wrong bore hole depth the clearance was „closed“ and too high axial force was applied to the bearings due to the tightening of the bolts of the labyrinth ring

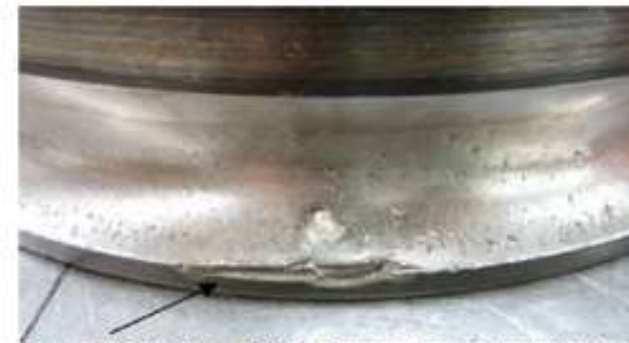
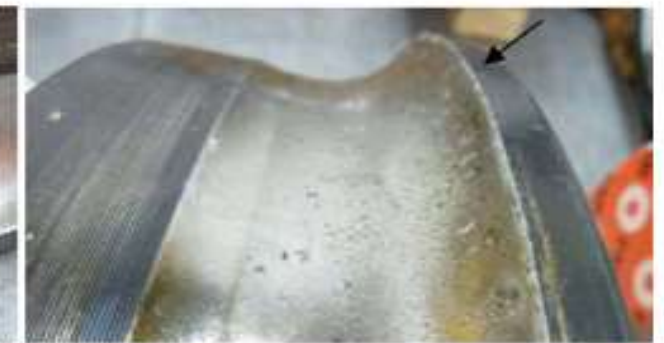
figure 25: bearing B13.2 - inner ring - circumferential damage

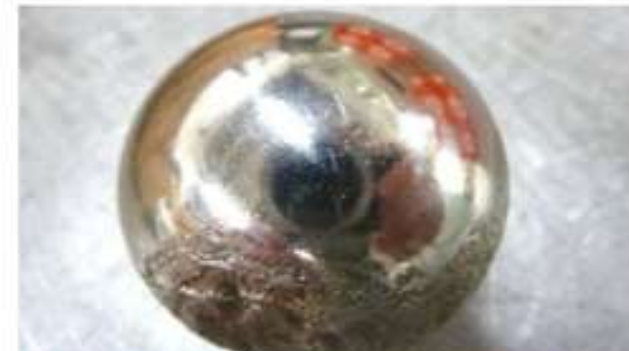
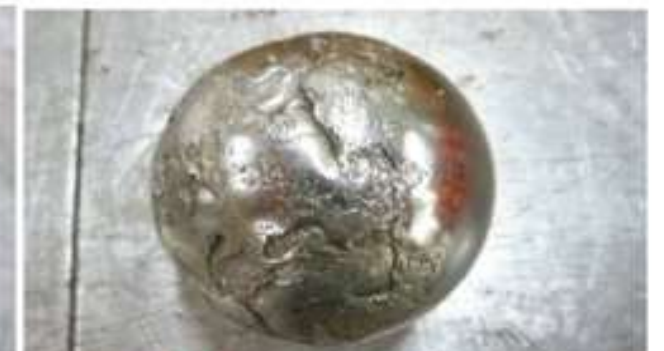
figure 26: bearing B13.2 - rolling elements - abrasive wear on all balls

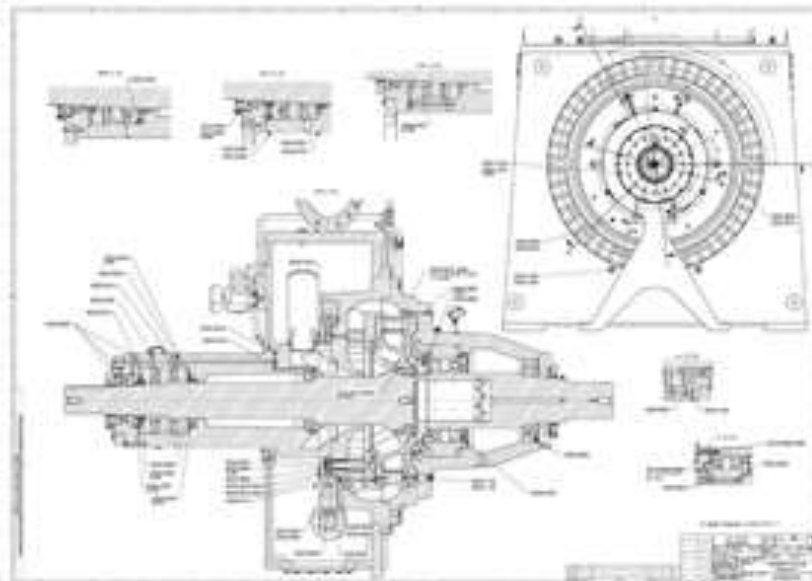
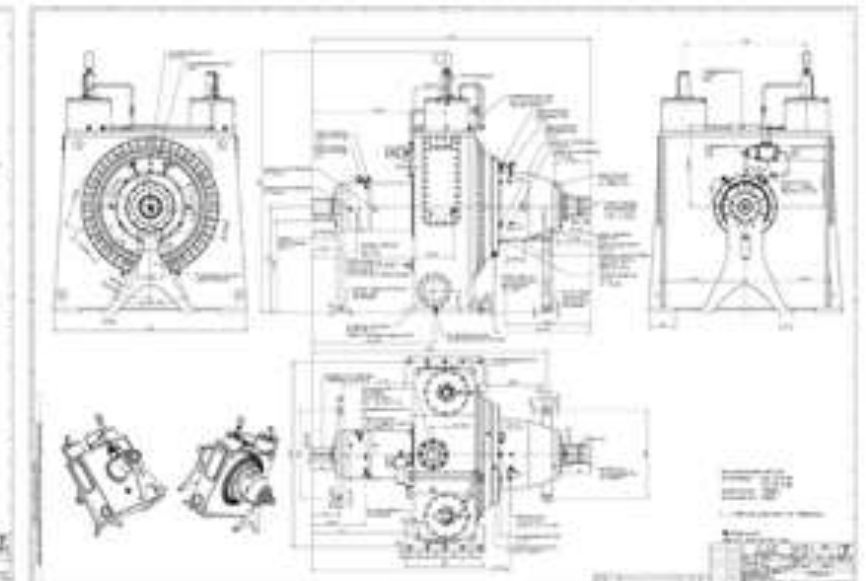
Figure 4: Assembly plan 91500620510

With Load fro Test
Bearing Life Time is
88987 Hrs or >10
Years
