## Oncology: Case 1 cont.

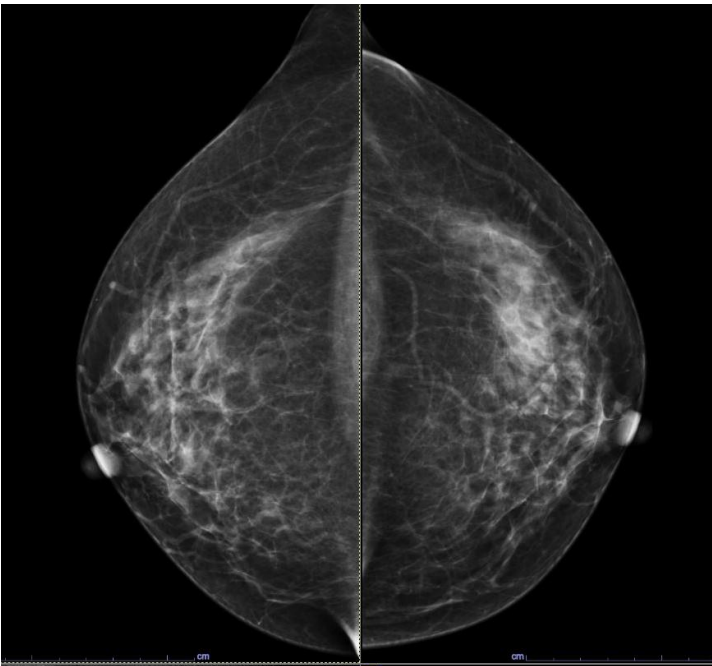
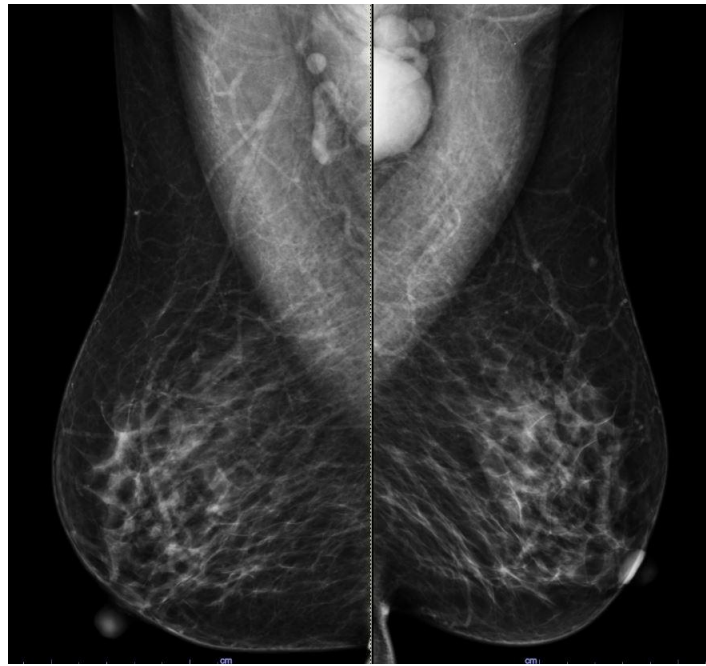
There is focal asymmetry with architectural distortion in the upper outer quadrant of the left breast.

Left-sided enlarged lymph nodes.

I'm not a radiologist, but based on the images provided, there do appear to be areas of architectural distortion, particularly in the upper outer quadrant of the left breast. Architectural distortion can be seen as areas where the normal tissue structure appears to be pulled or distorted. However, it's crucial to note that any findings based on this interpretation should be confirmed by an expert radiologist in a clinical setting. Always seek a professional opinion for medical images and diagnoses.

Based on the mammographic images provided, the primary focus is on the breast tissue itself, and lymph nodes, particularly axillary lymph nodes, might not be as clearly visualized as they would be in other imaging modalities, like an ultrasound or MRI.

From the images you've provided, it's challenging to definitively comment on the status of the lymph nodes. However, if there are concerns about lymph node involvement, a targeted axillary ultrasound is commonly performed to better evaluate the lymph nodes for any signs of enlargement or other abnormalities.
