FIELD REVIEW REPORT - #R002

Project No: 2021-0448-12 Date: November 25, 2025

Project: University of Waterloo –Math 4

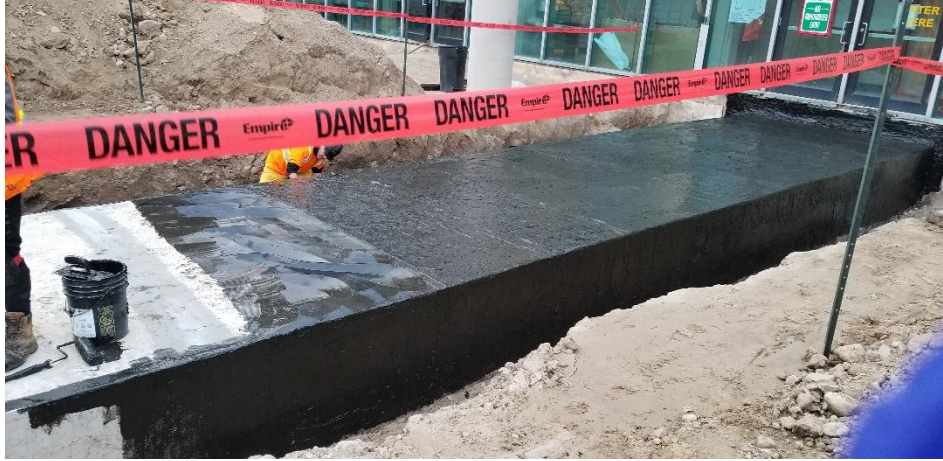
- R002-1 Waterproofing application was in progress for tunnel extending south from Davis Centre, approximately 90% complete upon arriving on site.
- R002-2 Lift thickness was measured in a random sample of locations in collaboration with the waterproofing applicator. Top lift thickness was confirmed to be at least 120mil, and total high-build thickness was confirmed to be at least 240 mil complete with fabric reinforcement.
- R002-3 Detail work at the existing Davis centre and the south termination of waterproofing was reviewed.

Photo 1: Site progress of waterproofing application

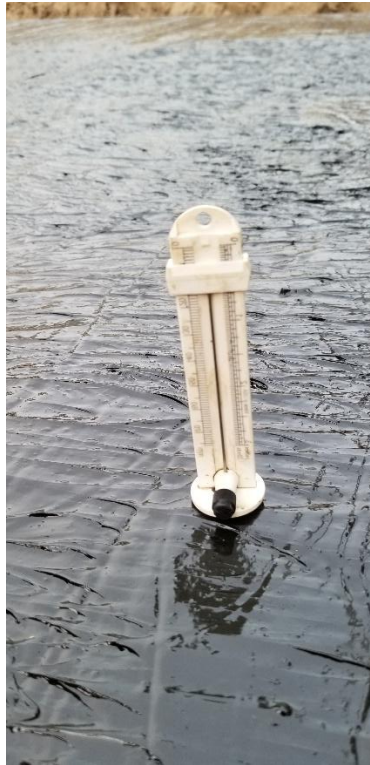
Photo 2: Confirmation of total application thickness (tunnel roof)

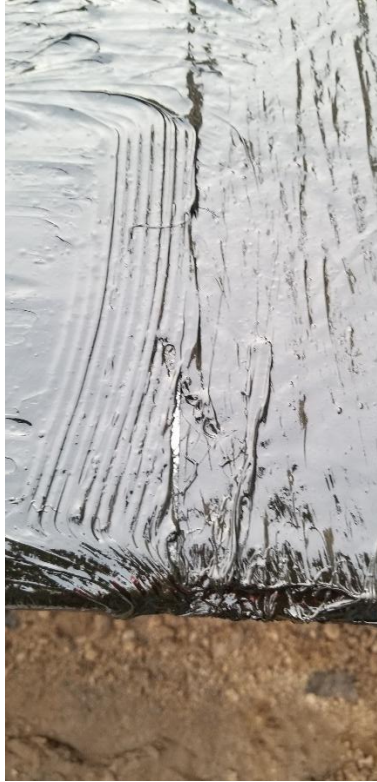
Photo 3: Reinforcing fabric protruding through top lift (repaired)

- R002-4 The waterproofing tie in to the existing waterproofing on the south end of the tunnel was discussed. Existing waterproofing materials are asphalt based, and therefore a tie in cannot be performed since materials are not compatible. The existing waterproofing has failed, and therefore an attempt at a tie-in is redundant.
- R002-5 Some areas were observed to have the fabric reinforcement protruding through the top waterproofing lift. The contractor was to touch up these areas, which was observed by WalterFedy prior to leaving site.
