Internet of Things Security
Case Study:

IP CAMERAS

UNIVERSITÀ
DEGLI STUDI DI BARI
ALDO MORO

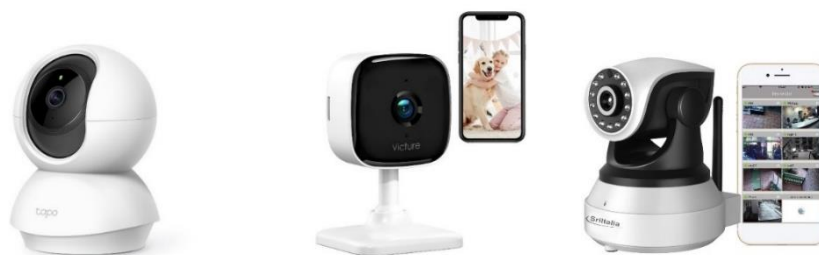
Figure 2: Our devices: TAPO C200 (left), Victure PC440 (center), SriItalia SP017-S (right)

- *TapoC200*: The Tapo C200 is an IP camera designed for home use. Tapo C200 has several technical features such as compatibility with the main smart home systems (e.g., Alexa and Google Assistant); night vision, resolution up to Full HD; motion detection; acoustic alarm; data storage; voice control; use with third-party software; webcam mode. To use the Tapo C200, a TP-Link account is required which allows access to the various cloud services offered. Access to the TP-Link account is via the Tapo app, which is available free. The application has a simple and intuitive user interface, from which it is possible to use and manage the devices of the Tapo family, including the Tapo C200. The range of services offered for the Tapo C200 includes Remote access and control of the Tapo C200; Sharing the Tapo C200 with other accounts; synchronization of settings; integrating the Tapo C200 with smart home systems and receiving motion notifications.

- *Victure PC440*: It's an indoor wi-fi camera that offers several features such as sound and motion detection, two-way audio, night vision, and cloud / SD storage. It's a system designed for the surveillance of infants, the elderly, and pets. It is supported by the secure and tested Amazon Web Service (AWS) to protect the privacy of its client. AWS complies with FBI Criminal Justice Information Security (CJIS) standards. All Victure data transmissions adopt the HTTPS encryption protocol, protecting all communications between user and server. For example, when streaming cameras feed the o mobile phone, Victure protects the data stream with multiple security layers such as HTTPS, transport layer security, and Twofish encryption.

- *SriItalia SP017-S*: It's an IP security camera smartly designed to let users watch live videos directly from home, office, or anywhere. It offers many features such as remote control, Infrared night vision, local storage feature, motion detection, and email notification while providing uninterrupted video recording. Furthermore, it can be synchronized via AP Hotspot when offline so that, using a wireless access point, the camera can be connected to the phone directly without a router.

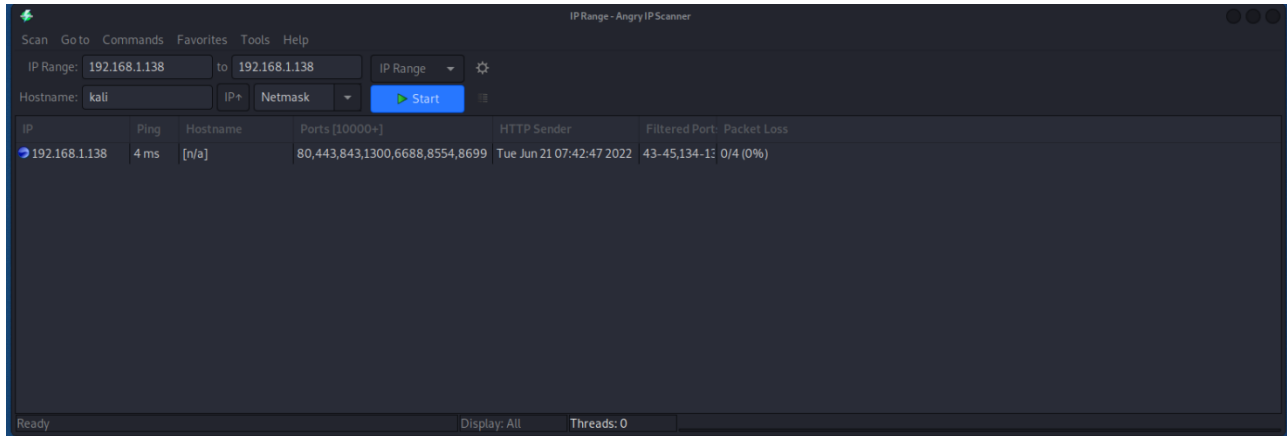
Figure 5: Angry IP scan usage

We used it, in combination with `nmap`, to discover new open ports and any exploitable vulnerabilities.

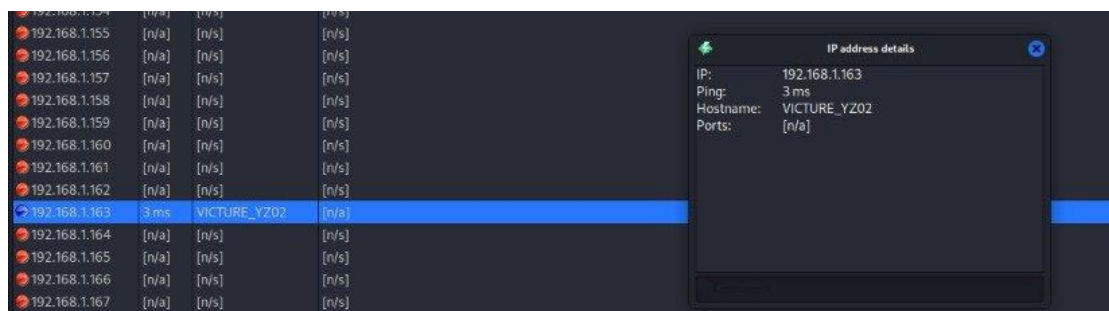
Figure 11: Angry IP Scanner on launched on the Victure camera. No open ports were found.

Not satisfied, we attempted to use another tool we found in the literature which is the Angry IP Scanner but no open ports were found.

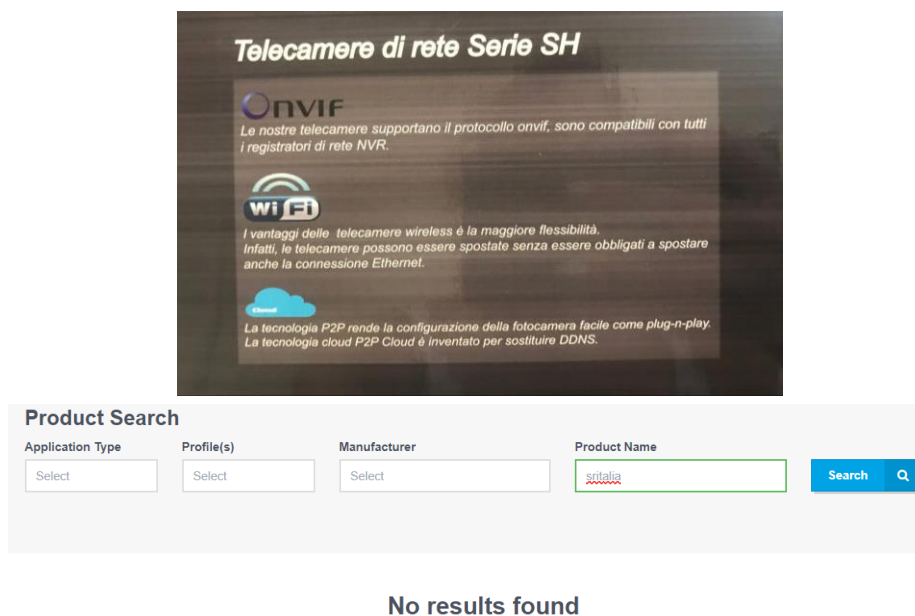
Figure 14: SriItalia doesn't seem to be ONVIF compliant, but the box says otherwise

Even though the *SriItalia SP017-S* claims to be ONVIF compliant – they also put this information on the box, as displayed in Figure 14, top–, the official ONVIF website⁷ has no records about the product – Figure 14, bottom. Anyway, we assumed the truthfulness of the information provided by the box.

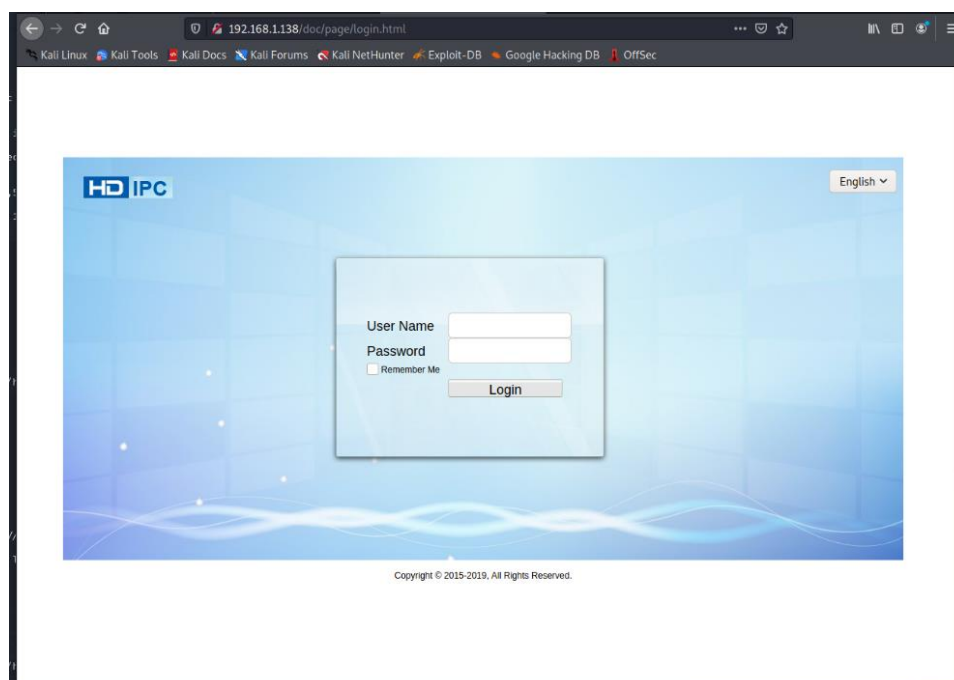
Figure 15: SriItalia Login page after using the IP of the Cam as an URL

After inserting the IP address of the Cam in the search bar, we were prompted with a login web page, as shown in Figure 15.

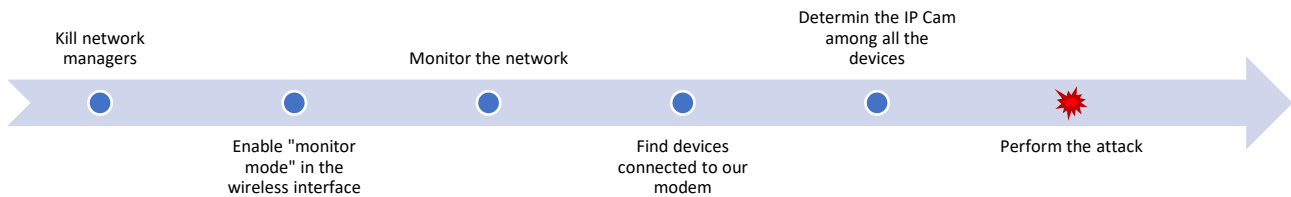
Figure 18: De-authentication Framework

- 1) Kill interfering processes: we kill interfering processes that can cause trouble.
- 2) Enable “monitor mode” in the wireless interface: such modality allows to read all the packets of data and control the traffic received on wireless-only networks.
- 3) Monitor the network.
- 4) Find devices connected to our modem.
- 5) Determine the IP cam among all the devices.
- 6) Perform the attack.

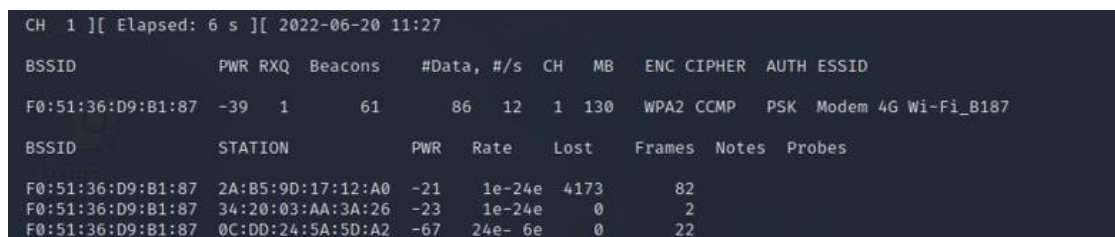
BSSID	PWR	RXQ	Beacons	#Data, #/s	CH	MB	ENC	CIPHER	AUTH	ESSID
F0:51:36:D9:B1:87	-39	1	61	86 12	1	130	WPA2	CCMP	PSK	Modem 4G Wi-Fi_B187

BSSID	STATION	PWR	Rate	Lost	Frames	Notes	Probes
F0:51:36:D9:B1:87	2A:B5:9D:17:12:A0	-21	1e-24e	4173	82		
F0:51:36:D9:B1:87	34:20:03:AA:3A:26	-23	1e-24e	0	2		
F0:51:36:D9:B1:87	0C:DD:24:5A:5D:A2	-67	24e- 6e	0	22

The output of the previous command will be something similar to what is displayed in Figure 24 which shows that only three devices are connected to the network.

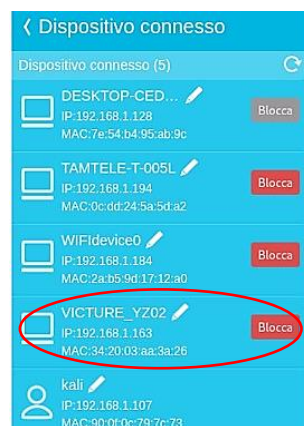
Figure 25: IP Cam MAC Address

- By attempting to perform the attack on all of the detected devices, starting from the first.
- By entering the Wi-Fi modem connection management system, as in Figure 25.

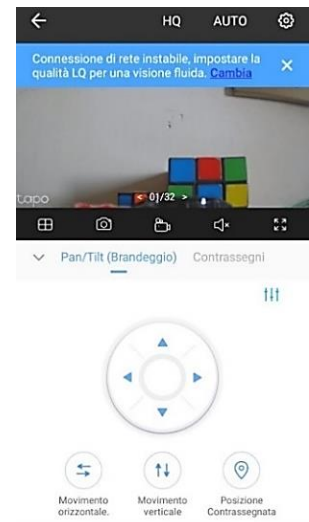
Figure 27: TAPO De-authentication

At a first attempt, we specified a little number of requests, and the DoS attack didn't work.

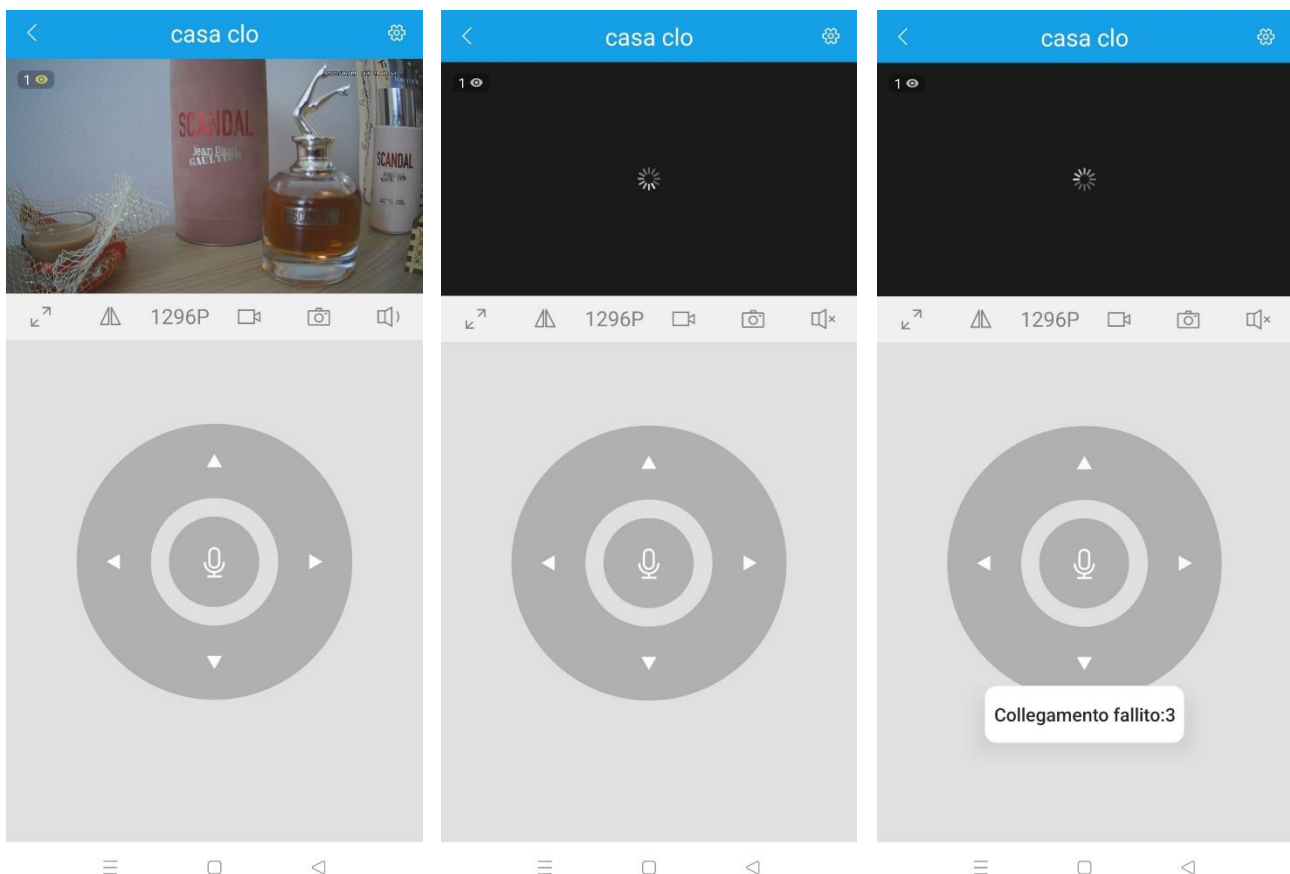
Figure 30: SriItalia SP017-S De-authentication

Even if we tried to re-authenticate, after unplugging the Cam, the *SriItalia* needed a few minutes before returning operative.

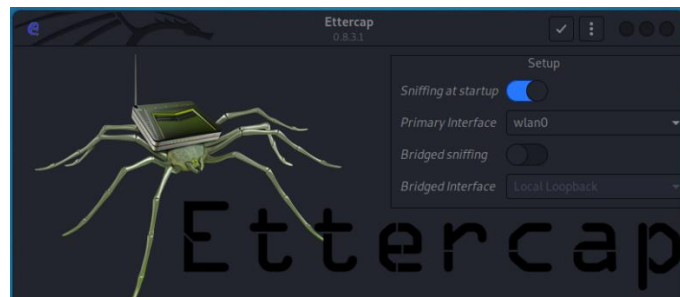
Figure 31: Ettercap: selection of the interface

First thing, we had to set up the network interface by selecting the wlan0 one - Figure 31.

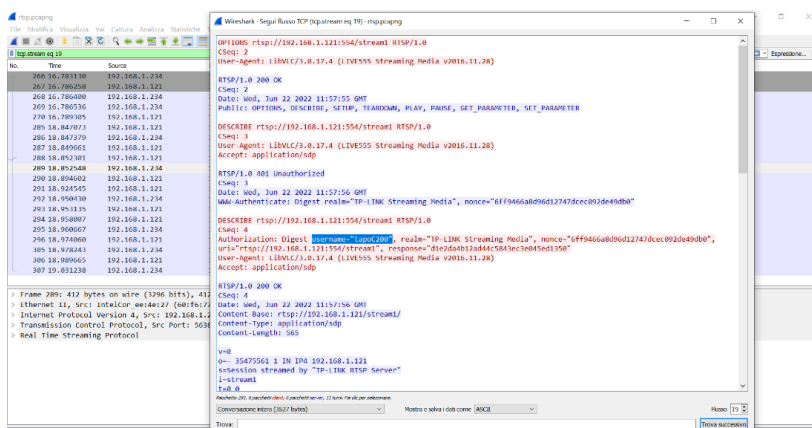
Figure 34: TAPOC200 RTSP credentials in clear

During the exchange of packets between the Ip camera and the machine, which was running the VLC media player using the RTSP protocol, we were able to capture the `username` in clear text and a suspicious cryptographical `nonce` – `6ff9466a8d96d127dcec092de49db0` – that suggested the use of Digest Authentication to obfuscate passwords – some articles, such as [2], found the use of this authentication method by different cameras. In the latter article we captured this relevant piece of information:

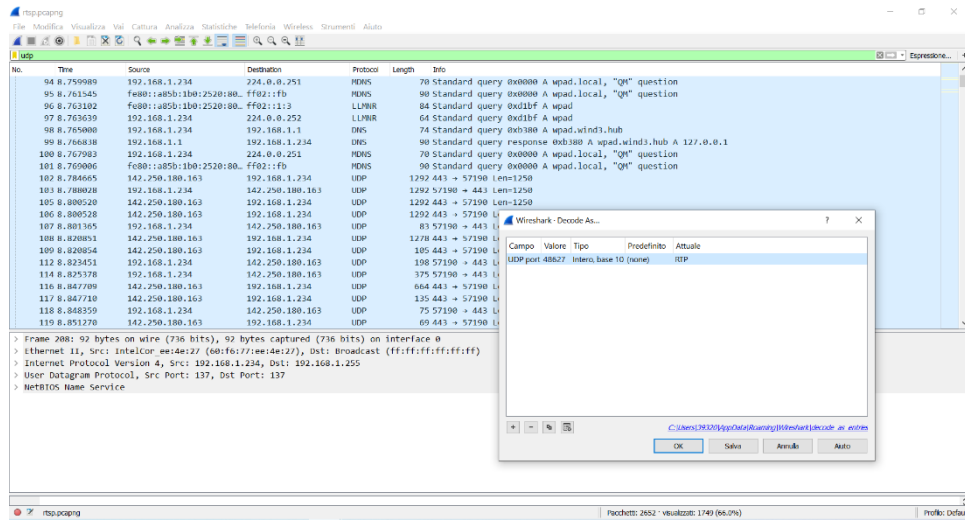
Figure 35: TAPOC200 UDP to RTP decryption's procedure

Moreover, we saw that the UDP traffic could be decrypted in RTP packages by setting Modifica→Preferenze→Protocolli→h.264→select the number of dynamic decrypting, in this case: 96.

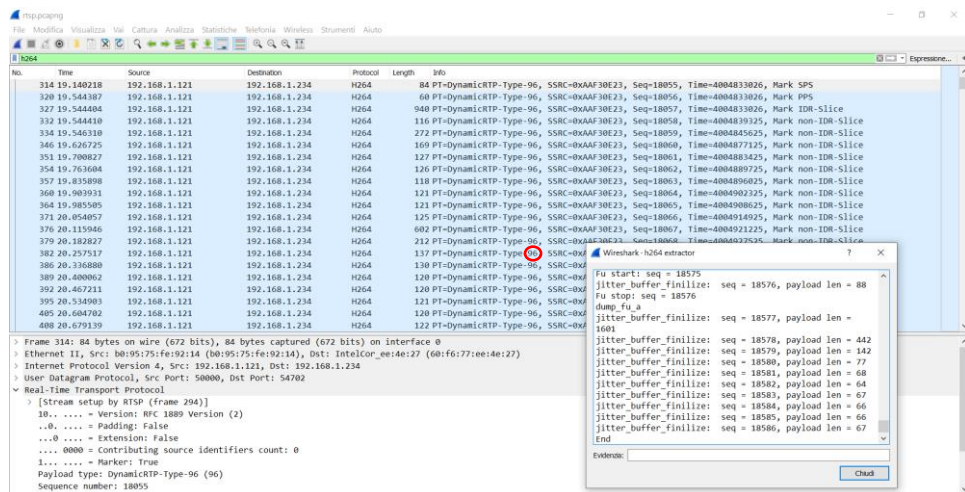
Figure 36: TAPOC200 RTP to h.264 decryption's procedure and data dump

This resulted in H.264¹³ packages that could be simply filtered employing the h264 Wireshark filter. After that, using the h264 extractor plugin¹⁴, we were finally able to dump a file containing the media streaming, that we called dump.h264.

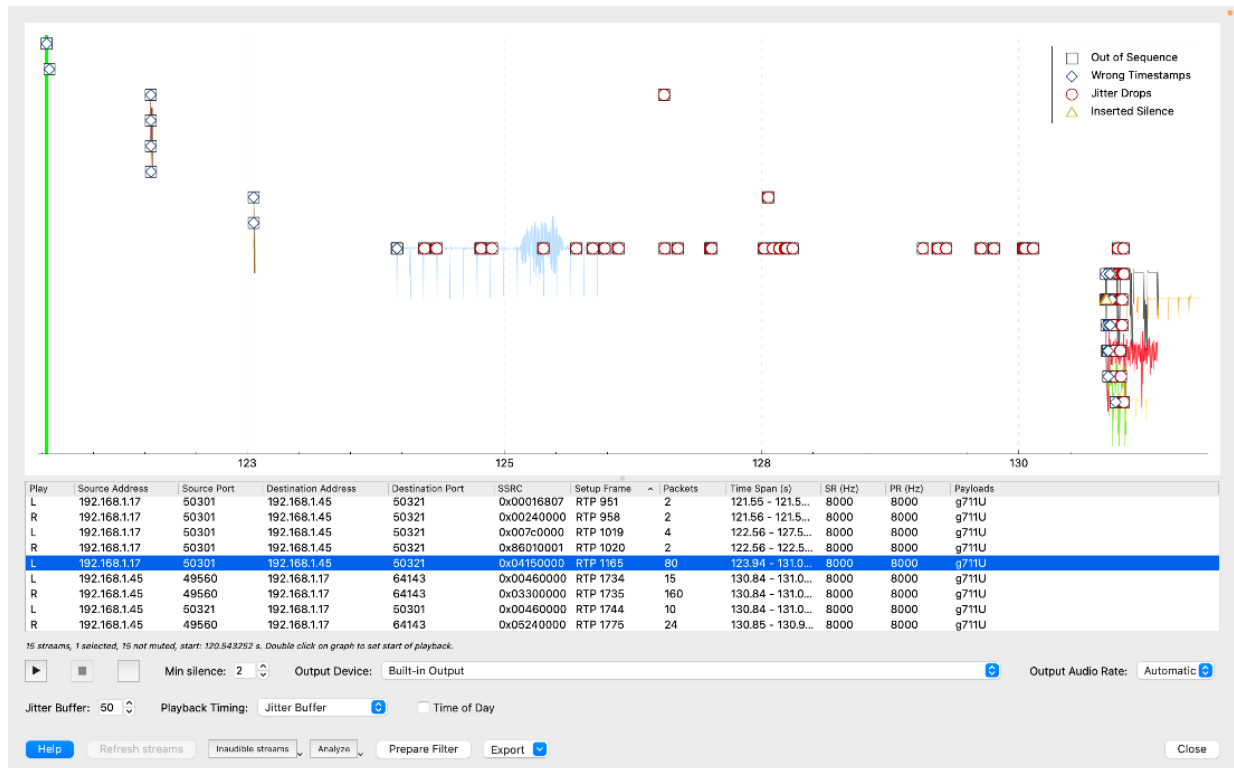
Figure 40: VICTURE PC440 RTP player

Looking at the graph it immediately stands out to the eye that at one point there is a regular wave,

in fact, by playing it we obtained the audio previously echoed through the IP Camera.

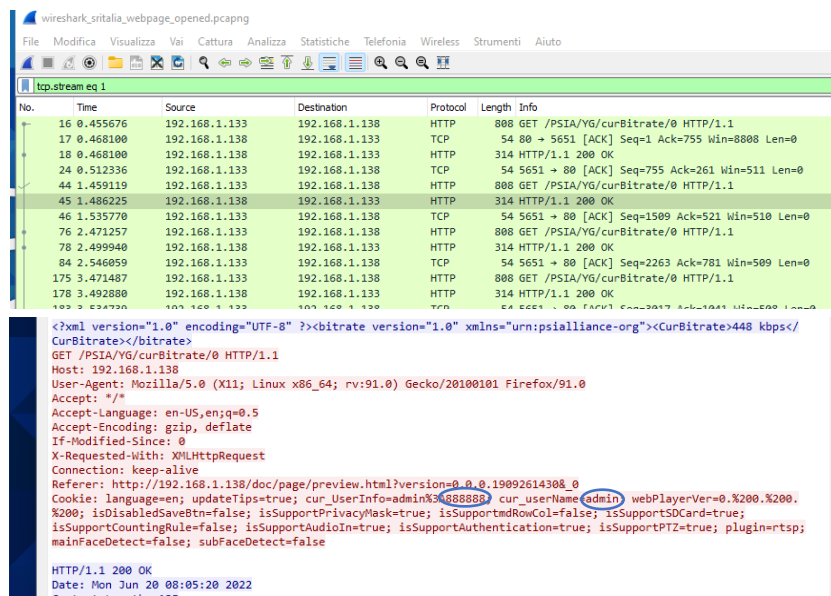
Figure 45: Wireshark SriItalia capturing authentication credentials in clear text

An interesting HTTP exchange was captured via Wireshark while authenticating to the up-above mentioned webpage in which username and password turned out to be in clear text which is very dangerous since a potential attacker could exploit it – Figure 45.

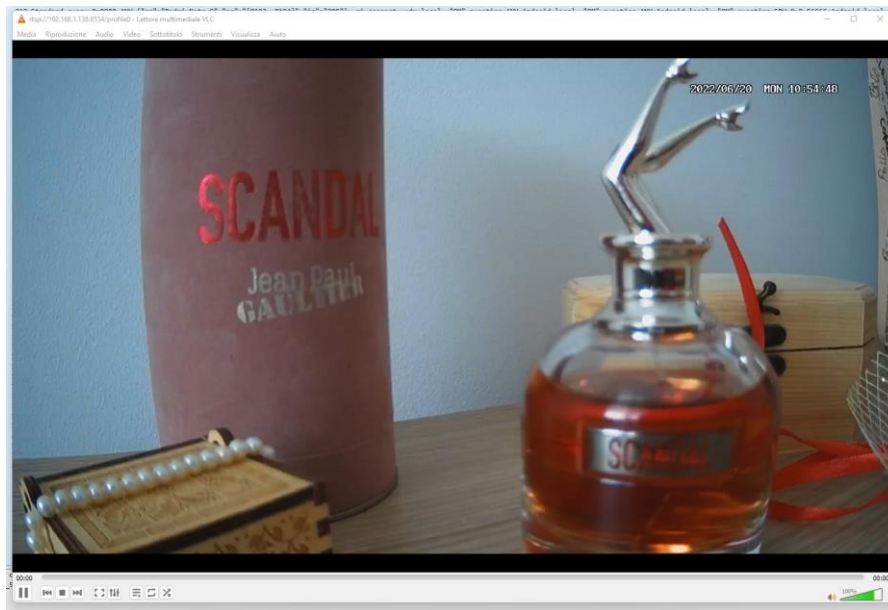
Figure 47: VLC live stream of the SriItalia

In a matter of seconds, the VLC player prompted us with the live stream of the camera – Figure 47 – while the viewer counter on the app remained fixed to 1.
