SOCIETY FOR ECOSYSTEM RESTORATION
IN NORTHERN BRITISH COLUMBIA

Bulkley River and Morice River Watershed Groups Fish Passage Restoration Planning 2021 - DRAFT

Prepared for
Habitat Conservation Trust Foundation - CAT21-6-288
BC Fish Passage Remediation Program
Canadian Wildlife Federation

Version 0.0.8 - DRAFT
2022-04-27

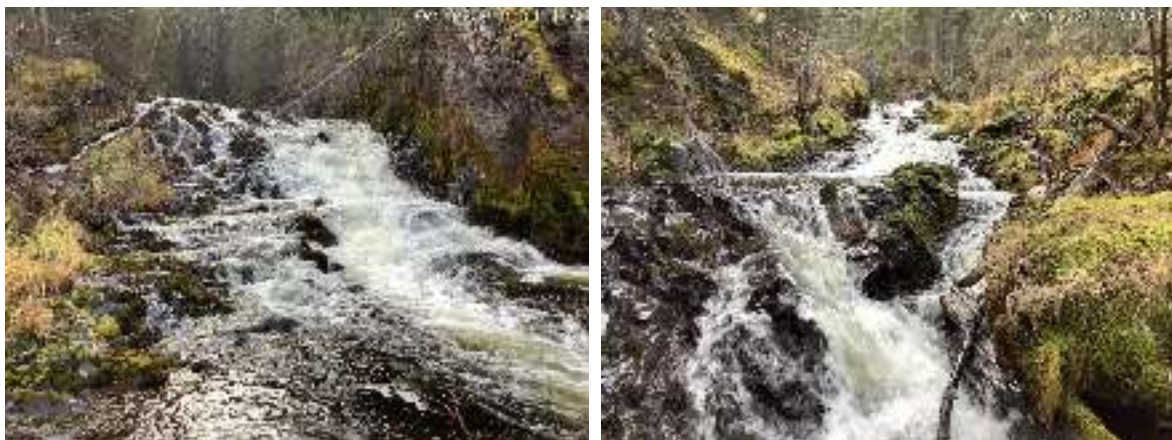
Figure 4.1: Left: Bulkley Falls main channel. Right: Bulkley Falls side channel.

Approximately 11.3 km downstream of the Bulkley Lake outlet and just upstream of Watson Creek, the upper Bulkley falls is an approximately 4m high narrow rock sill that crosses the Bulkley River, producing a steep cascade section. This obstacle to fish passage is recorded as an almost complete barrier to fish passage for salmon during low water flows. Coho have not been observed beyond the falls since 1972 (Wilson and Rabnett 2007).

Dyson (1949) and Stokes (1956) report substantial use of habitat above Bulkley Falls by steelhead, chinook, coho and sockeye utilization in the past (pre-1950) based on spawning reports. Both authors concluded that the Bulkley Falls pose a partial obstruction to migrating fish based on flow levels. Chinook, which migrate early in the summer when water levels are high, have been noted as able to ascend the falls in normal to high water years and in high water years it was thought that coho and steelhead could ascend. A. Gottesfeld and Rabnett (2007) report that the falls are almost completely impassable to all salmon during low water flows. Stokes (1956) reports that there was high value spawning habitat located within the first 3km of the Bulkley River from the outlet of Bulkley Lake.

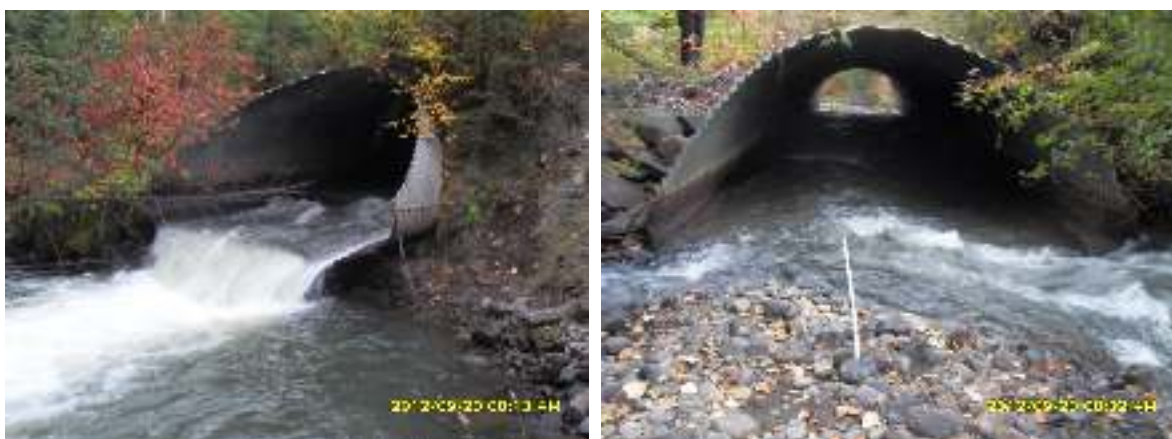
Figure 5.4: Left: Outlet of PSCIS crossing 57944 in 2012. Photo from PSCIS. Right: Inlet of PSCIS crossing 57944 in 2012. Photo from PSCIS.

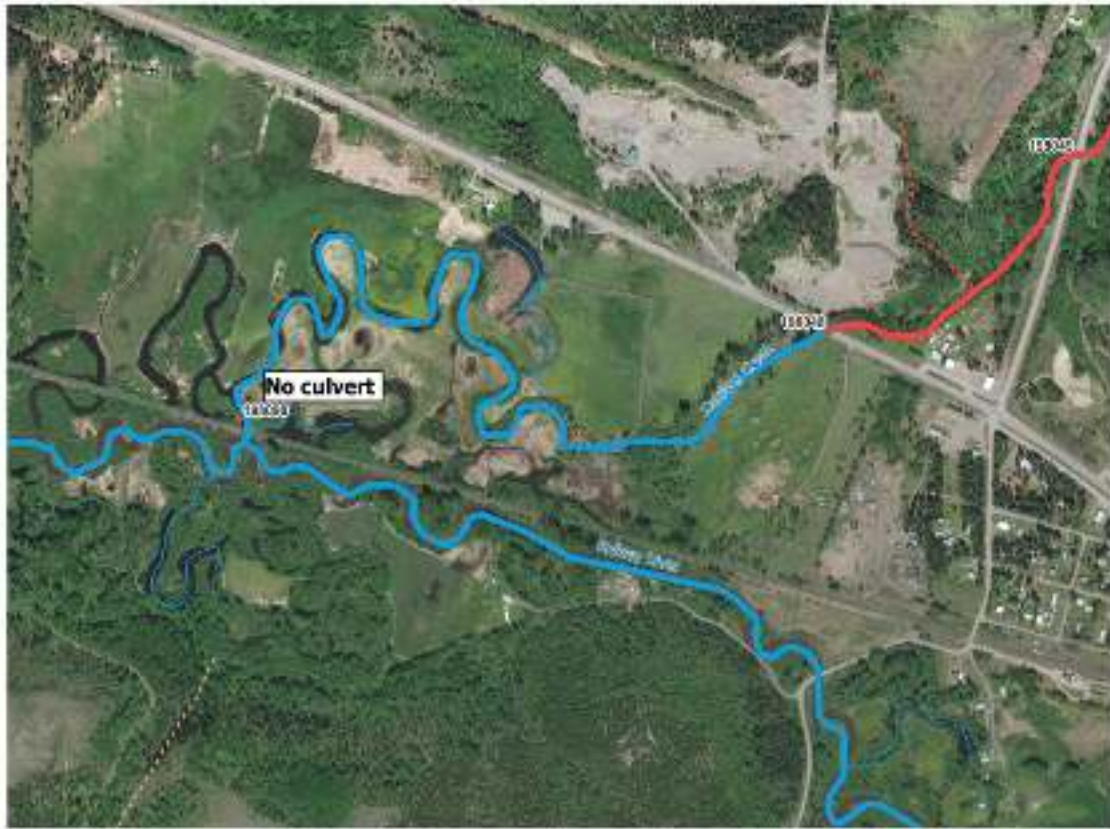
Figure 5.32: Location of potential location of crossing 198090 which was not present in the field.
