SOCIETY FOR ECOSYSTEM RESTORATION
IN NORTHERN BRITISH COLUMBIA

Bulkley River and Morice River Watershed Groups Fish Passage Restoration Planning 2021 - DRAFT

Prepared for
Habitat Conservation Trust Foundation - CAT21-6-288
BC Fish Passage Remediation Program
Canadian Wildlife Federation

Version 0.0.9 - DRAFT
2022-04-29

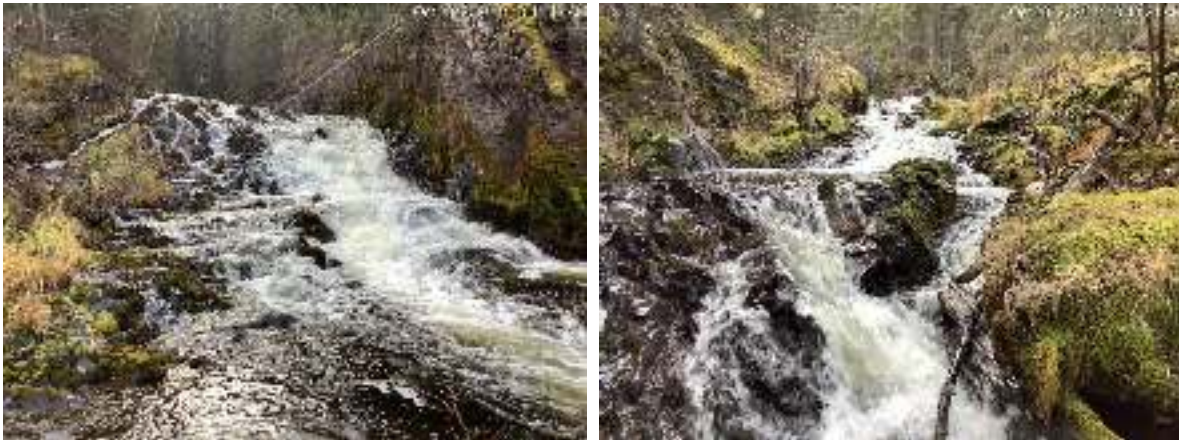
Figure 4.1: Left: Bulkley Falls main channel. Right: Bulkley Falls side channel.

Approximately 11.3 km downstream of the Bulkley Lake outlet and just upstream of Watson Creek, the upper Bulkley falls is an approximately 4m high narrow rock sill that crosses the Bulkley River, producing a steep cascade section. This obstacle to fish passage is recorded as an almost complete barrier to fish passage for salmon during low water flows. Coho have not been observed beyond the falls since 1972 (Wilson and Rabnett 2007).

Dyson (1949) and Stokes (1956) report substantial use of habitat above Bulkley Falls by steelhead, chinook, coho and sockeye utilization in the past (pre-1950) based on spawning reports. Both authors concluded that the Bulkley Falls pose a partial obstruction to migrating fish based on flow levels. Chinook, which migrate early in the summer when water levels are high, have been noted as able to ascend the falls in normal to high water years and in high water years it was thought that coho and steelhead could ascend. A. Gottesfeld and Rabnett (2007) report that the falls are almost completely impassable to all salmon during low water flows. Stokes (1956) reports that there was high value spawning habitat located within the first 3km of the Bulkley River from the outlet of Bulkley Lake.

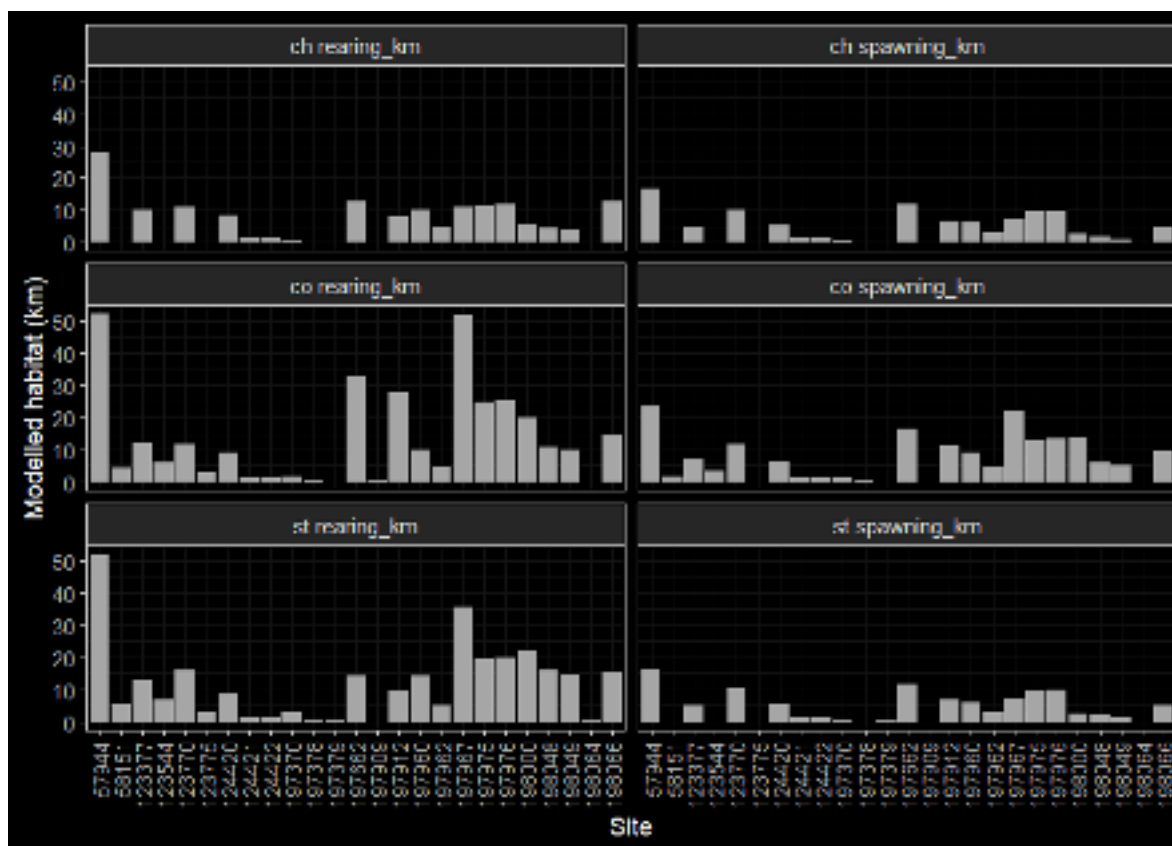
Figure 4.2: Summary of potential habitat upstream of habitat confirmation assessment sites estimated based on modelled channel width and upstream channel length.

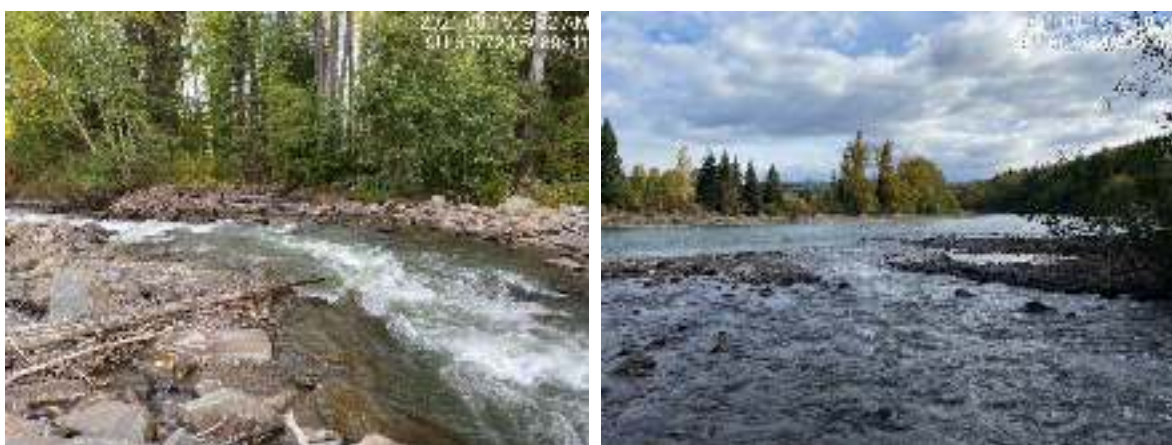
Figure 5.1: Left: Typical habitat downstream of PSCIS crossing 57944. Right: Typical habitat downstream of PSCIS crossing 57944.

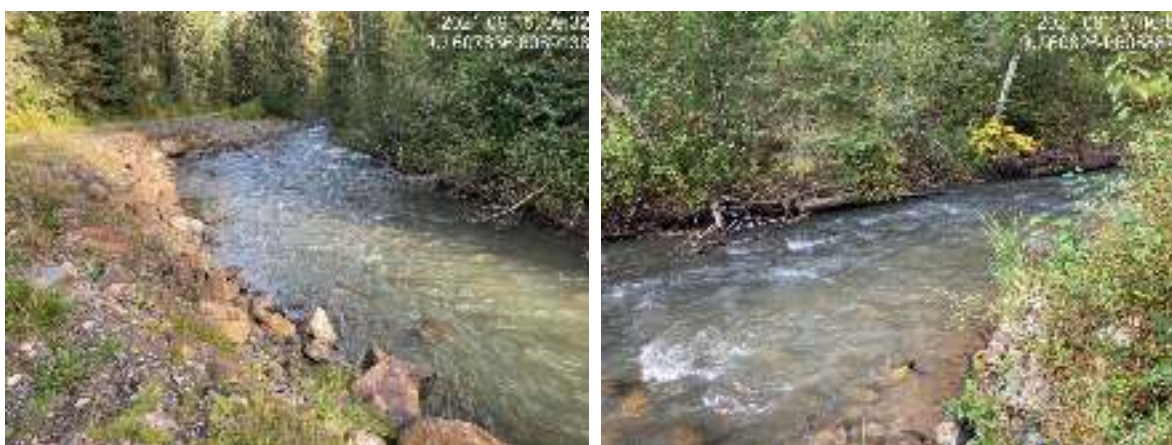
Figure 5.2: Left: Typical habitat upstream of PSCIS crossing 57944. Right: Typical habitat upstream of PSCIS crossing 57944.

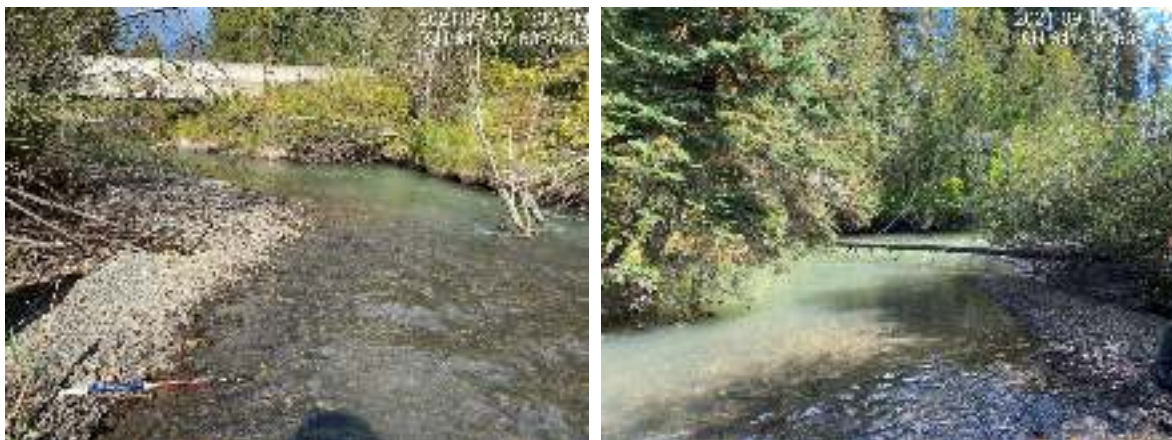
Figure 5.3: Left: Typical habitat upstream of PSCIS crossing 57944. Right: Typical habitat upstream of PSCIS crossing 57944.

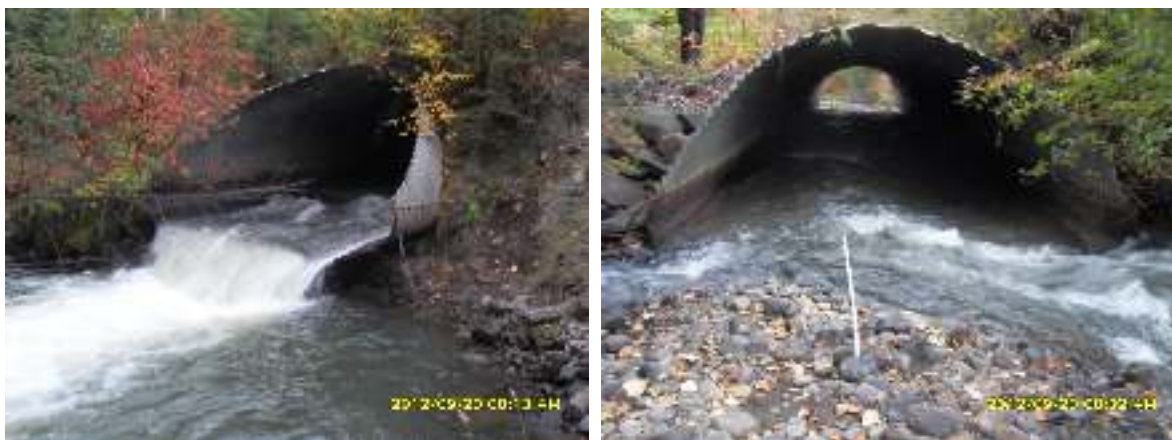
Figure 5.4: Left: Outlet of PSCIS crossing 57944 in 2012. Photo from PSCIS. Right: Inlet of PSCIS crossing 57944 in 2012. Photo from PSCIS.

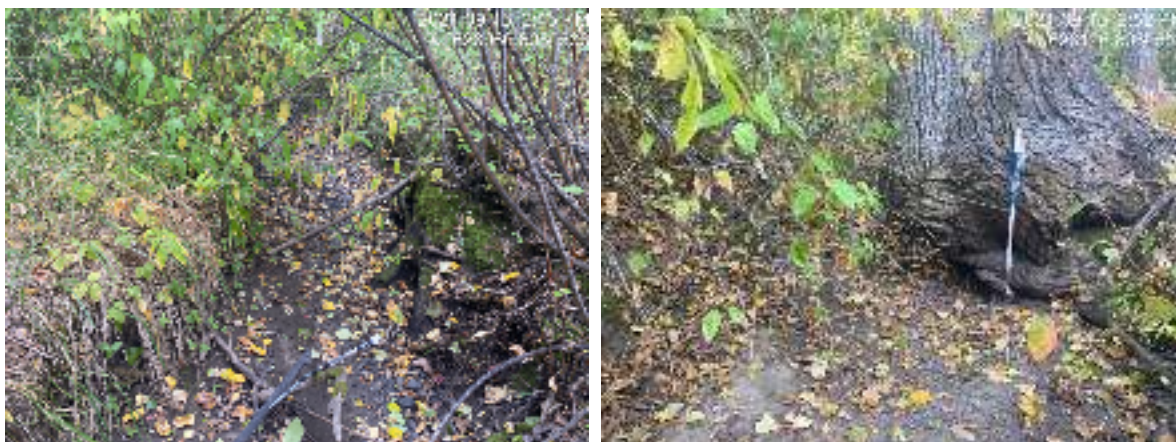
The stream was surveyed downstream from crossing 123544 for NAM (Figure 5.5). The average channel width was 2.6m, the average wetted width was NAM, and the average gradient was 2%.,

Figure 5.5: Left: Habitat downstream of PSCIS crossing 123544. Right: Habitat downstream of PSCIS crossing 123544.

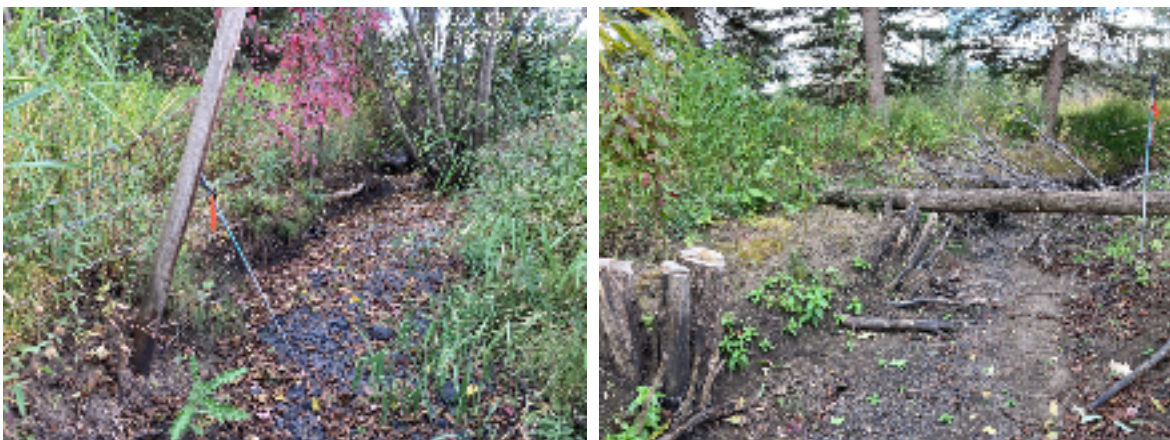
Figure 5.6: Left: Habitat downstream of PSCIS crossing 58151. Right: Typical habitat upstream of PSCIS crossing 123544.

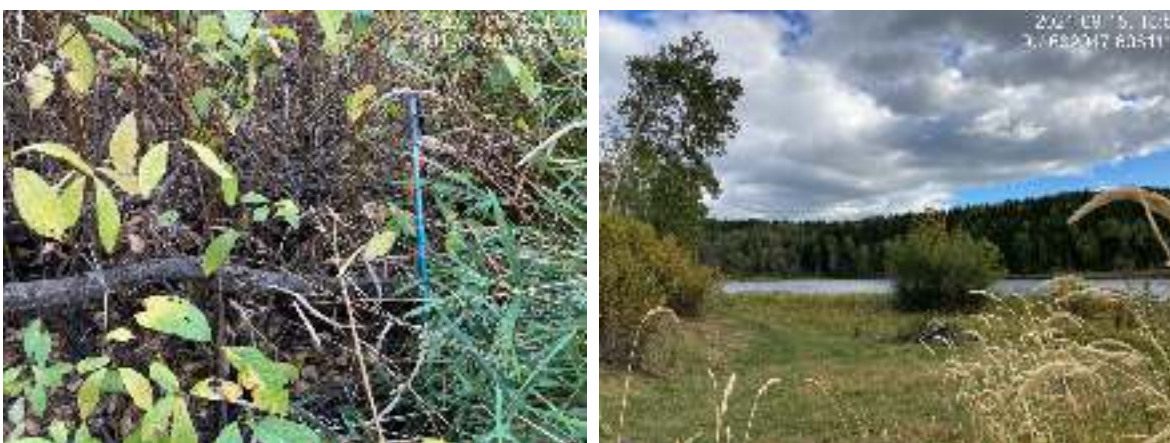
Figure 5.7: Left: Typical habitat upstream of PSCIS crossing 58151. Right: Typical habitat upstream of PSCIS crossing 58151.

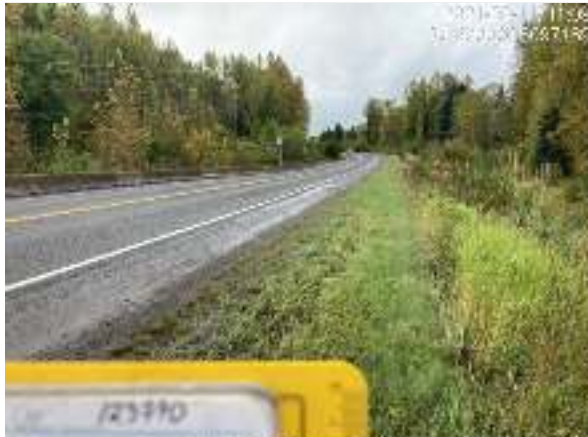
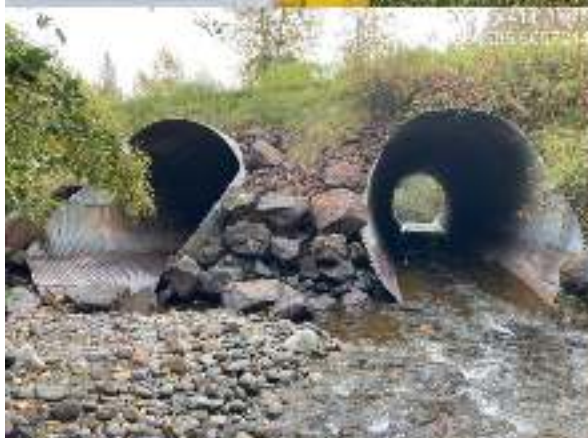
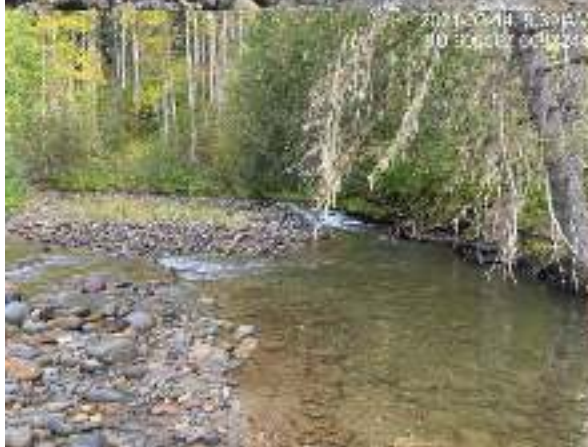
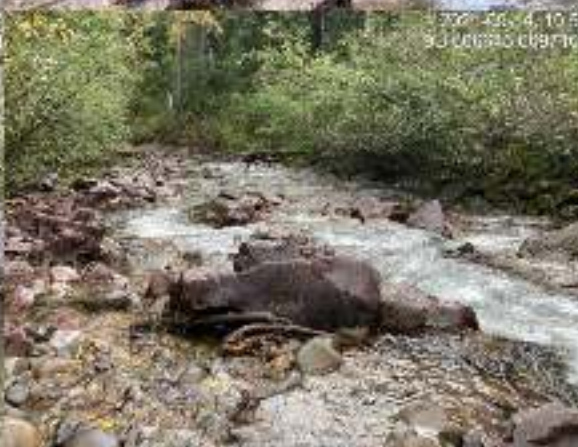
Location and Stream Data	•	Crossing Characteristics	-
<p>Comments: Both pipes have outlet drop and water flowing through. Water depth in left pipe is 0.01m, left pipe no embedment. Inlet drop only on right one. Also has baffling with substrate but baffling not in place for downstream ~3m, so not continuous. Estimated pool depth. 10:52</p>

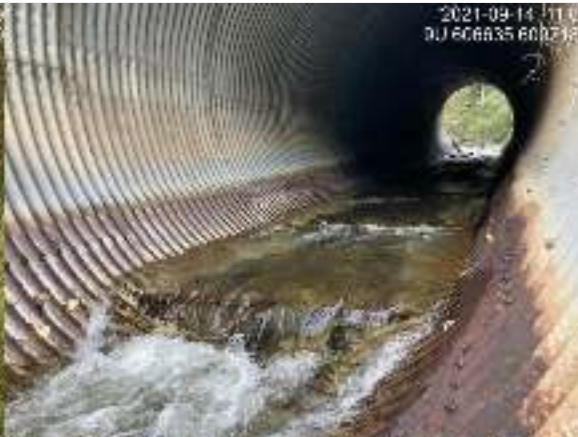
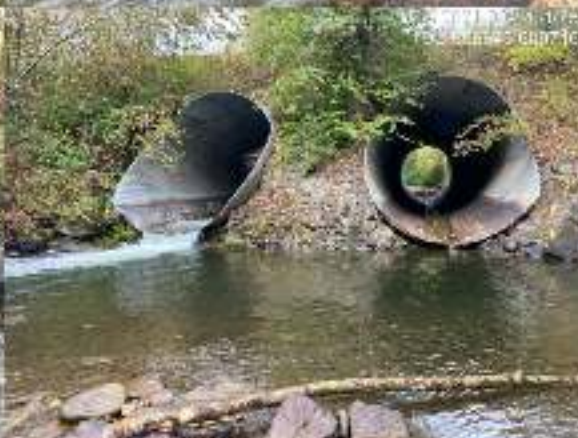
Location and Stream Data	•	Crossing Characteristics	–
Location and Stream Data	•	Crossing Characteristics	–
Date	2021-09-07	Crossing Sub Type	Round Culvert
PSCIS ID	123770	Diameter (m)	4
External ID	–	Length (m)	36
Crew	KP AN	Embedded	No
UTM Zone	9	Depth Embedded (m)	–
Easting	606626.5	Resemble Channel	No
Northing	6097185	Backwatered	No
Stream	John Brown	Percent Backwatered	–
Road	Highway 16	Fill Depth (m)	3.5
Road Tenure	MoTi Arterial	Outlet Drop (m)	0.64
Channel Width (m)	12.3	Outlet Pool Depth (m)	1.5
Stream Slope (%)	2.9	Inlet Drop	Yes
Beaver Activity	No	Slope (%)	2
Habitat Value	Medium	Valley Fill	Deep Fill
Final score	37	Barrier Result	Barrier
Fix type	Replace with New Open Bottom Structure	Fix Span / Diameter	19
Photos: From top left clockwise: Road/Site Card, Barrel, Outlet, Downstream, Upstream, Inlet.

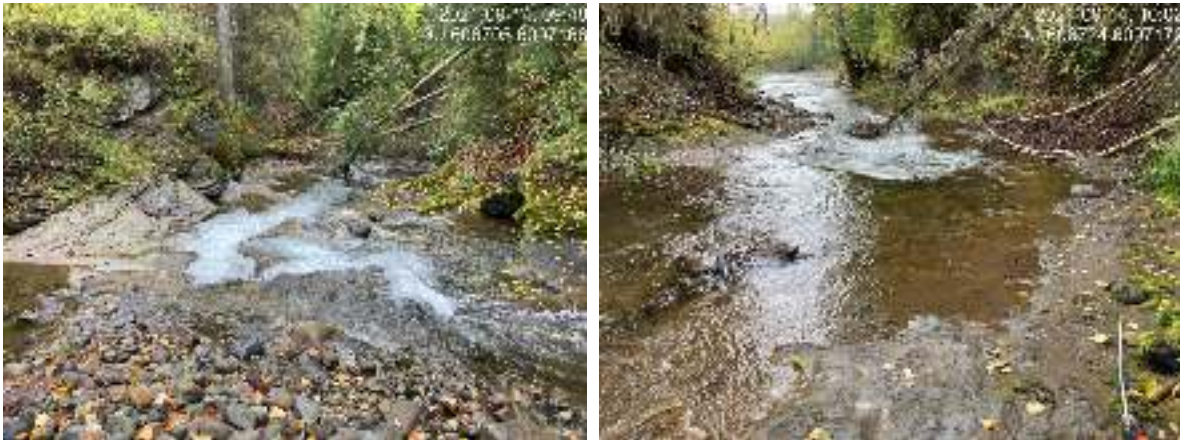
The stream was surveyed downstream from crossing 123770 for 230m to the confluence with the Bulkley River (Figure [5.9](#)). Total cover amount was rated as moderate with boulders dominant. Cover was also present as deep pools and overhanging vegetation. The average channel width was 13.6m, the average wetted width was 8.3m and the average gradient was 4.1%. The dominant substrate was large rock/bedrock with cobbles subdominant. Although rated as an important migration corridor, the habitat was rated as medium value for salmonid rearing and spawning with high flows and limited complexity. Several dead pink salmon were noted on the fan at the confluence with the Bulkley River.

Figure 5.9: Left: Typical habitat downstream of PSCIS crossing 123770. Right: Typical habitat downstream of PSCIS crossing 123770.

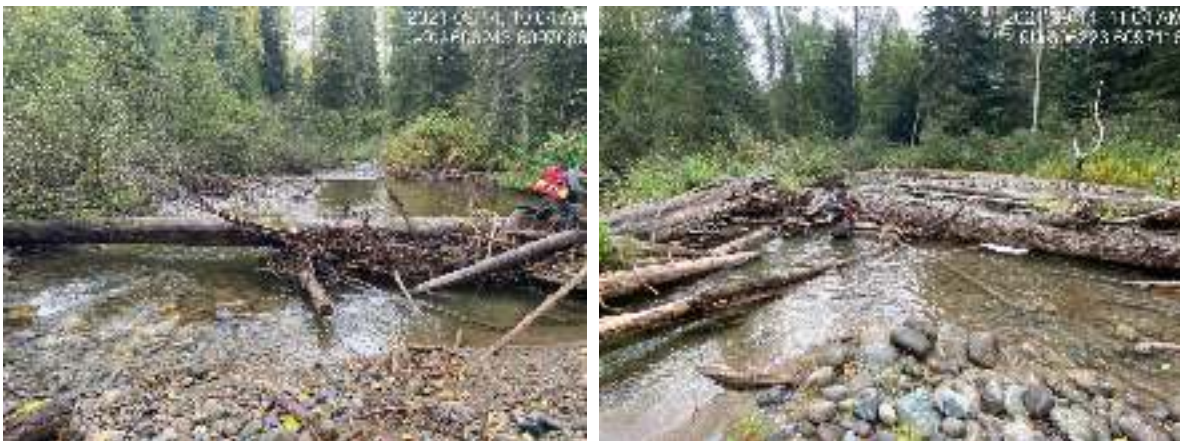
Figure 5.10: Left: Typical habitat upstream of PSCIS crossing 123770. Right: Typical habitat upstream of PSCIS crossing 123770.

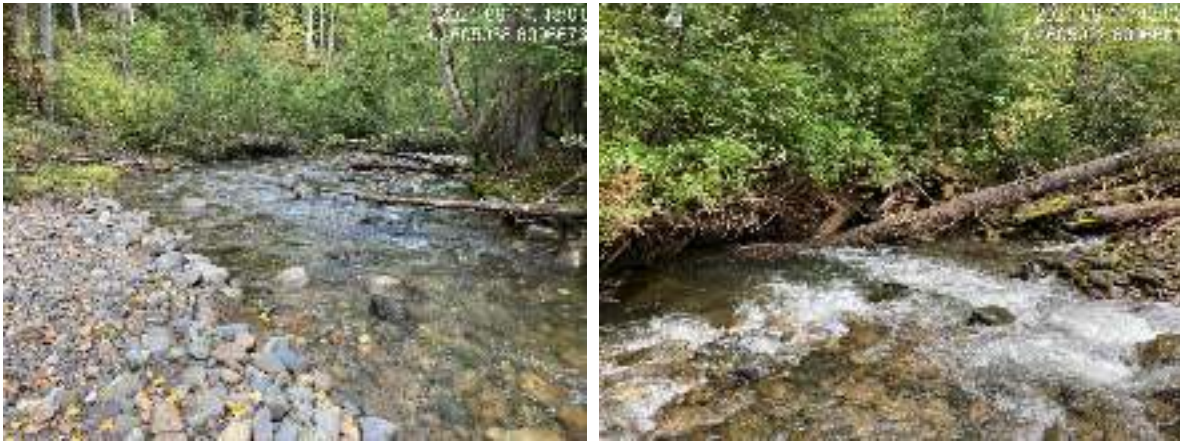
Figure 5.11: Left: Typical habitat upstream of PSCIS crossing 123770. Right: Typical habitat upstream of PSCIS crossing 123770.

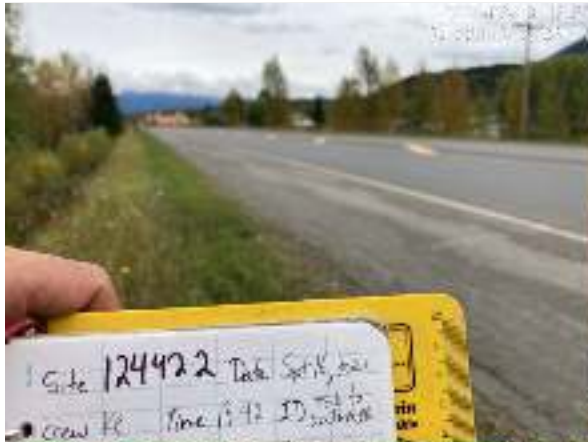
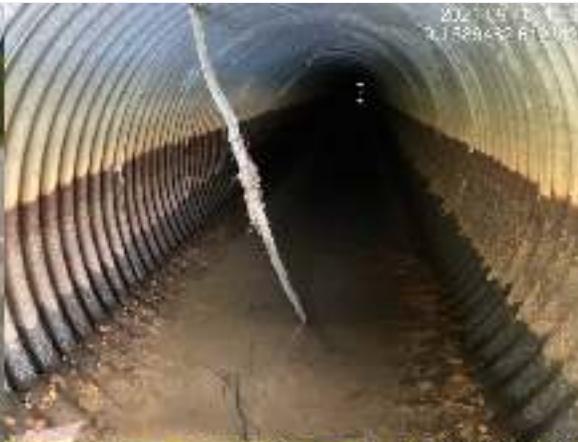
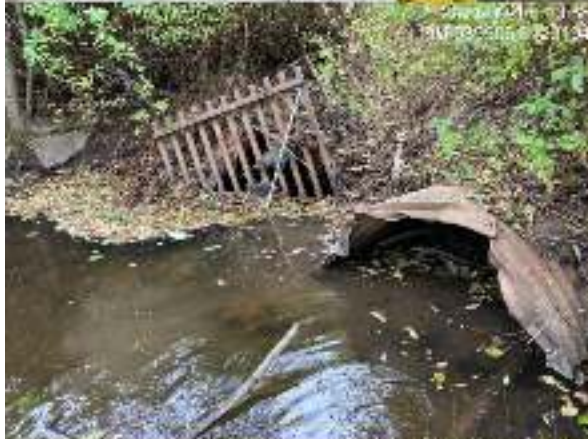
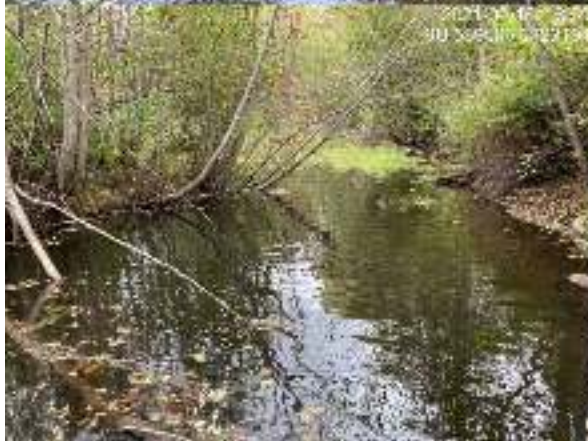
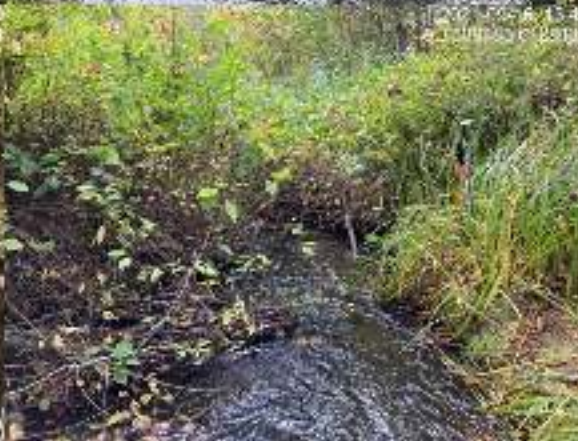
Location and Stream Data	•	Crossing Characteristics	-
<p>Comments: 2 pipes. Both have water, left bank one is flowing. Assessment comments indicate right bank pipe is backwatered 100% but changed to 25% based on photos and past PSCIS data and photos which also indicated not backwatered. Suspect blockage due to debris. Outlet water depth, fish sighted in outlet of right barrel. 13:42</p>

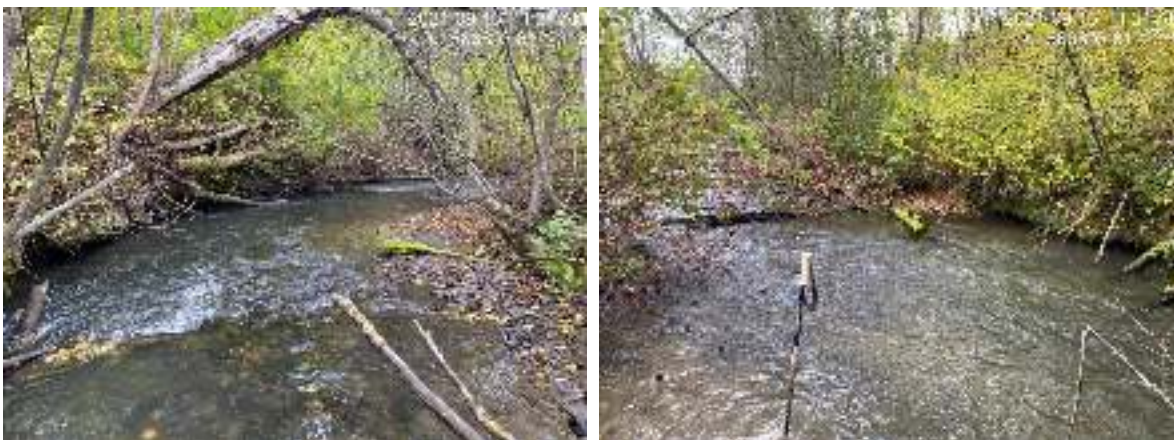
Figure 5.13: Left: Habitat upstream of PSCIS crossing 124420. Right: Habitat upstream of PSCIS crossing 124420.

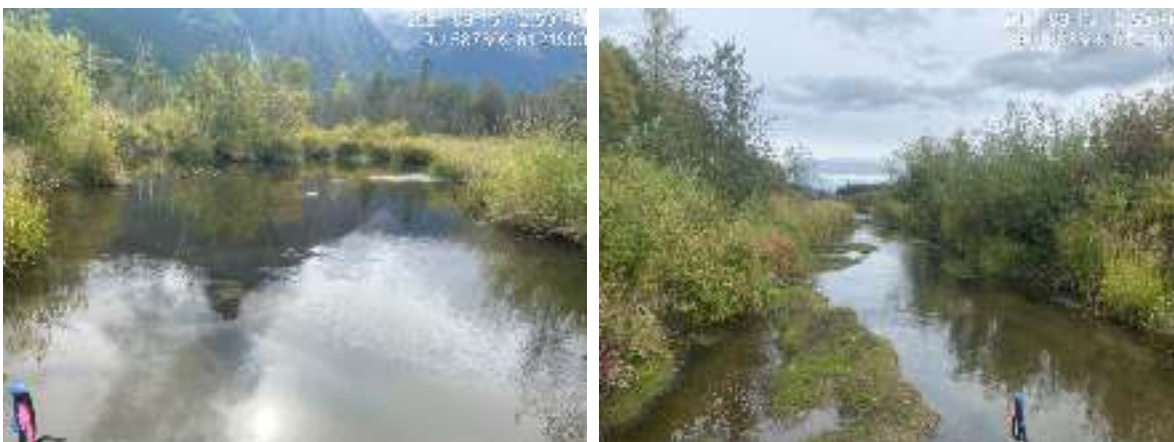
Figure 5.14: Left: Habitat upstream of PSCIS crossing 124420. Right: Habitat upstream of PSCIS crossing 124420 within Waterfall Creek.

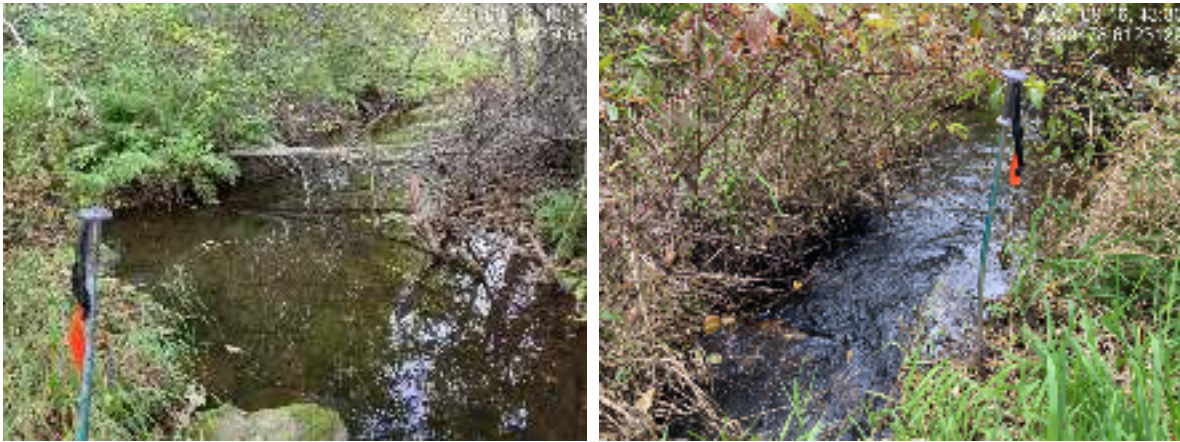
Figure 5.15: Left: Typical habitat upstream of PSCIS crossing 124420. Right: Typical habitat upstream of PSCIS crossing 124420.

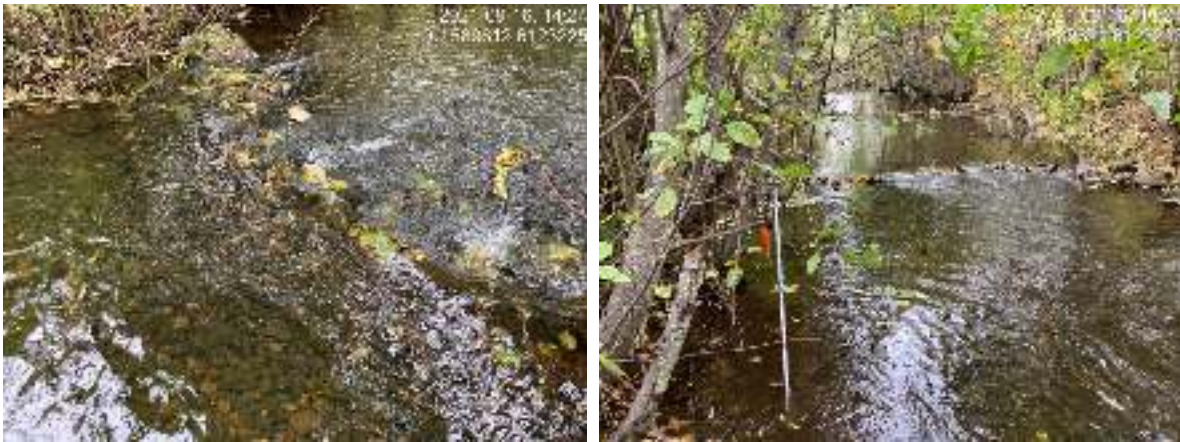
Figure 5.16: Left: Typical habitat upstream of PSCIS crossing 124420. Right: Typical habitat upstream of PSCIS crossing 124420.

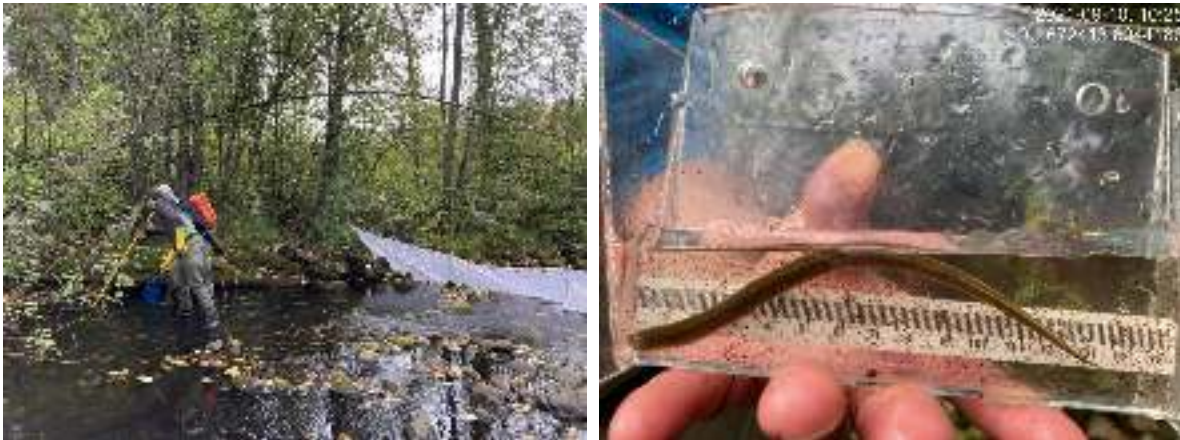
Figure 5.18: Left: Habitat downstream of PSCIS crossing 197662. Right: Lamprey captured downstream of PSCIS crossing 197662.

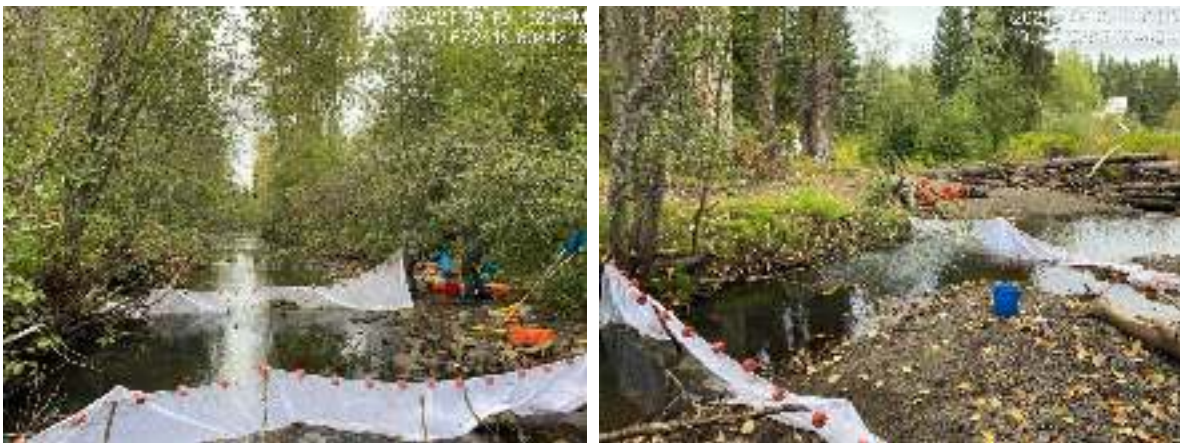
Figure 5.19: Left: Habitat upstream of PSCIS crossing 197662. Right: Habitat upstream of PSCIS crossing 197662.

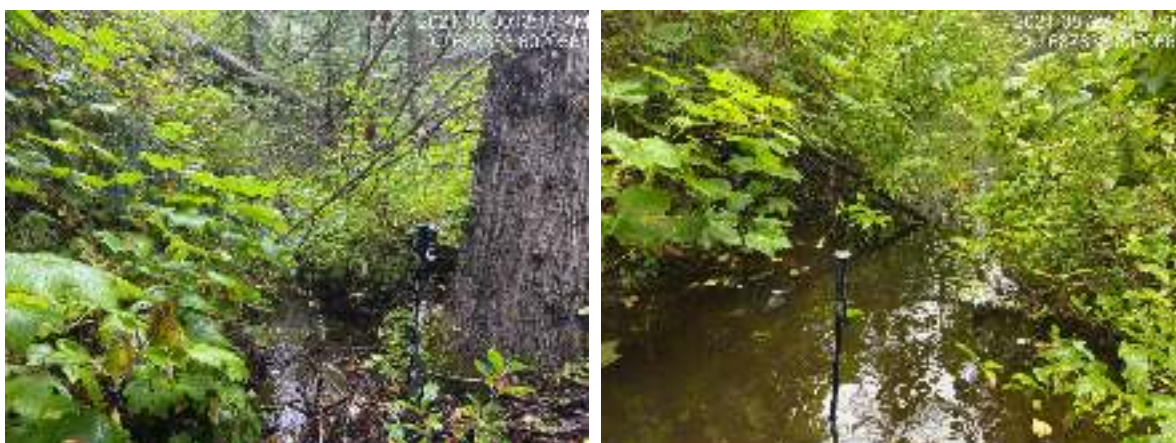
Figure 5.20: Left: Habitat downstream of PSCIS crossing 197909. Right: Habitat downstream of PSCIS crossing 197909.

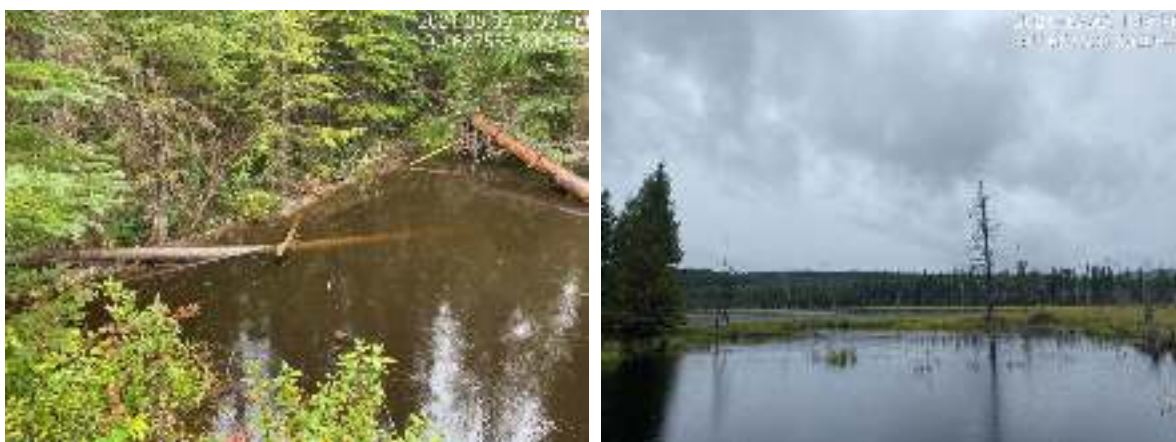
Figure 5.21: Left: Habitat upstream of PSCIS crossing 197909. Right: Habitat upstream of PSCIS crossing 197909.

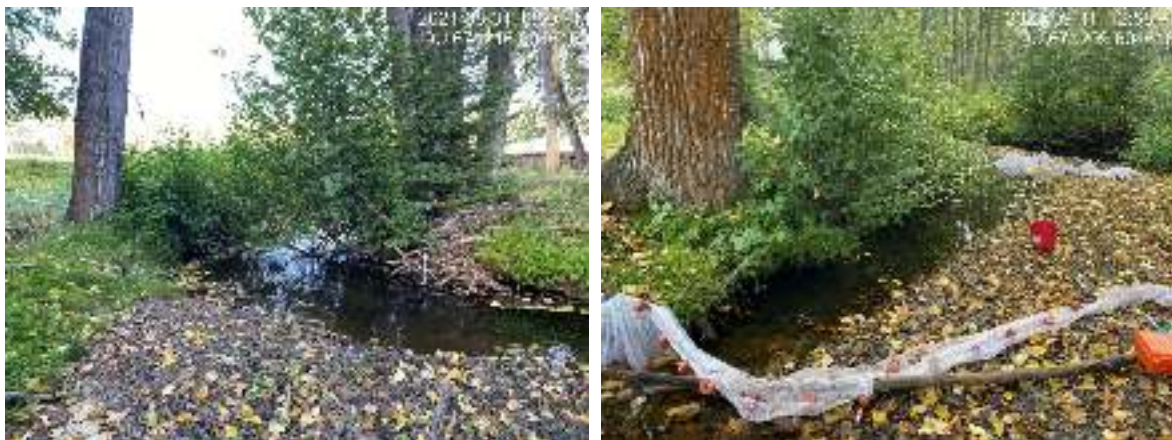
Figure 5.23: Left: Typical habitat downstream of PSCIS crossing 197912. Right: Typical habitat downstream of PSCIS crossing 197912.

Should restoration/maintenance activities proceed at the site, removal of PSCIS crossing 197912 is recommended. In addition to removal of the collapsed bridge, resloping of banks and the installation of live cuttings/pegboarding is recommended in three areas downstream where cattle trampling is resulting in significant erosion. A map of the erosion areas and associated prescriptions for rehabilitation of the downstream corners is provided as Figure [??](#). The cost of the work is estimated at \$30,000 for a cost benefit of 924 linear m/\$1000 and 3973.2 m²/\$1000.

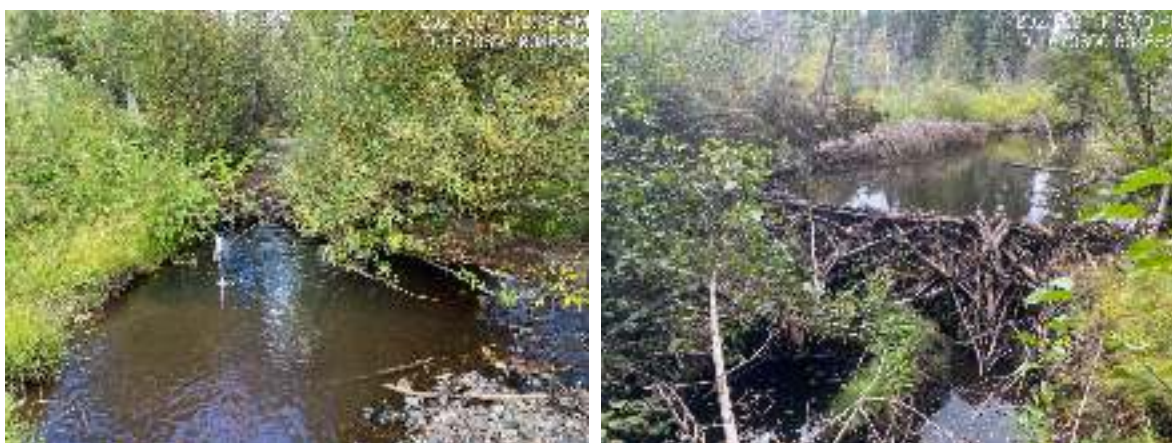
Figure 5.24: Left: Typical habitat upstream of PSCIS crossing 197912. Right: Typical habitat upstream of PSCIS crossing 197912.

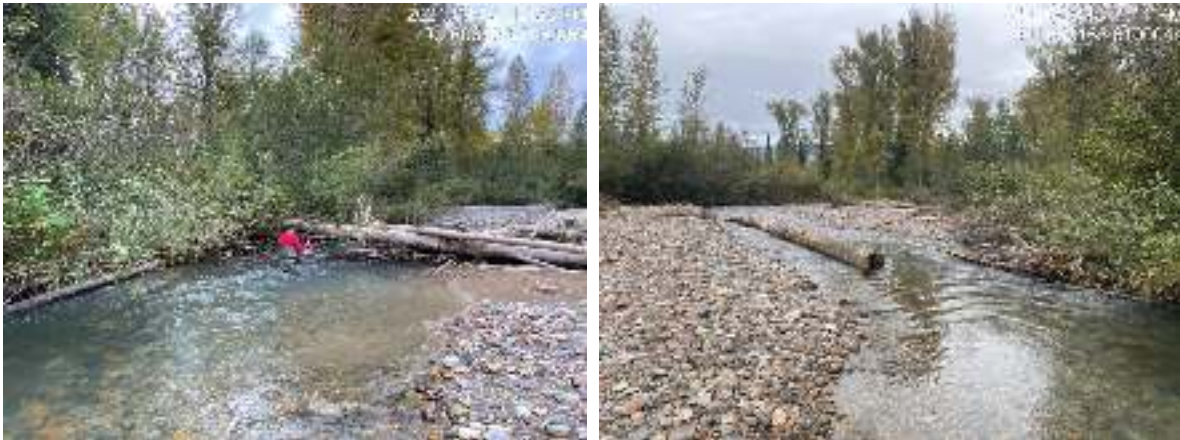
Figure 5.26: Left: Typical habitat downstream of PSCIS crossing 197960. Right: Typical habitat downstream of PSCIS crossing 197960.

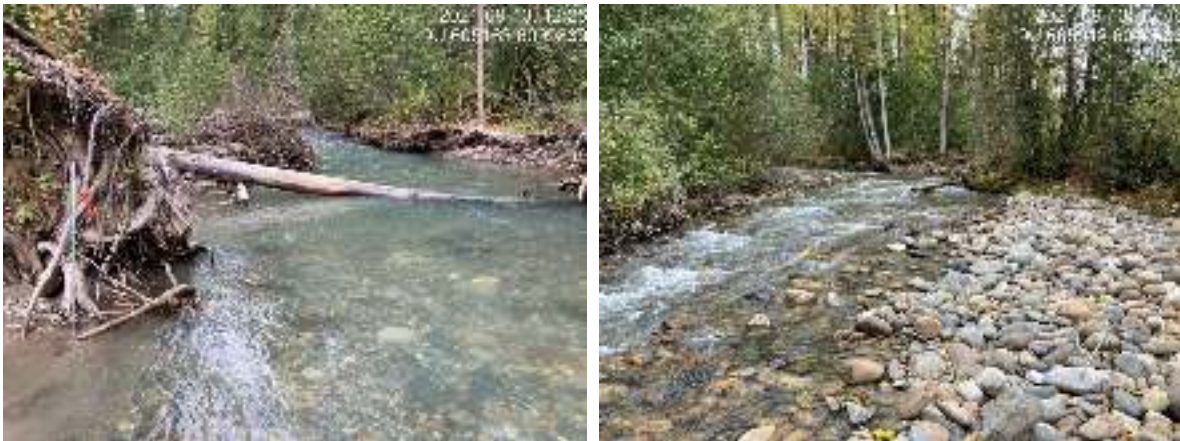
Figure 5.27: Left: Typical habitat upstream of PSCIS crossing 197960. Right: Typical habitat upstream of PSCIS crossing 197960.

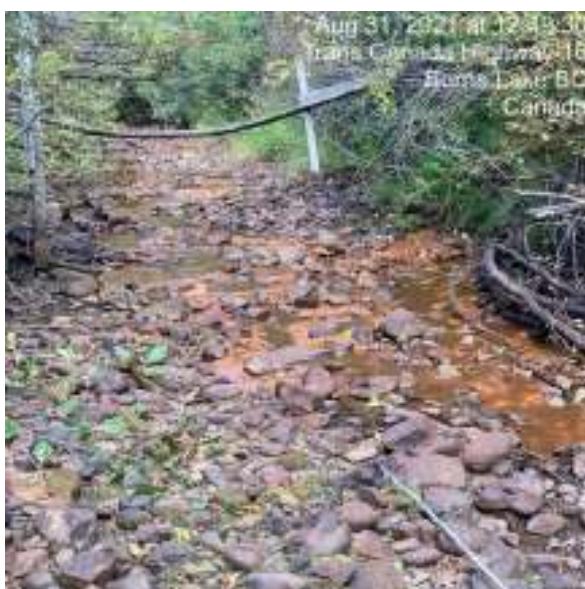
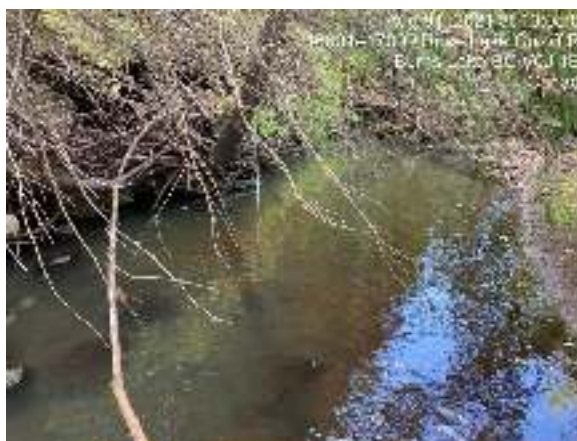
Figure 5.28: Left: Habitat downstream of PSCIS crossing 197967. Right: Habitat downstream of PSCIS crossing 197967.

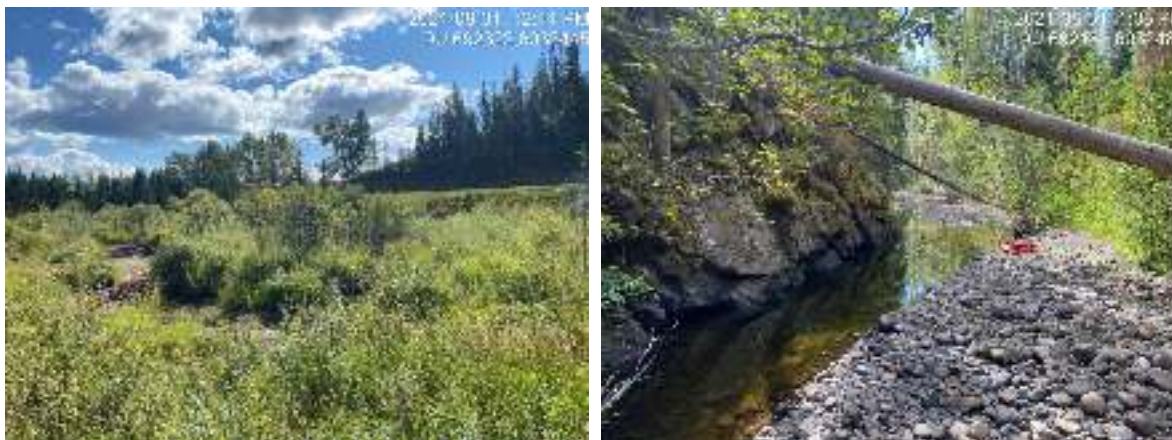
The stream was surveyed upstream from crossing 197967 for 800m (Figure 5.29). The dominant substrate was gravels with cobbles sub-dominant., The average channel width was 5.3m, the

Figure 5.29: Left: Habitat upstream of PSCIS crossing 197967. Right: Habitat upstream of PSCIS crossing 197967.

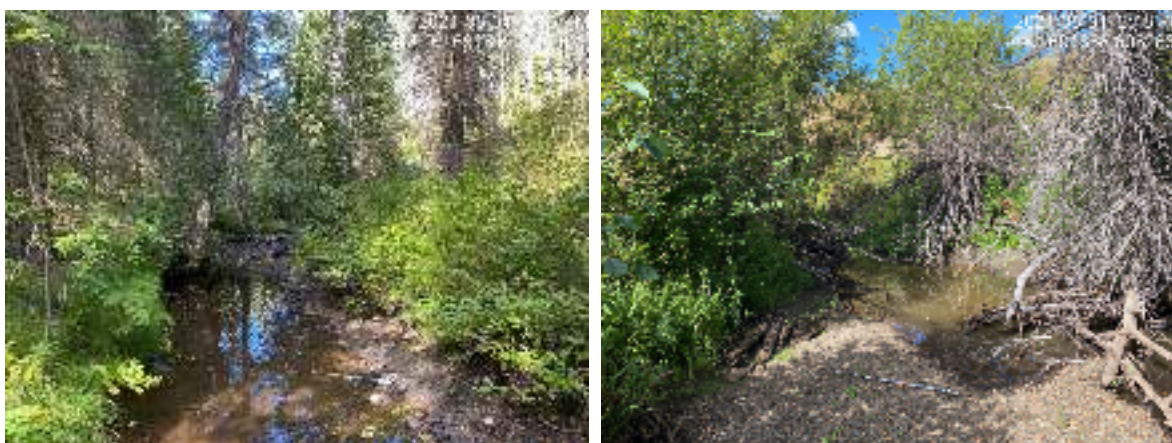
Figure 5.30: Left: Habitat upstream of PSCIS crossing 197967. Right: Habitat upstream of PSCIS crossing 197967.

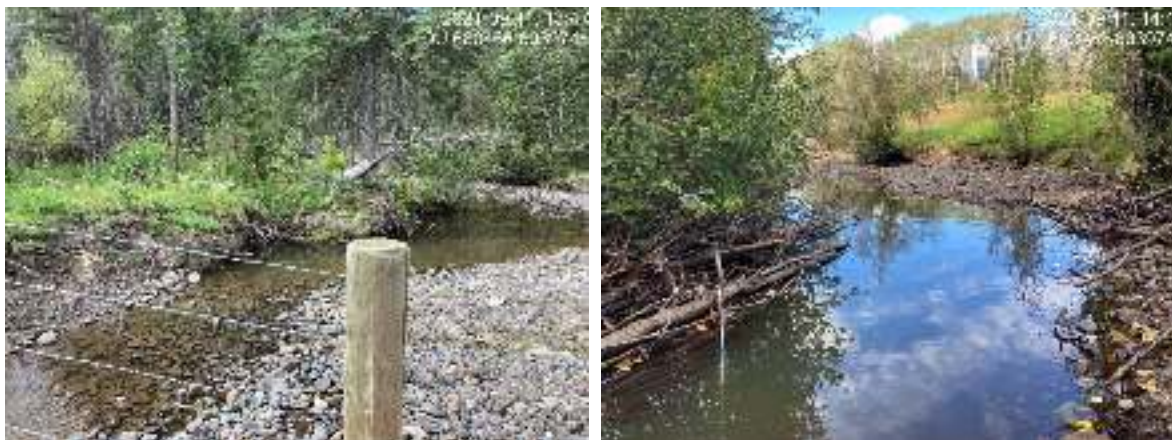
Figure 5.32: Left: Typical habitat downstream of PSCIS crossing 197976. Right: Typical habitat downstream of PSCIS crossing 197976.

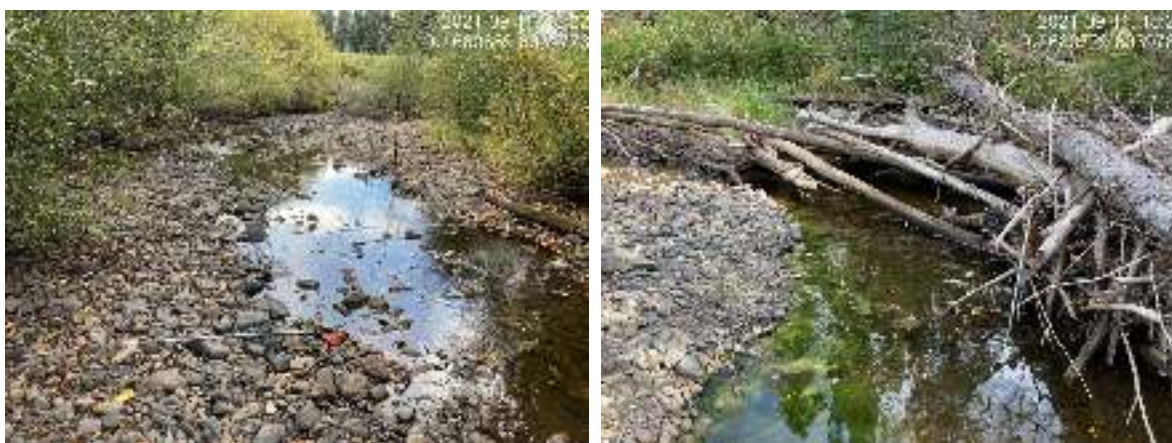
Figure 5.33: Left: Typical habitat upstream of PSCIS crossing 197976. Right: Typical habitat upstream of PSCIS crossing 197976.

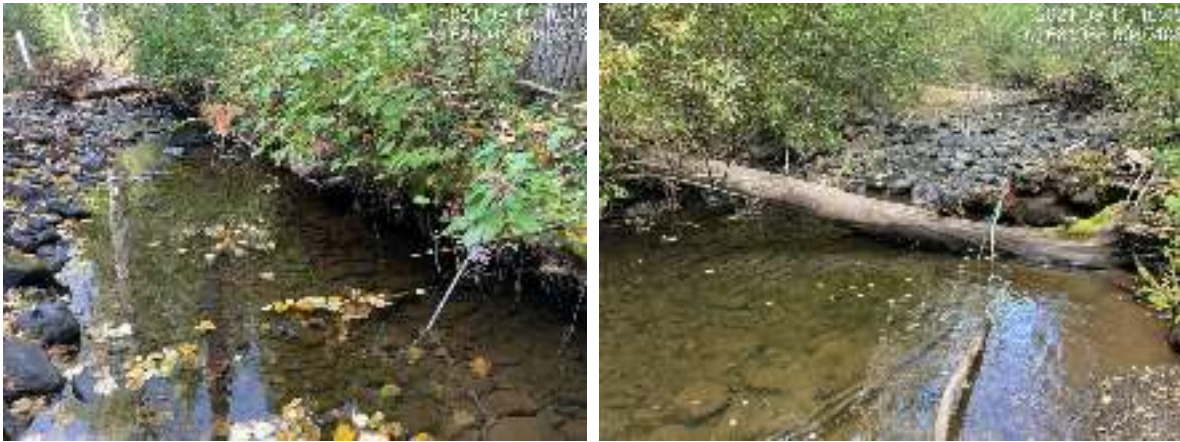
Figure 5.34: Left: Typical habitat upstream of PSCIS crossing 197975. Right: Typical habitat upstream of PSCIS crossing 197975.

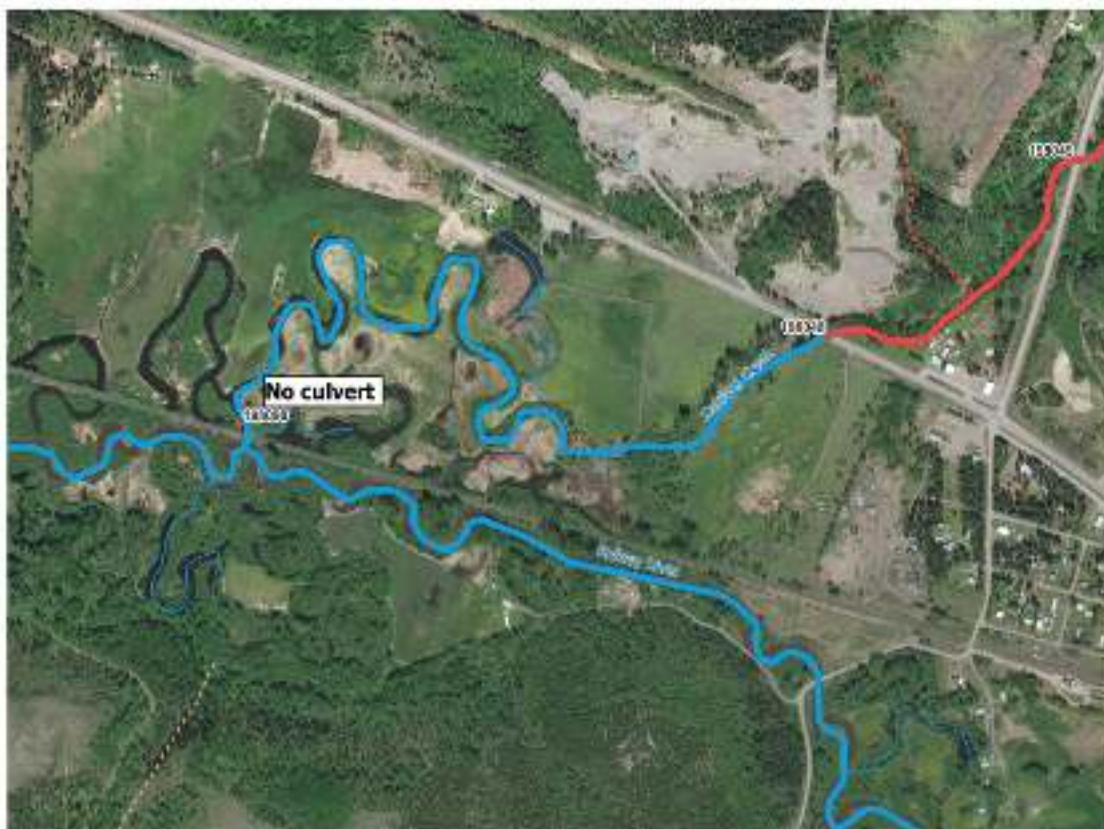
Figure 5.35: Location of potential location of crossing 198090 which was not present in the field.

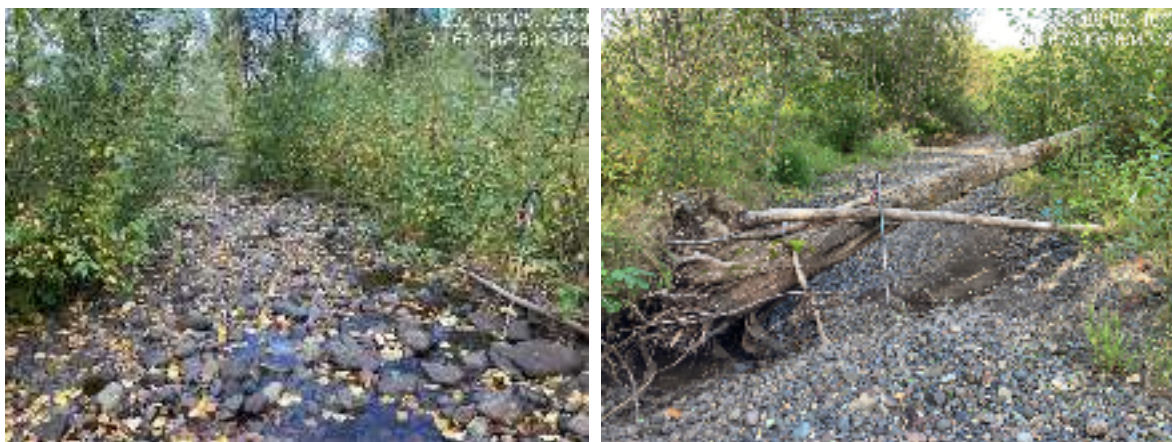
Figure 5.36: Left: Typical habitat downstream of PSCIS crossing 198048. Right: Typical habitat downstream of PSCIS crossing 198048.
