SOCIETY FOR ECOSYSTEM RESTORATION
IN NORTHERN BRITISH COLUMBIA

Bulkley River and Morice River Watershed Groups Fish Passage Restoration Planning 2021 - DRAFT

Prepared for
Habitat Conservation Trust Foundation - CAT21-6-288
BC Fish Passage Remediation Program
Canadian Wildlife Federation

Version 0.0.9 - DRAFT
2022-04-29

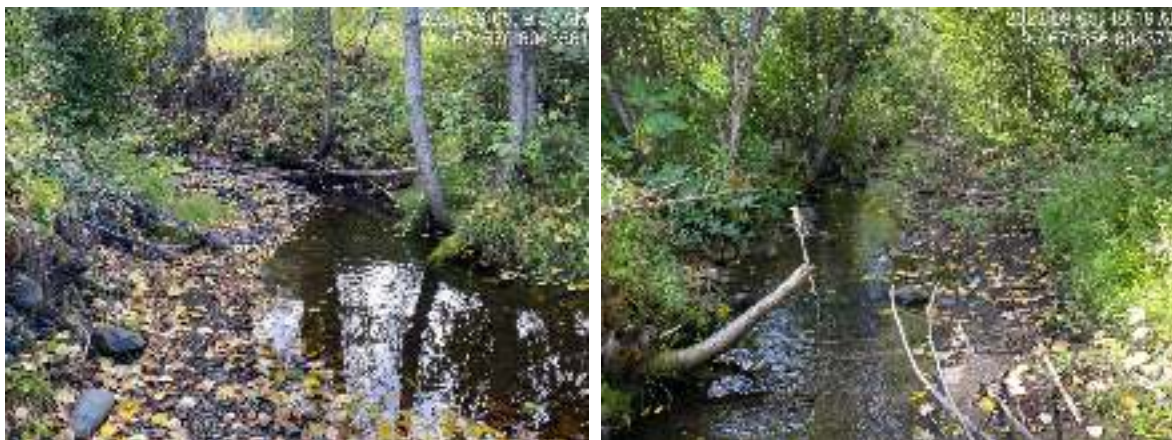
Figure 5.37: Left: Typical habitat upstream of PSCIS crossing 198048. Right: Typical habitat upstream of PSCIS crossing 198048.

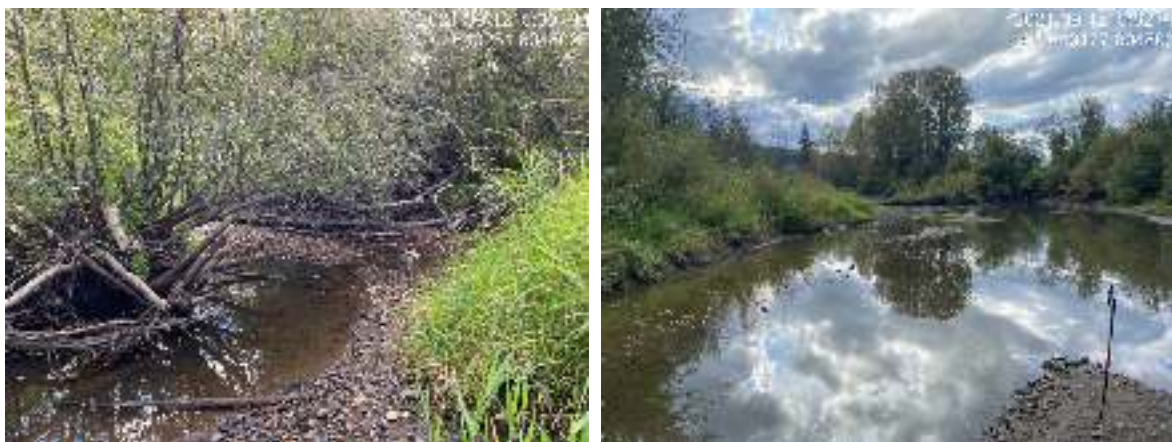
Figure 5.38: Left: Typical habitat downstream of PSCIS crossing 198066. Right: Habitat on side channel of Bulkley River downstream of crossing 198066.

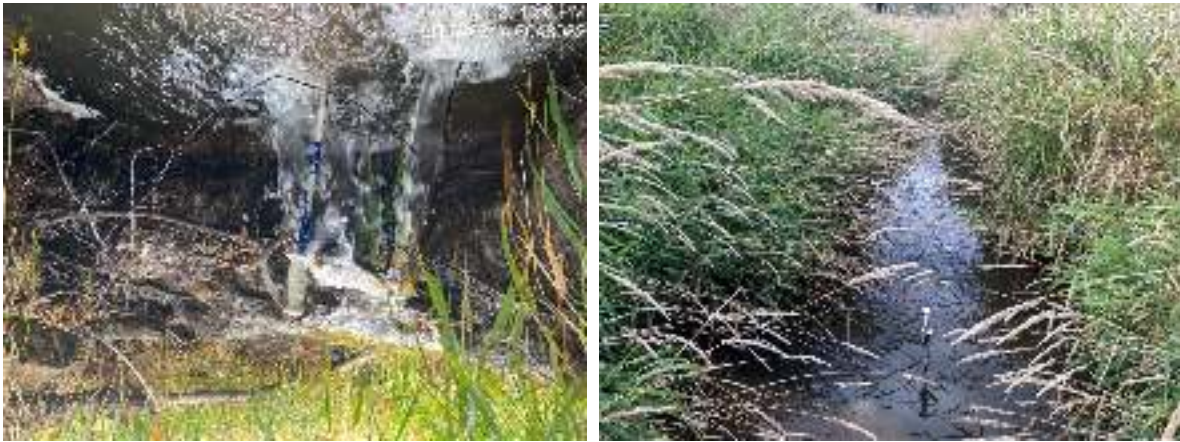
Figure 5.39: Left: Small drop (50cm high) located ~20m upstream of PSCIS crossing 198066. Right: Habitat immediately upstream of PSCIS crossing 198066 that flows through a hay field within an excavated trench for approximately 350m.
