# Air-coupled Ultrasonic Transduction System as an Applied Method for the Robotic Utility Inspection Collar | *Proposal* |

Department of Computer & Electrical Engineering & Computer Science, Florida Atlantic  
University, Boca Raton, FL 33431, USA

FPL Representative & Sponsor: Troy Lewis

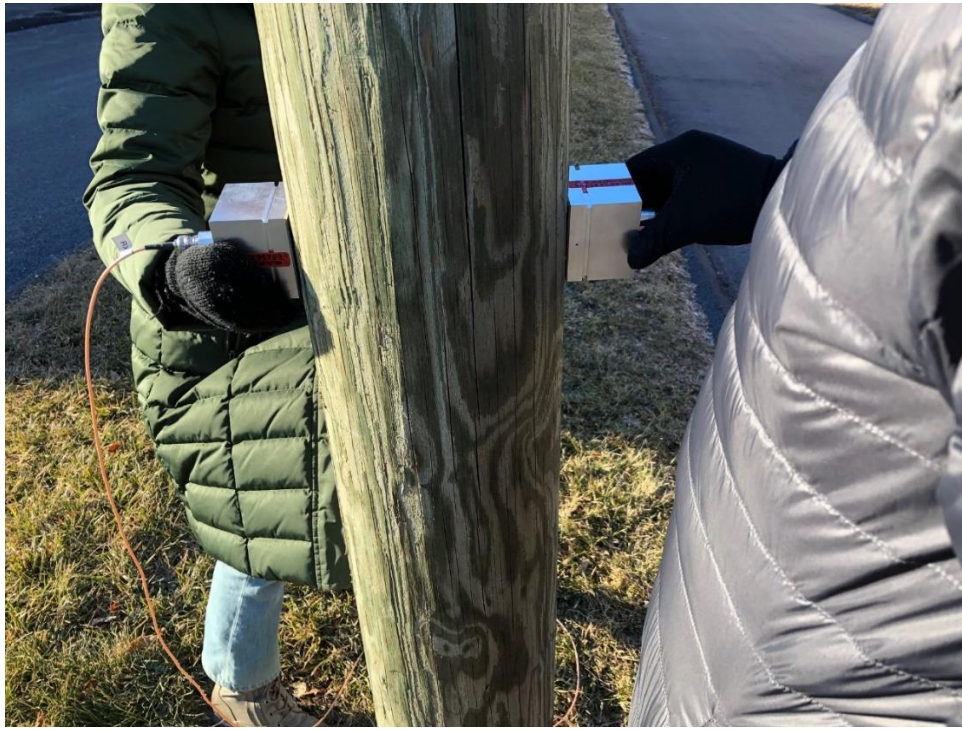
*Figure 4.2.1: Field test setup*

Informal testing was conducted on a wooden utility pole by *The Ultran Group, Inc.* They attempted to test for successful propagation using a planar/unfocused NCG50-D50 and S50 transducers that used 50kHz, 100kHz, and 200kHz frequencies with a standard pulser and a high-voltage pulser. Successful propagation through the pole was noted by the 50kHz frequency with increased gain to 84Db from the receiving transducer. The 84dB gain from the receiving transducer produced enough noise to dampen the signal completely so averaging was applied. Although the 50kHz frequency was able to transmit through the pole, it was noted that a larger diameter transducer would produce more profound results for NDE applications on the large diameter pole. The 100kHz and 200kHz frequencies for this experiment were proved to be unsuccessful, but further modifications to signal processing could possibly produce effective results with these frequencies. The test setup is noted in Figure 4.2.1, 4.2.2, and 4.2.3 below (Whetzel, 2021).

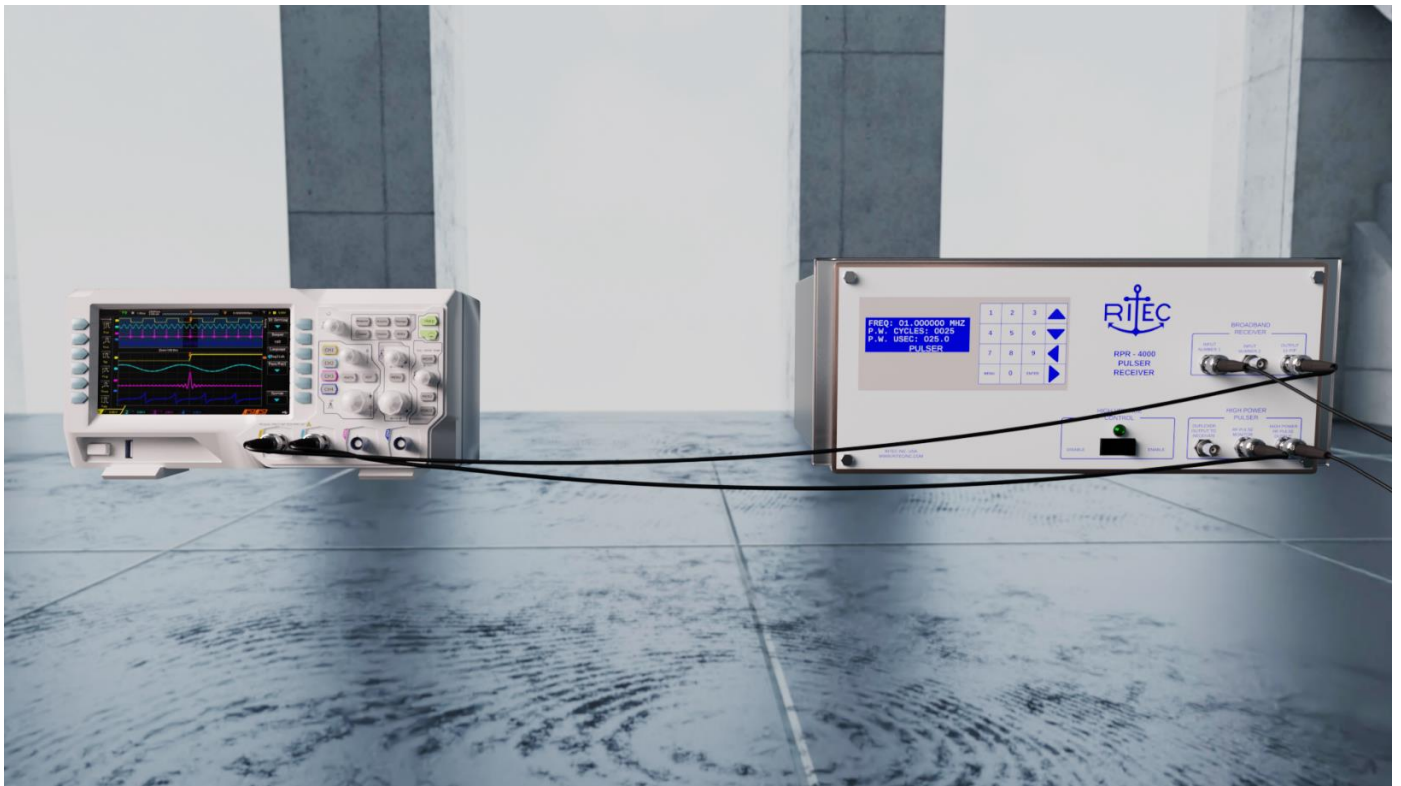
*Figure 4.4: The RPR-4000, transducer, and oscilloscope configuration.*

The RPR-4000 High Power Pulser/Receiver from RITEC, Inc. will be used to excite, drive, and receive the signals from the transducers. The transmitting transducer will be connected to the RT-150 Termination via BNC cable before being connected to the high power pulser. The RT-150 reduces reflections that can affect the shape of the toneburst as well as provide more control of the voltage amplitude. The receiving transducer will be connected to the broadband receiver which contains a microprocessor that controls the receiver gain, filter settings, and receiver input. The RPR-4000 has a front panel keypad and menu screens for controlling all the functions of the high-power pulser. The output of the broadband receiver and the RF pulse monitor will be connected to the TDS 2012C Oscilloscope from Tektronix, Inc. Except for the Duplexer (not needed), the following configuration is pictured in Figure 4.4 below.
