# A new era of fishing vessel safety emerges

## ABSTRACT

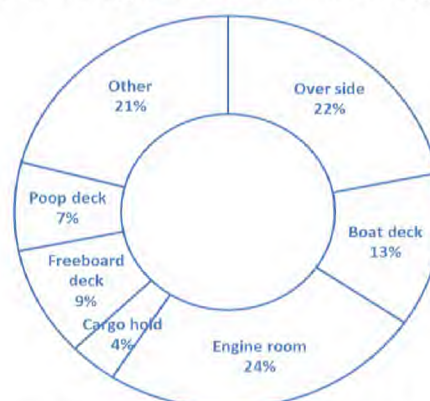
Out of all the recorded accidents over 60% involve trawlers, whilst 15% dredgers (EMSA, 2015). The most critical location of the main casualties is the engine room as shown in Figure 1 .

**Figure 1: Main Casualty Areas in Fishing Vessel Accidents**

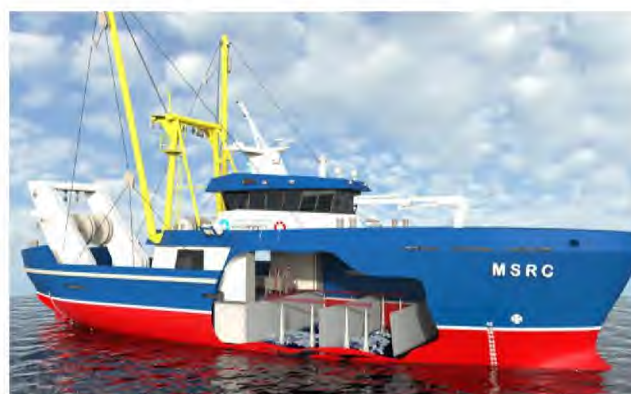
Two electrically driven internal gear pumps, located on the resin and hardener lines respectively, are used to deliver both foam components to a number of mixing nozzles located within the protected compartment. Each pump may be operated from the main or emergency electrical supply and must be started by manual means either remotely from the bridge control console or from their local switches. Both resin and hardener lines have re-circulation loops whereby the pumps can be used to circulate each component periodically. This enables faster foam deployment as it removes the requirement for pump-priming while also allowing the pumps to be tested when necessary.

Figure 3: DSRS Graphical Representation

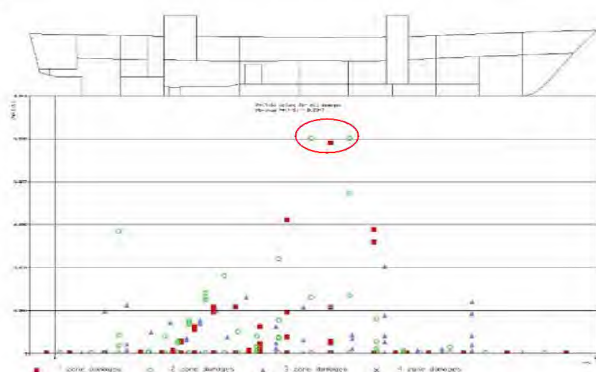
These local risk values could then be mapped along the vessel according to damage centre in order to form the risk profile as depicted for an example in Figure 5.

Figure 5: Example Case, Local Risk Profile

In the above risk profile, risk is plotted on the vertical axis and the damage position along the horizontal. Differing lengths of damage, as measured by multiples of adjacent zones, are distinguished by marker type and colour. This enables the identification of safety critical design areas, hence opportunities where safety could be improved most significantly and efficiently. Three cases in particular, circled in Figure 5 are identified as large risk contributors. As such, it can be reasoned that the DSRS would be best applied in the protection of one or both compartments, which give rise to this risk in the most efficient way.

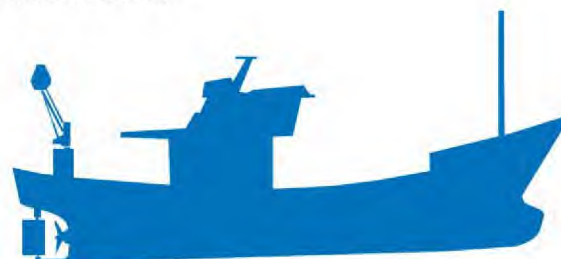
Figure 6: Vessel Profile

The vessel is an example of a typical fishing vessel operating within UK coastal waters. It is operated by 15 crew members with the provision of cabins for overnight sail. Also, it is subdivided into 8 watertight compartments and it is not equipped with life boats due to coastal operation. The principal particulars are provided in Table 1 below along with the vessel's profile in Figure 6.

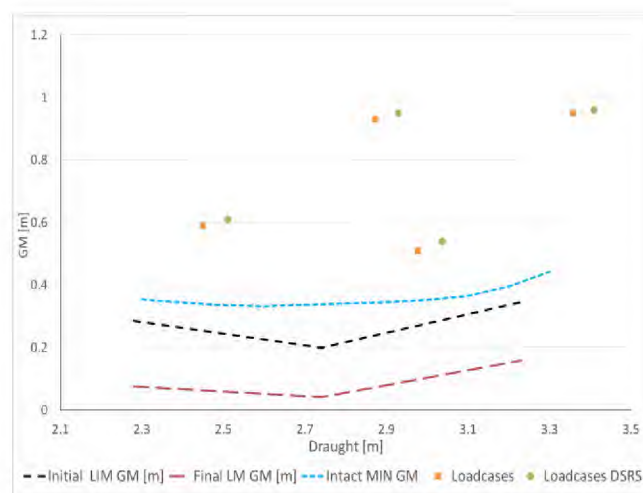
assessed, demonstrating further the improvements afforded. As it is displayed in Figure 9, in terms of damage stability alone, the new derived limiting GM curve compared to the original limiting GM curve yields a decrease of approximately 79% for the partial subdivision draught and around 55% for the deepest draught respectively. This can be translated into substantial contribution to the safety of the vessel.

Figure 9: GM (m) for intact and damage stability

Intact stability is paramount for small vessels and therefore it is necessary to account for the change imposed by the additional weight of the system. As it is apparent from Figure 9, four different load cases have been assessed. The difference in the GM and draught can be justified purely by the increase in the weight. The effects of this change on the load case GM margin ranges from 2% to 17% reduction. Finally, the vessel complies with all fishing vessel intact stability criteria as outlined within IMO's resolution A749-4.2.
