On the Experimental Investigation on the Capsizing of Small Fishing Vessels

Luis Pérez Rojas
Carlos López Pavón
Francisco Pérez Arribas
Ainara Martín Landaluce

ETSIN Model Basin, UPM. Madrid (Spain)

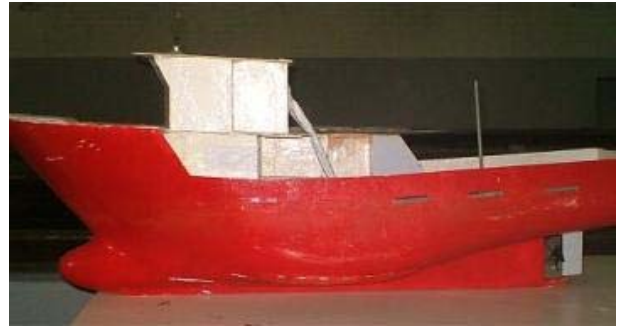
Fig. 3 Model of the ship "O Bahía"

The models were built in FRP, reproducing underwater hull and also superstructure.

The “O Bahía” model was provided with bulwark ports and their closures, which reproduced those in the shipwrecked vessel.

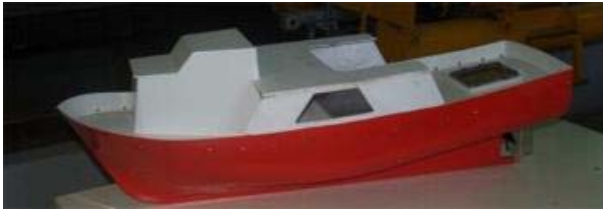
Fig. 7: Model of the ship “Enrique el Morico”

Detailed plans of “Enrique el Morico” boat were not available, so the information about the situation of the scuppers was obtained from a ship built in the same mould. The situations of the scuppers are supposed to be similar in both boats, as they were built at the same shipyard, and in the same mould.

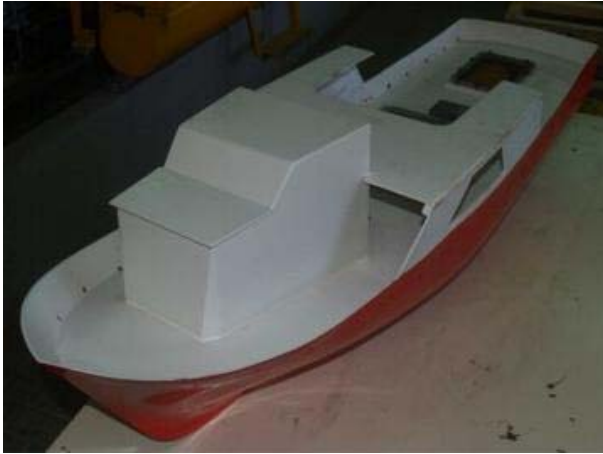
Fig. 8 : Model of the ship “Enrique el Morico”

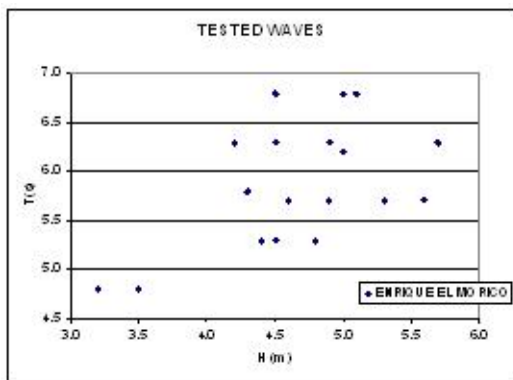
Selected waves were steep and sometimes breaking waves. Test conditions were rougher than those at the accident. Although ships were loaded in the same way as at their accidents, cargo movements and water retention have been neglected at the experiment. The waves used when performing the experiments are presented at the following tables:

Fig. 10: Tested waves for the model of the “Enrique el Morico”

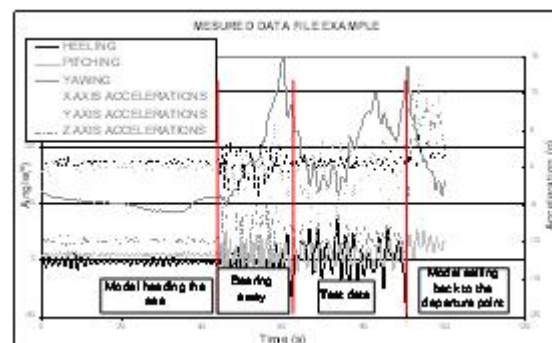
A file containing time, acceleration and angular position for each axis was recorded for every run. Next, only the part where the ship was sailing in following and quartering seas was considered, neglecting the other situations. Trim data was corrected after every run, in order to refer this data to the water line. This correction was needed because the inertial unit was installed at its base trimmed. Yawing data was only used to know the beginning and the end of the run (that corresponded to appreciable variations in the heading), so this information was deleted once the data was analysed.

Fig. 11: Measured data during the tests
