Capturing Runoff in Alumni Mall

By Mike Hennessy, Antonio Garcia, Tyler Reavis, Nico Meiswinkel, Jack Michaelis

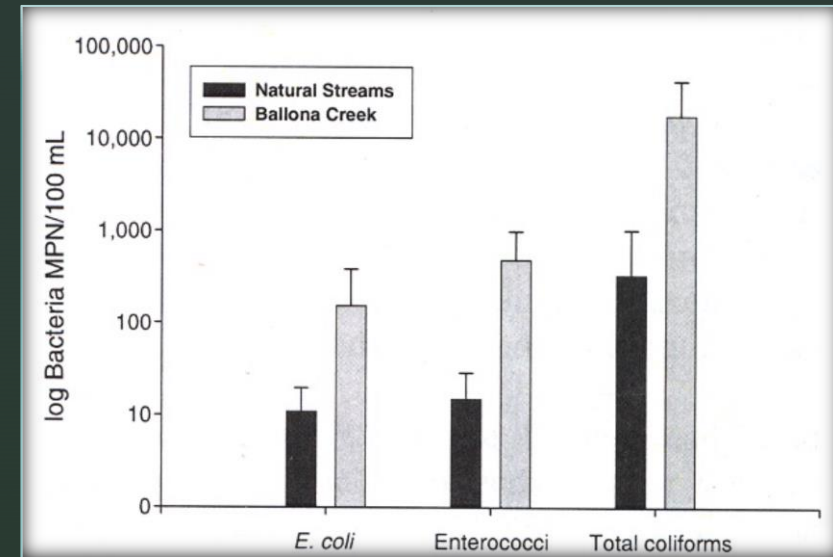
FIGURE:3 Ballona Creek Contaminates

- Location: part of the Ballona Creek Watershed
- The Ballona Creek Watershed can be classified as urban runoff
- Higher levels of contaminants
- Nearly twice as much e-coli, enterococci, and general coliforms
- Common contaminants
 - DDT's: disrupts hormones important to good health
 - PCB's: harmful industrial chemicals that cause birth defects
 - Trash and debris: cigarette butts and other contaminants from foot traffic

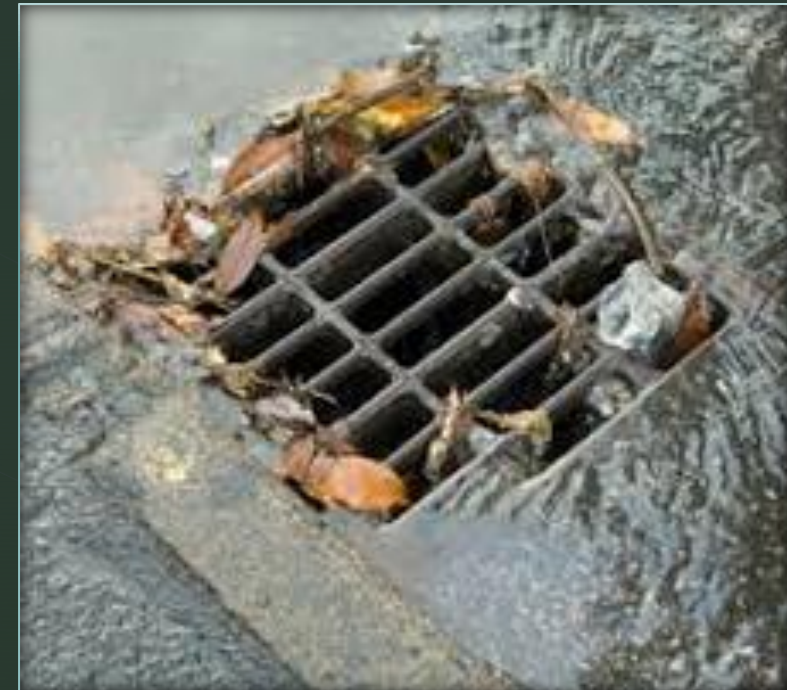
Figure 6: In-Line Filtration Grate

- Bio-Filtration
 - Natural alternative to filtration
 - Use biological agent present in soil to filter ground water
 - Effective against bio-degradable carbon based contaminates
 - Less impact to C-coefficient
- In-line filtration
 - Higher impact form (increases C-coefficient)
 - Can support higher levels of discharge
 - More Maintenance and easily clogged
- Campus application
 - Both techniques are viable for projected peak discharge
 - Bio-filtrations is lower impact that meets our needs

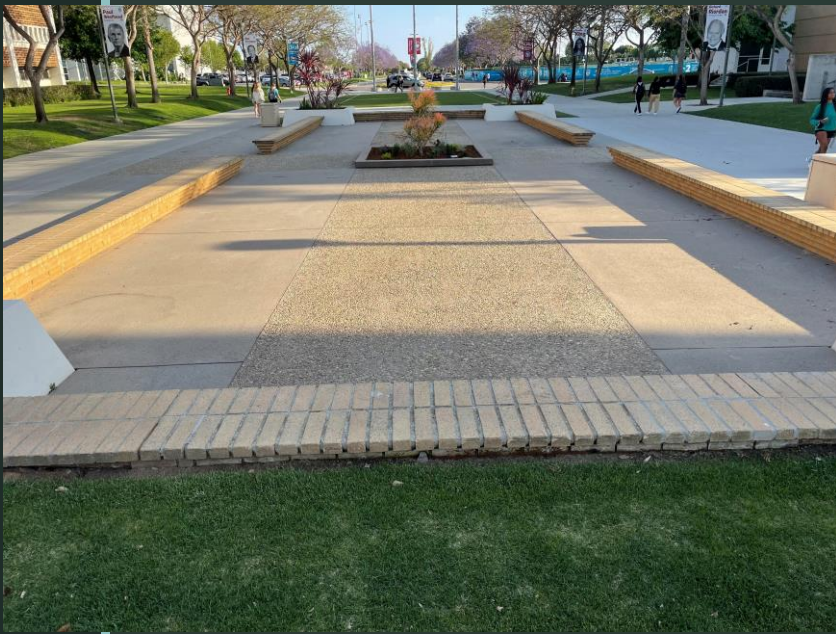
Figure 9: Concrete Area in Alumni Mall

- Excess concrete
- Insufficient drainage system
- Certain areas are “trapped” by benches
- Perfect subject for Low Impact Development to control run-off
- Clogged drainage tubes randomly dispersed along walk

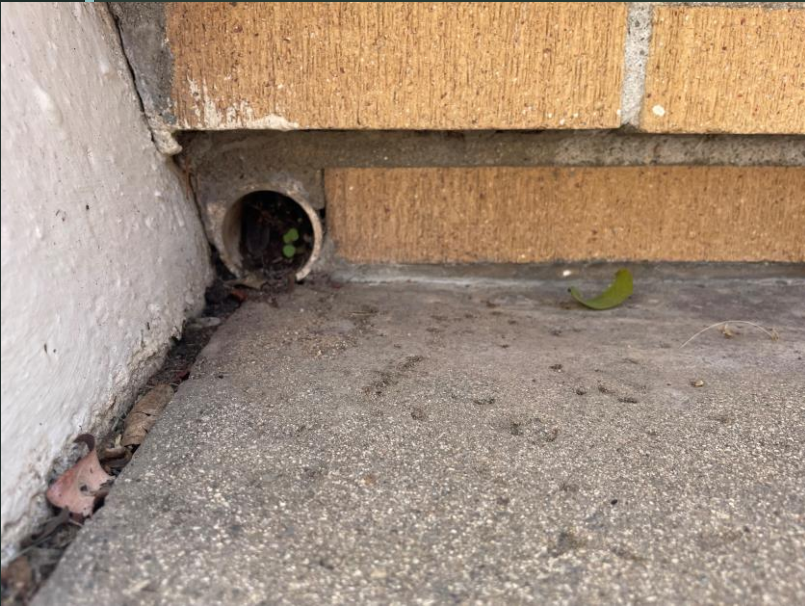
Figure 10: Clogged Tubes in Alumni Mall

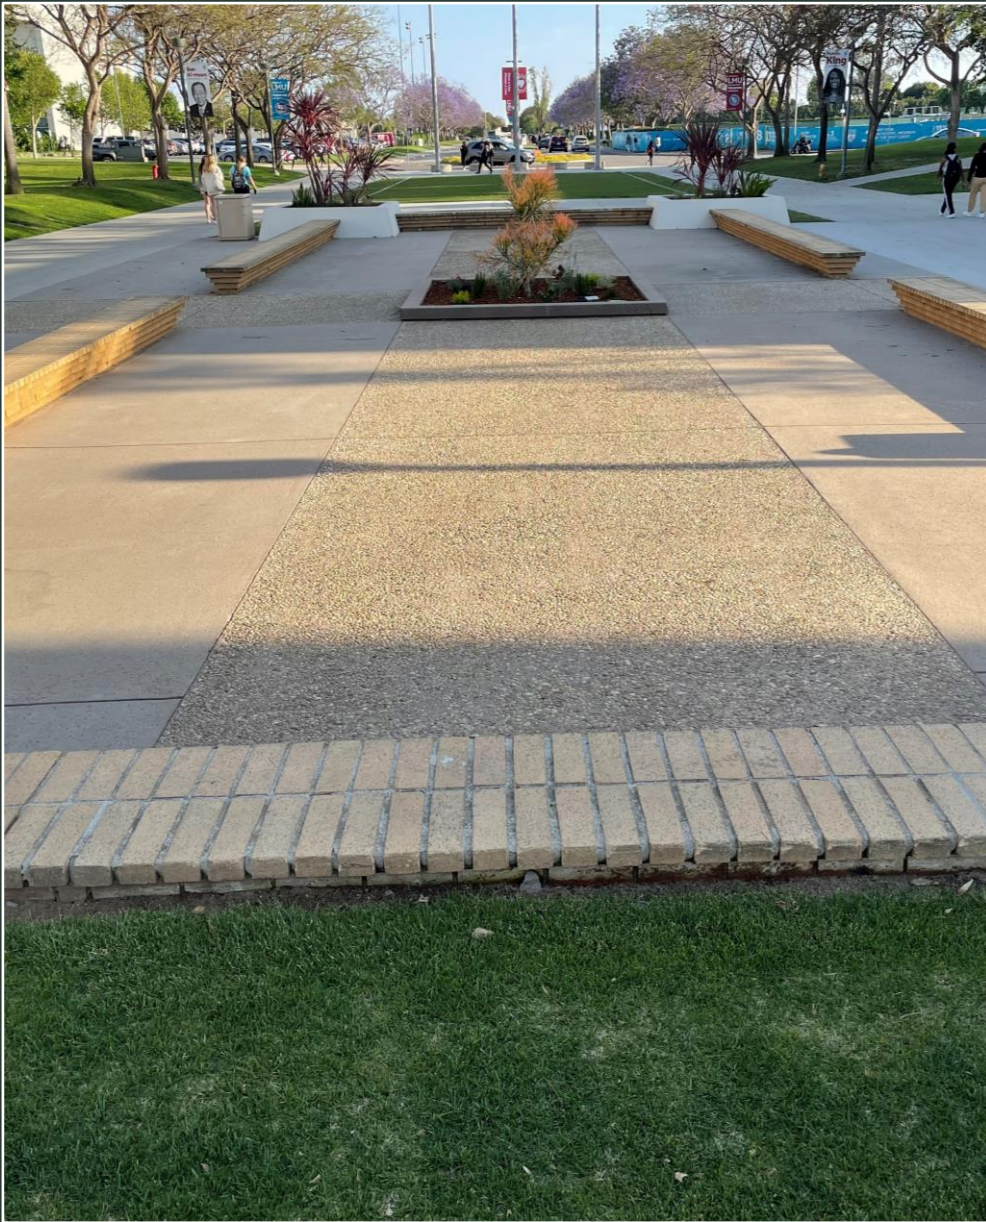
Figure 11: Target Area

- Two identical spots along Alumni Mall
- This area: minimal attention to runoff
- Benches create enclosed area trapping water
- Minimal filtration through the non-porous concrete
- Concrete is sloped towards the sides
- Diverts water to the grass banks on each side
- Captures water alongside the benches

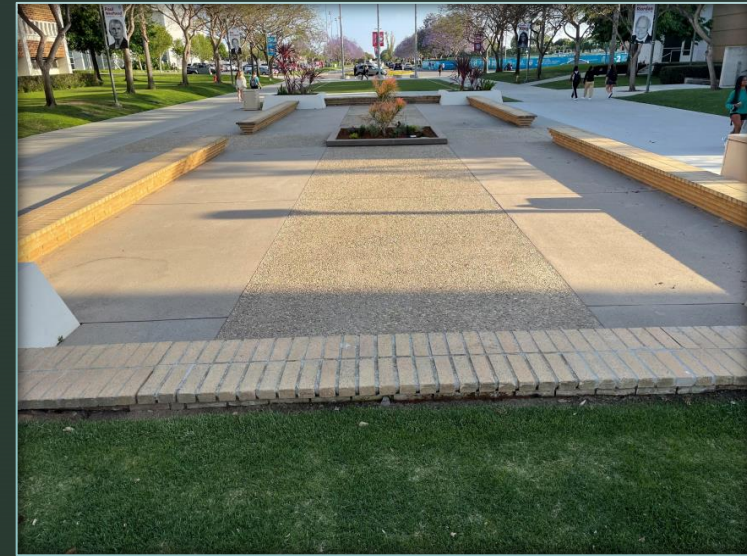
- Trench system like that on LMUs campus
- Focus on “trapped” area that prevents infiltration
- Create slight slope pointing inward
- Water is diverted to soil
- Runoff is captured and infiltrated into ground
- Clean water added back to ground water

Figure 12: Target Area for infiltration

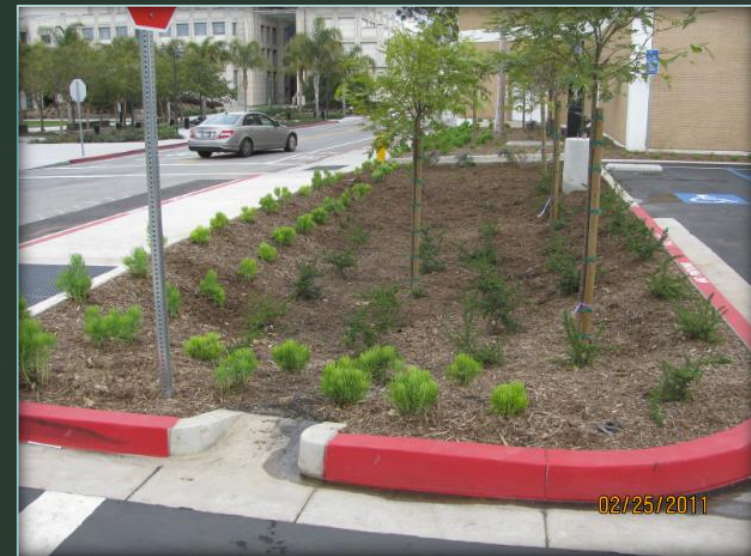
Figure 13: LMU trench system

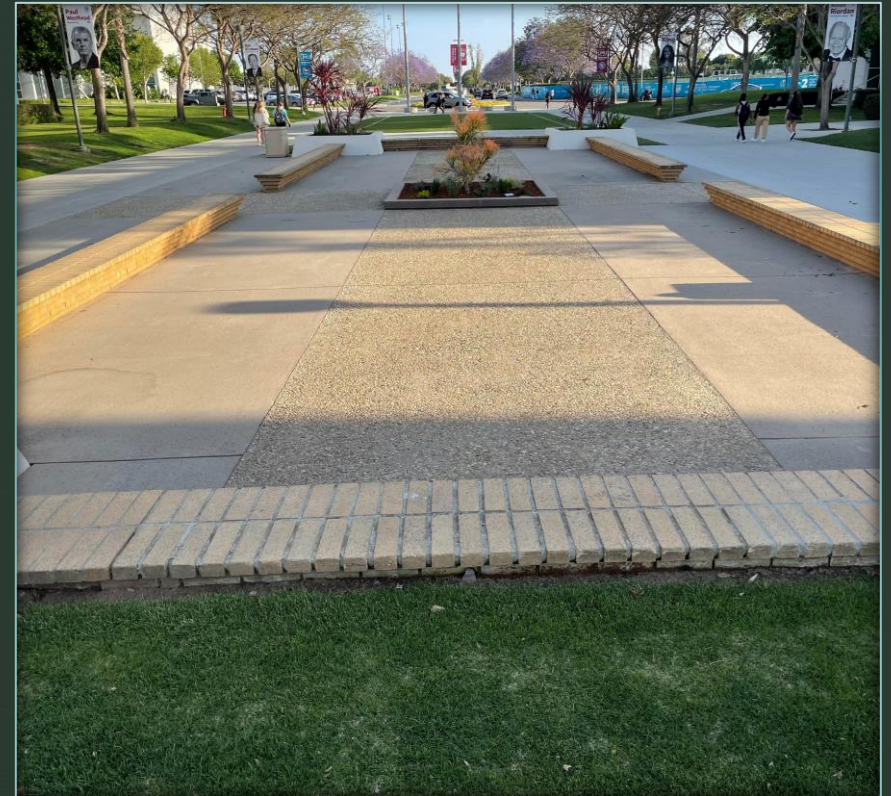
- Hire crew to remove concrete surrounding plantation box
- Hire someone to create surrounding sloped concrete boundary
- Insert trench system
 - Sand underneath soil and native plantation to infiltrate contaminated particles
 - Seeps to ground water system

Figure 18: Construction Area
