Guide to Streamgauging Sites in the Tuolumne River Drainage

version 1.2

October 3, 2003

Yosemite Hydroclimate Monitoring Network

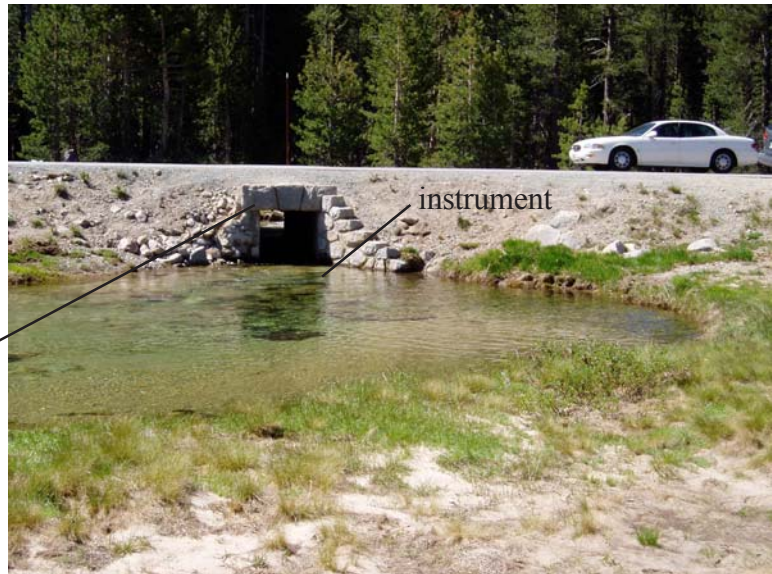
Tapedown: Marked with circle and line on downstream side of culvert, river right

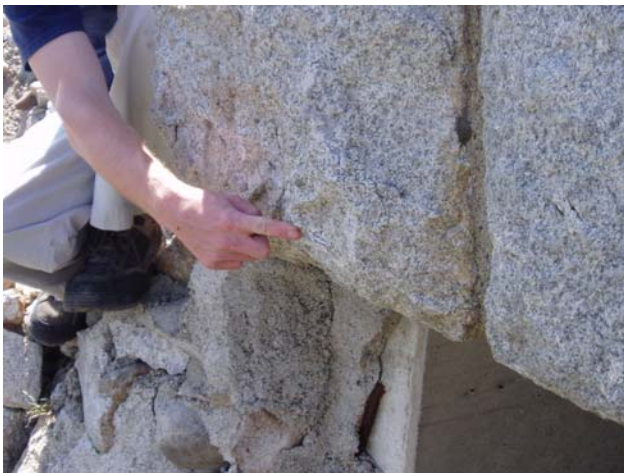
Tapedown-based Rating Curve:

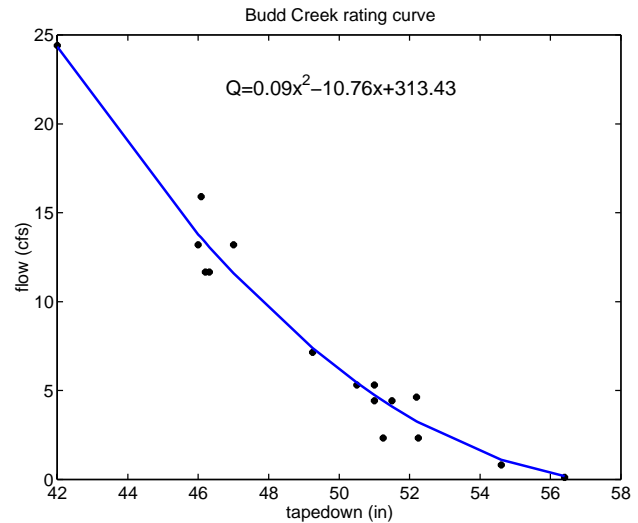
Flow Measurement: Taken downstream of culvert and fallen tree, in rectangular x-section

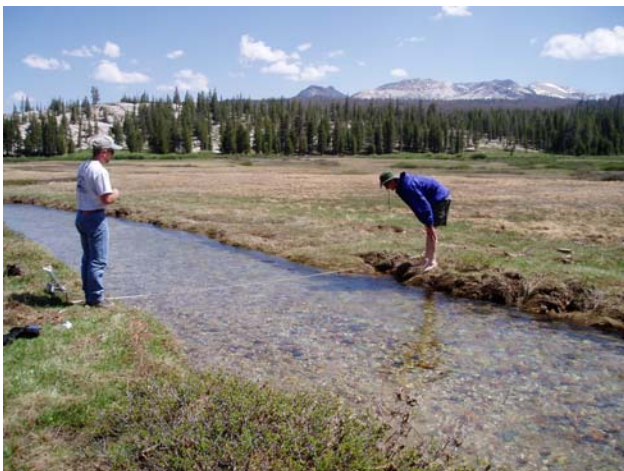
Streamflow record:

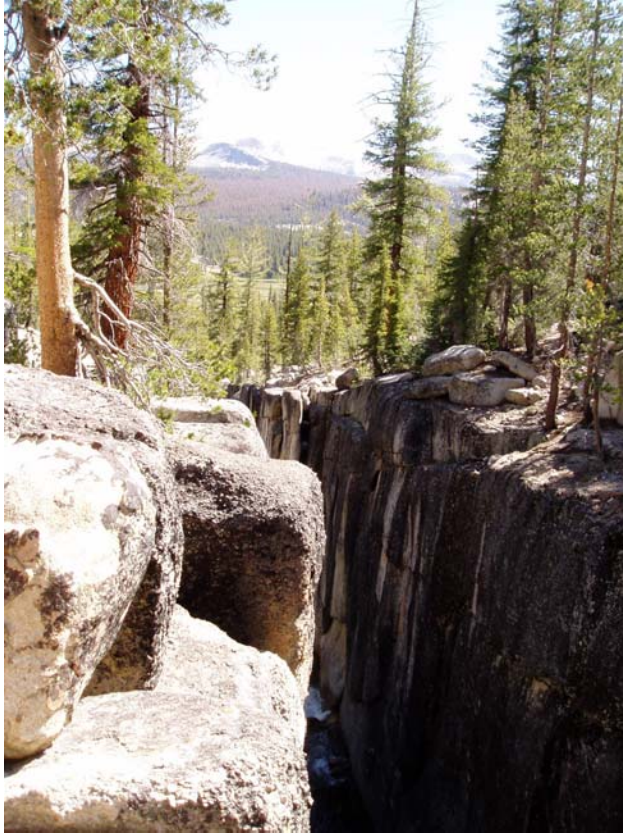
Deep crevasse through which Budd Creek flows.
P6260211

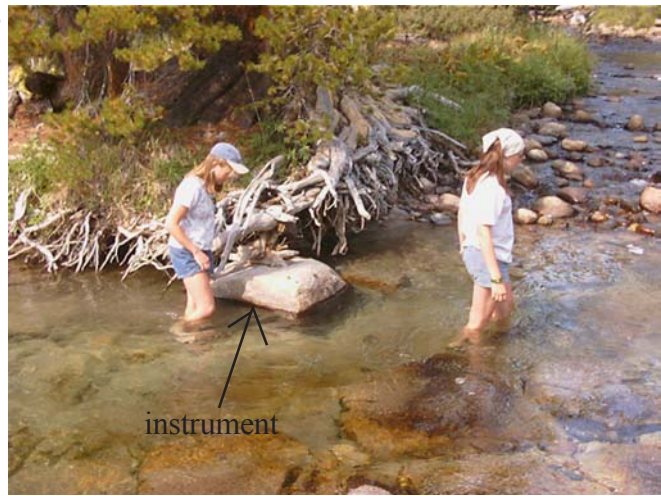
Instrument located upstream of bridge. SDC80034

Tapedown: Taken from mark on upstream side of bridge, stream left P6180079

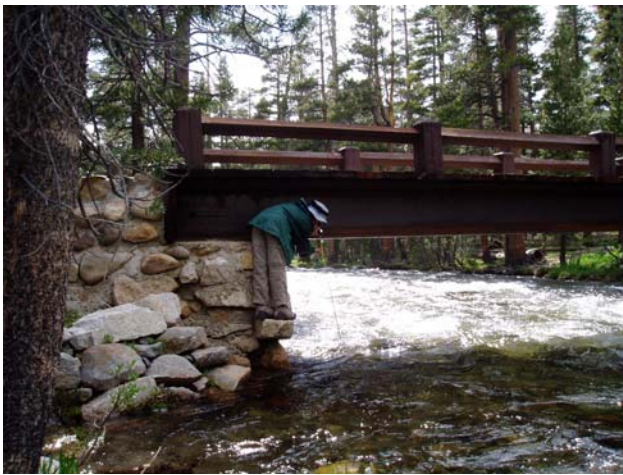
Tapedown-based rating curve:

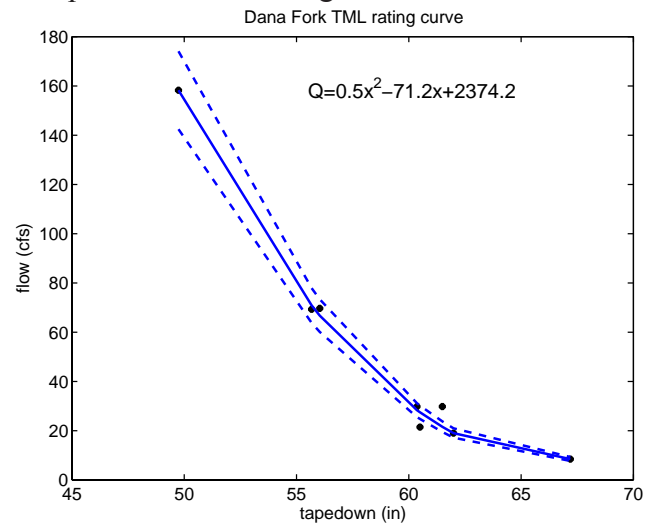
Flow measurement: Typically taken downstream of bridge and waterfall/swimhole near Dog lake Parking, just before channel divides. Velocity here is too low for pygmy meter during lower flows. P6250206

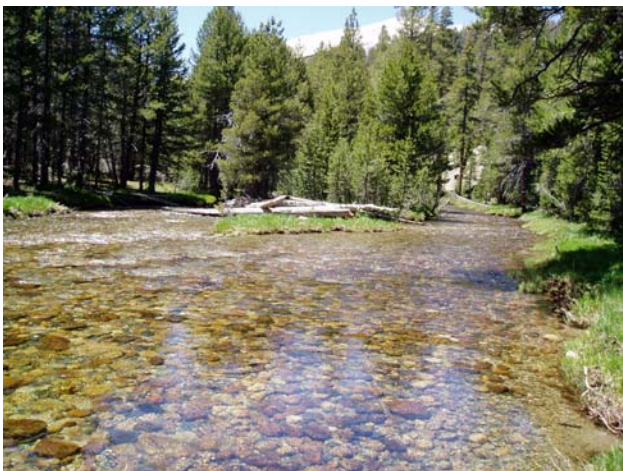
Streamflow record:

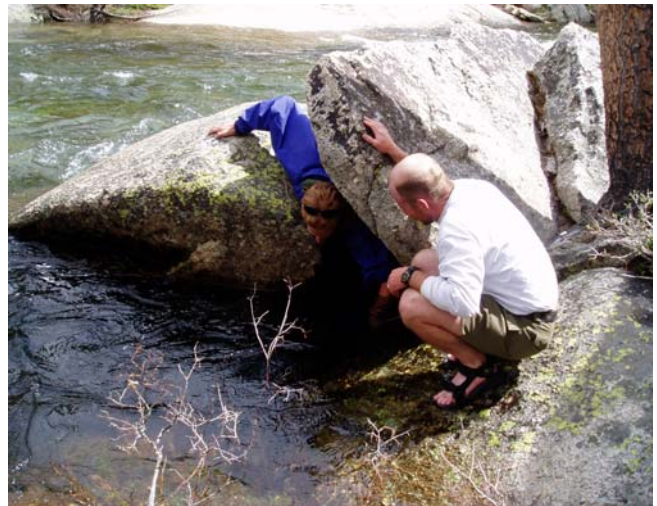
Instrument located upstream of rock down-stream of bridges. P6180072

Tapedown: Taken from mark on bridge closer to lodge, upstream, river right. P6180069

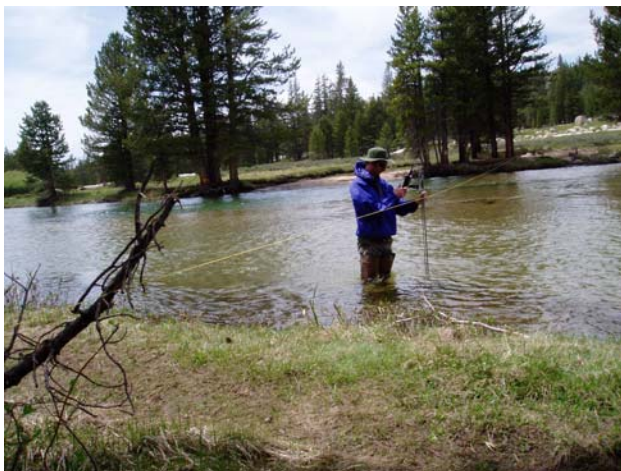
Flow measurement: Typically taken in meadow upstream of twin bridges. Location needs to shift slightly as flows become lower. P6180065

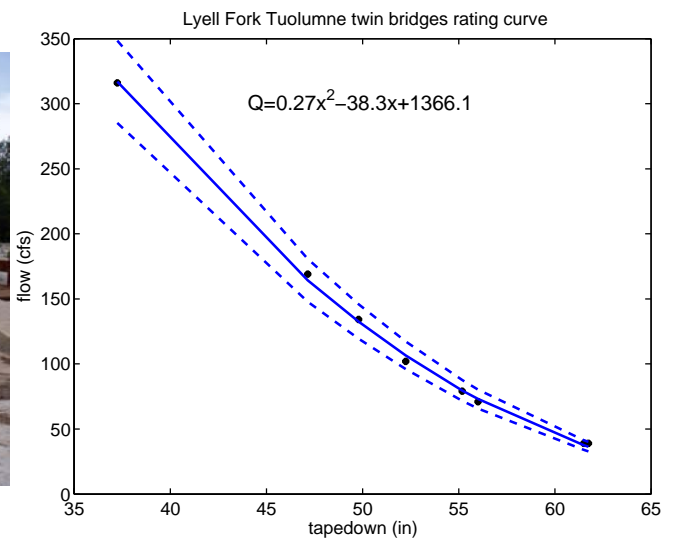
Tapedown-based rating curve:

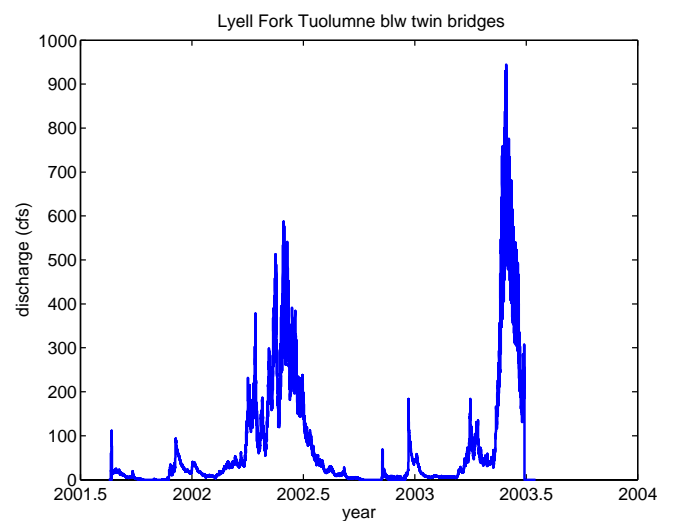
Streamflow record:

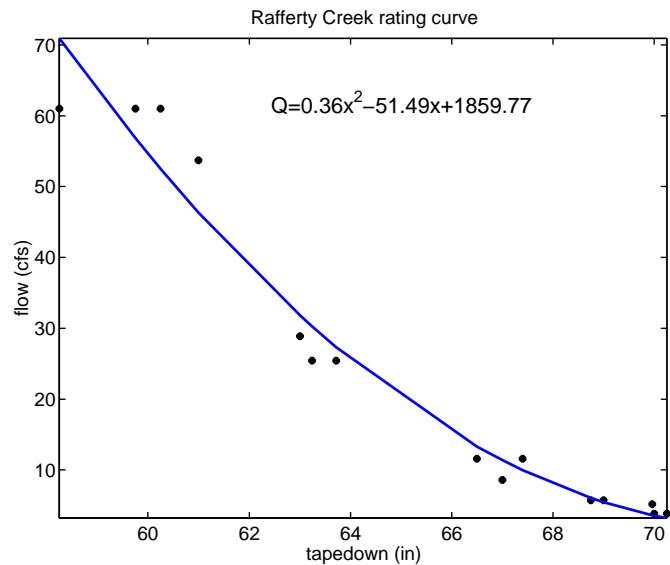
Tapedown-based Rating Curve:

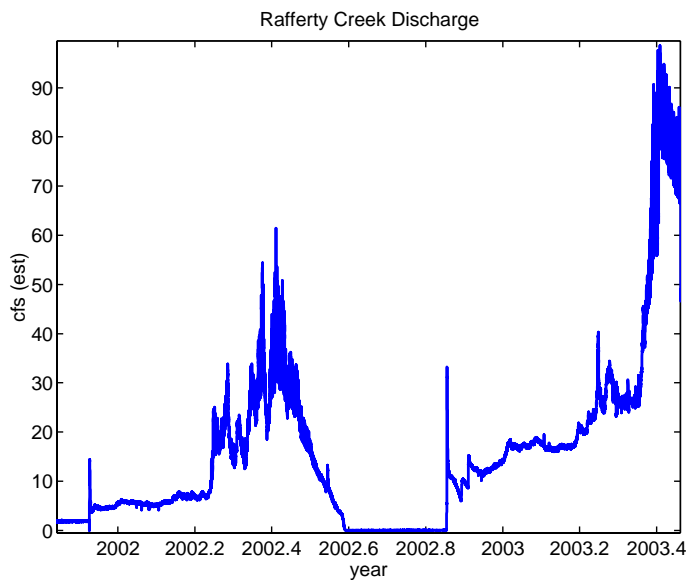
Streamflow record:

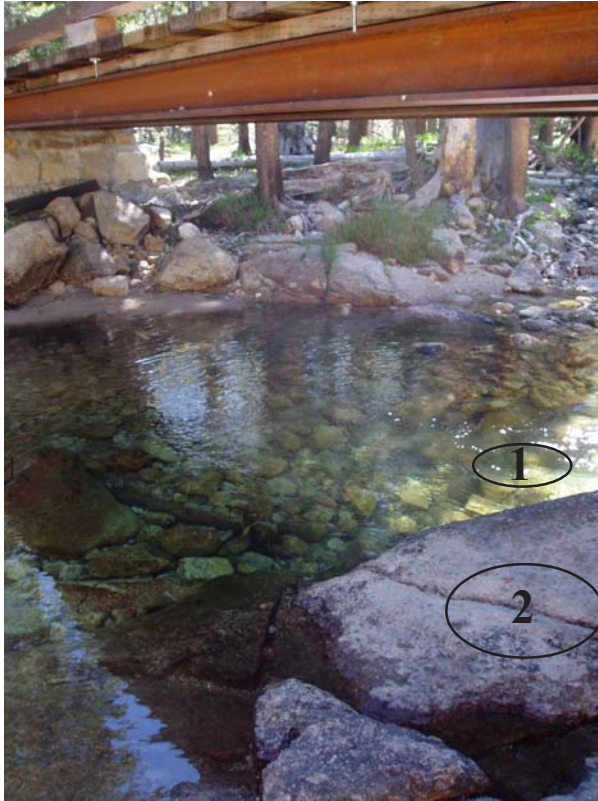
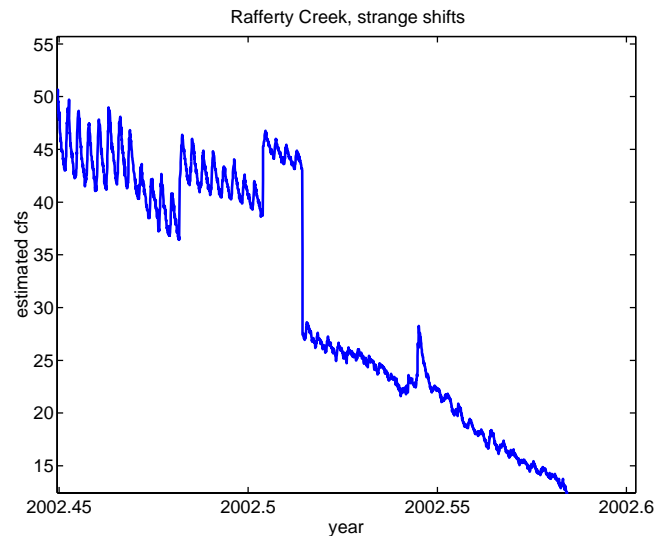
During summer 2002, the instrument seemed to shift dramatically in a period of an hour. This may be due to tourists moving the instrument. In August 2003, the instrument was reinstalled with a tighter cable and hidden carefully under rocks.

During peak flows in 2003, the instrument moved from the deep pool at site 1, to the much higher rock at site 2.

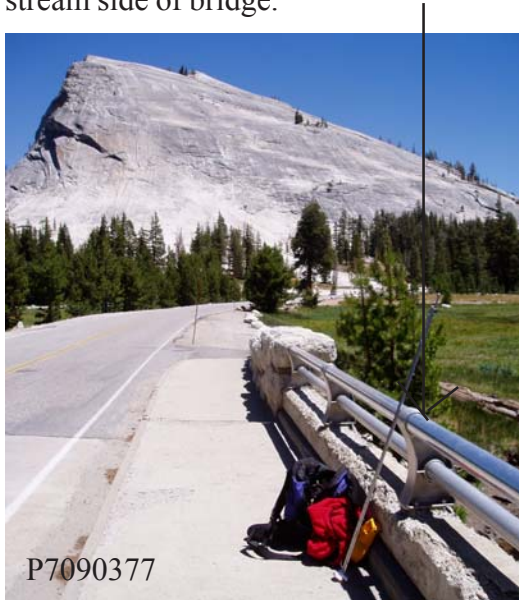
P7090377

Tapedown: Taken from mark on railing, up-stream side of bridge.

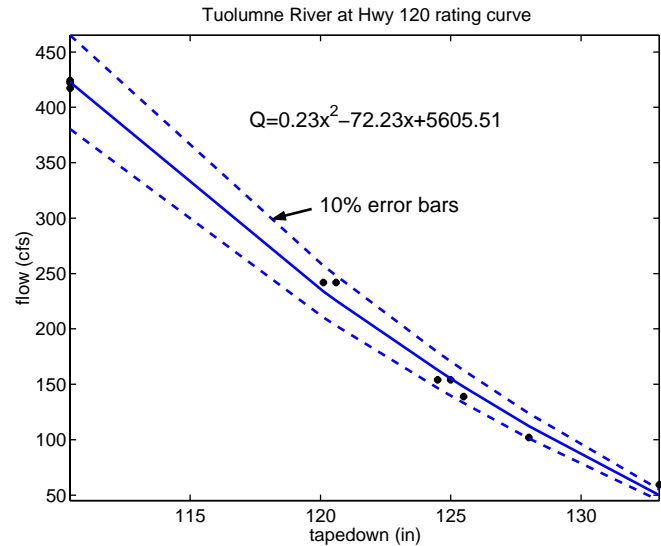
Tapedown-based rating curve:

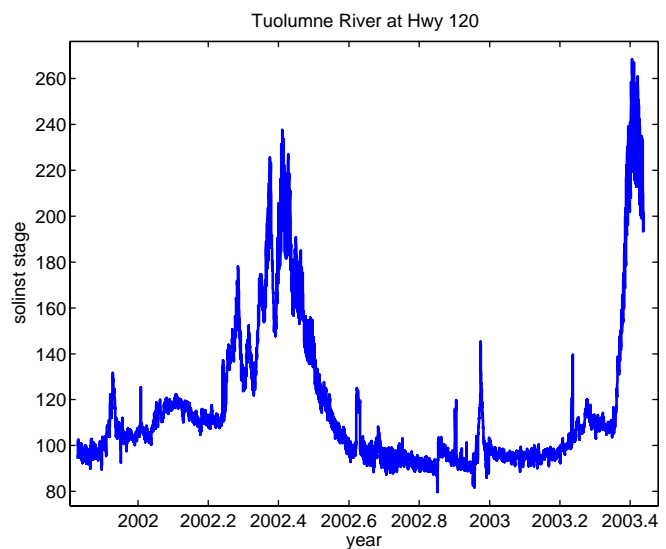
Streamflow record:

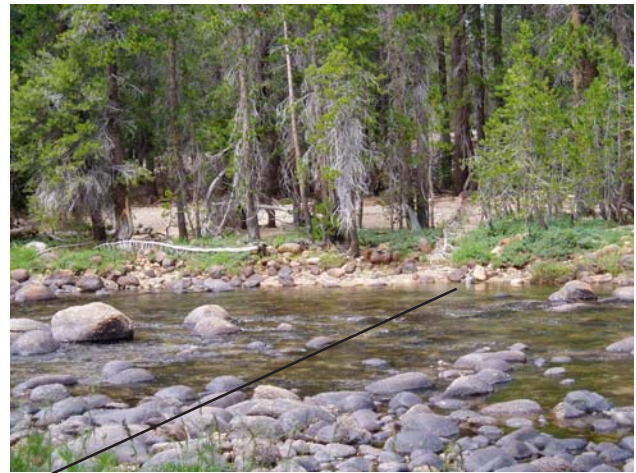
instrument

Tapedown: Taken from bridge near Tuolumne side of trail, upstream, river right towards center pylon, from bottom of horizontal metal. P8120920

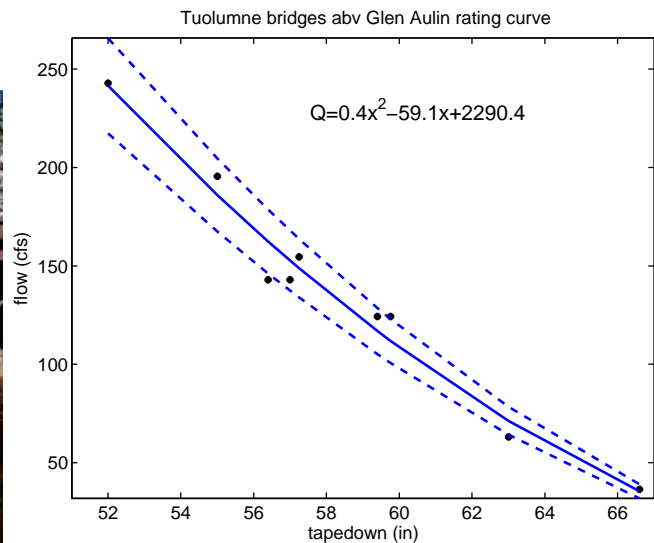
Tapedown-based rating curve:

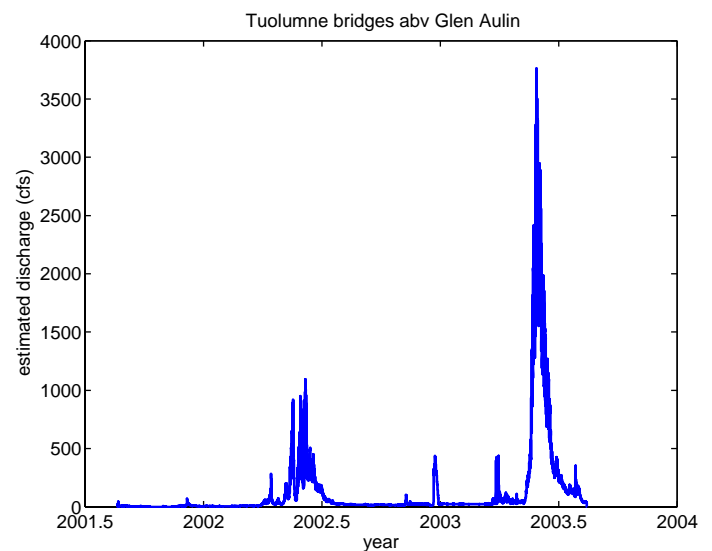
Streamflow record:

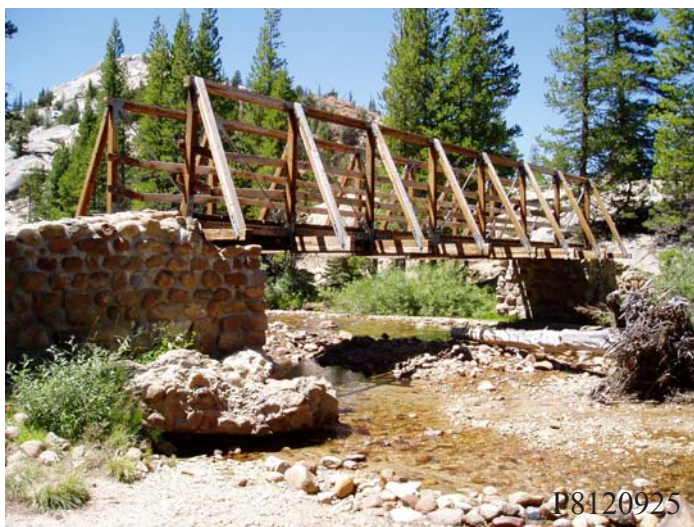
P8120925

Instrument located upstream of bridge, river right, in deep pool, under a bush.

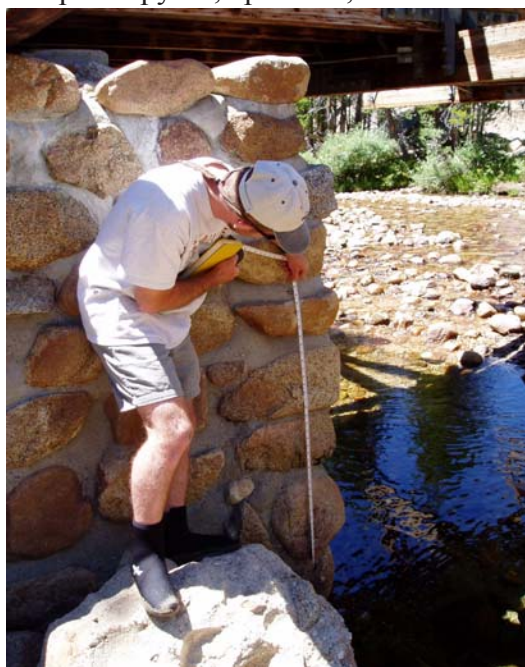
Tapedown: Taken from mark on Glen Aulin camp side pylon, upstream, river left. P8120924

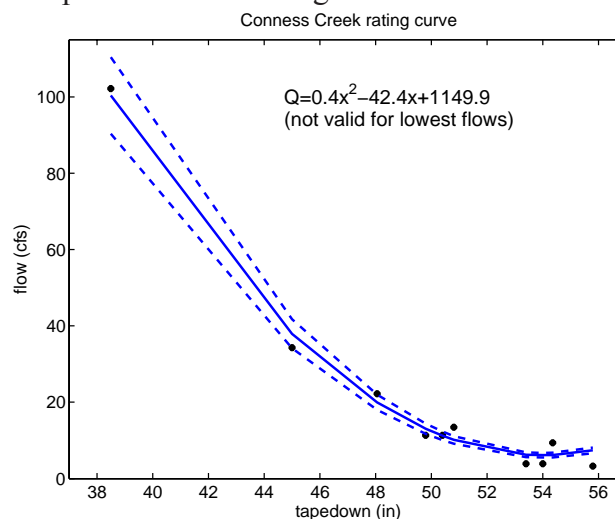
Tapedown-based rating curve:

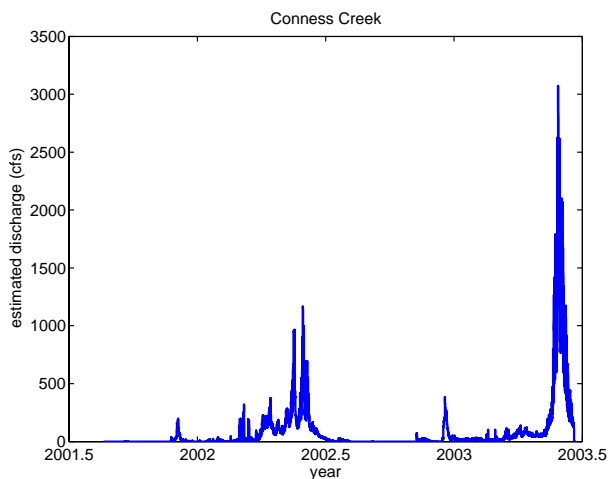
Streamflow record:

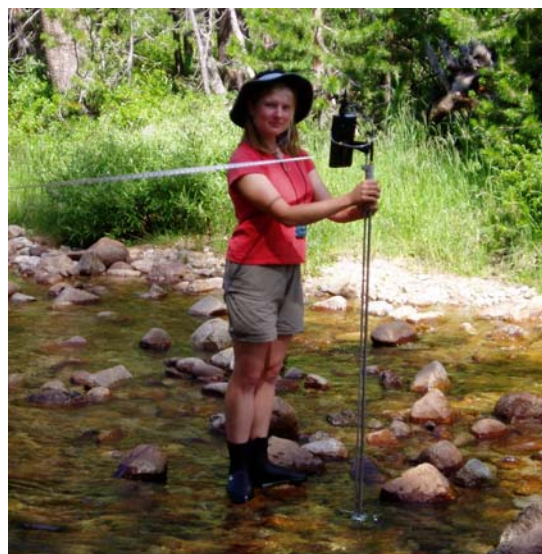
Flow measurement: No good cross-sections, but best available is upstream of bridge, next to camp.P7310753

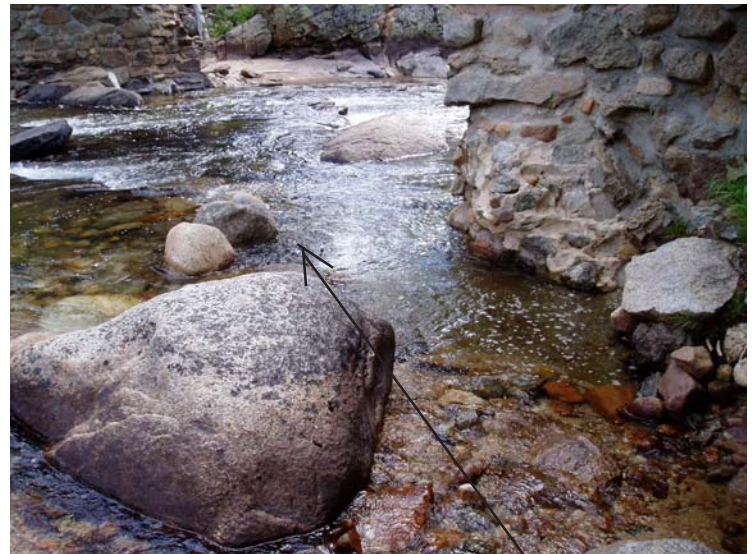
instrument

Tapedown: Taken from bottom horizontal metal ribar on bridge, upstream, river right, above instrument. Small arrow marks location. P8120926

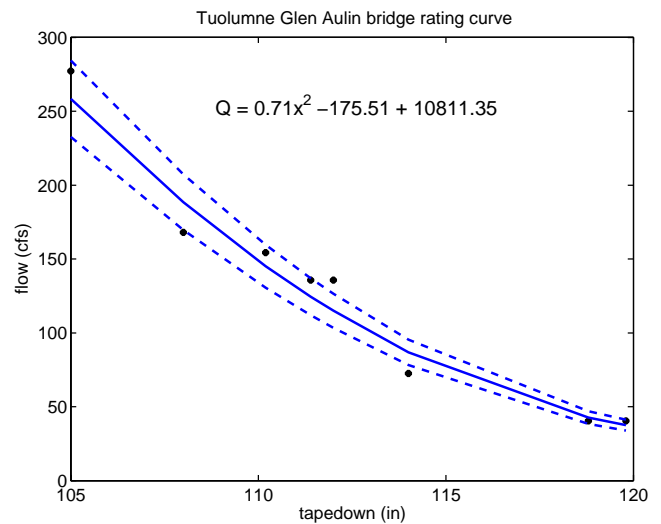
Tapedown-based rating curve: (Flow is a sum of Conness and Tuolumne below the falls.)

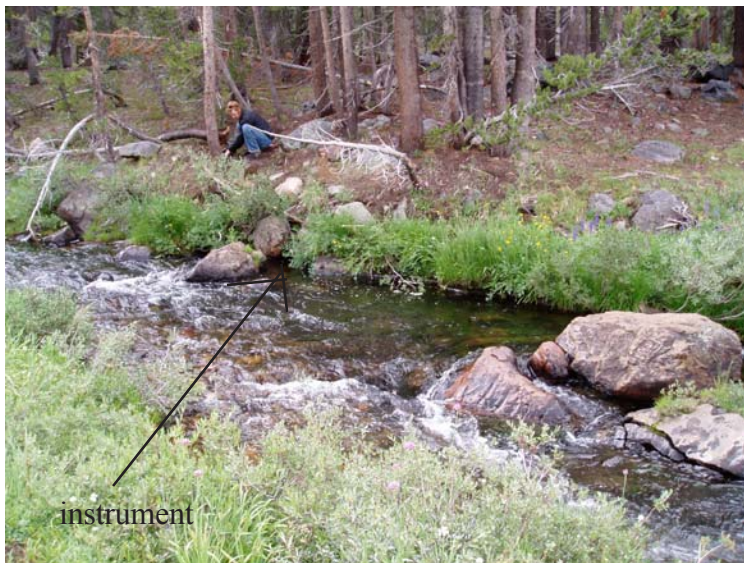
Instrument moved to new, more stable location 8/1/2003.
P8010772

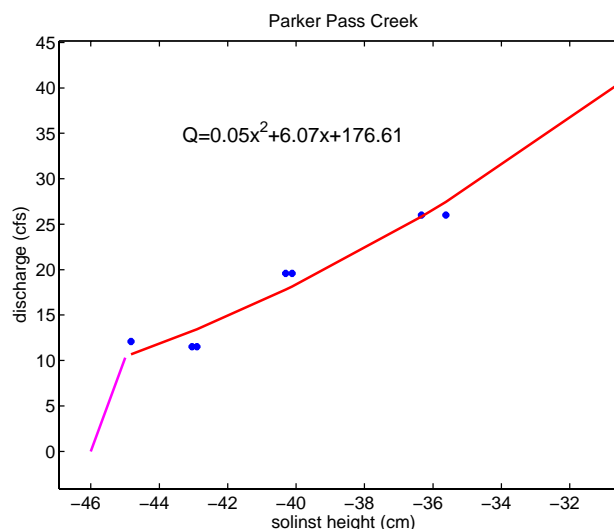
Solinst-based rating curve for summer 2003:

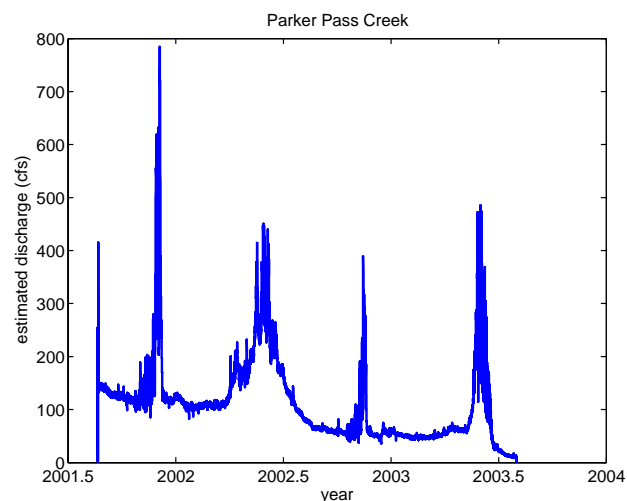
Streamflow record: There appears to be a linear drift in the instrument and/or the channel.

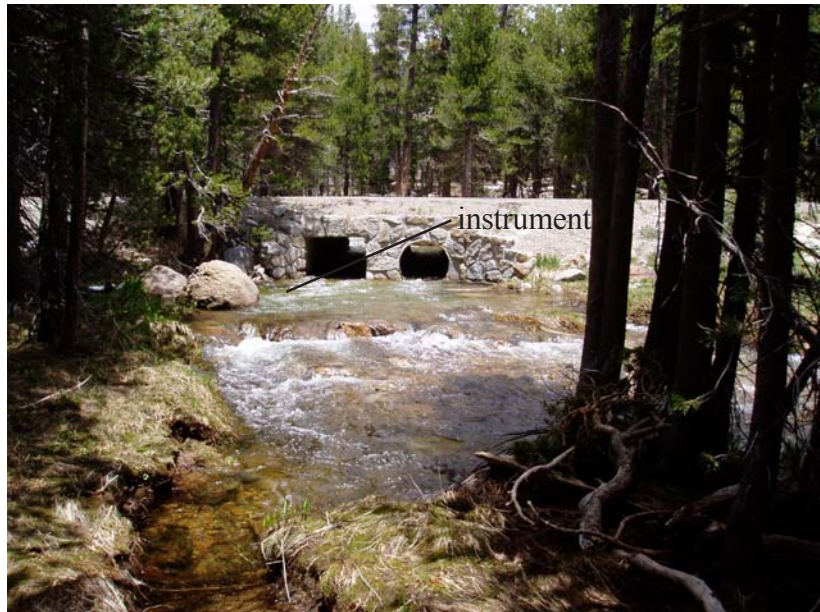
Tapedown: Marked with circle and line on upstream side of culvert, river left

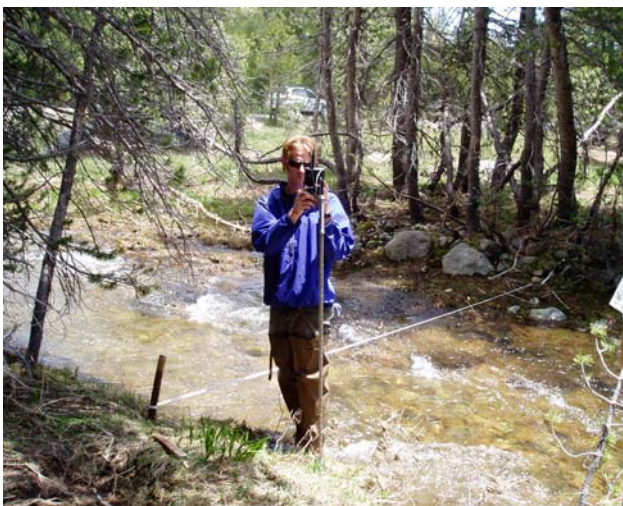
Flow Measurement: Taken downstream of culvert, location changes with flow, rocky

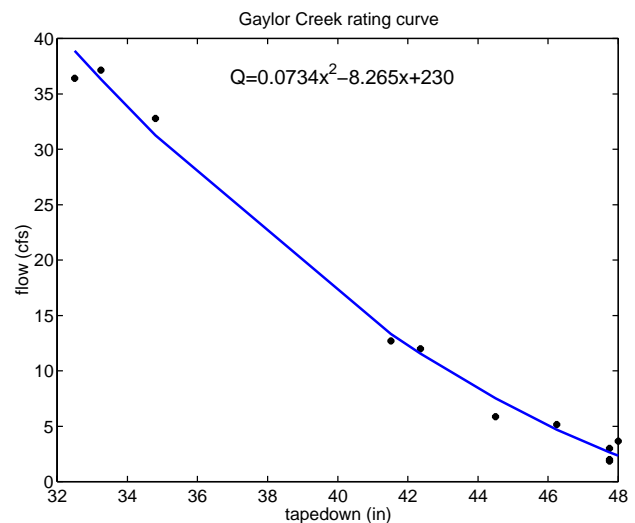
Tapedown-based Rating Curve:

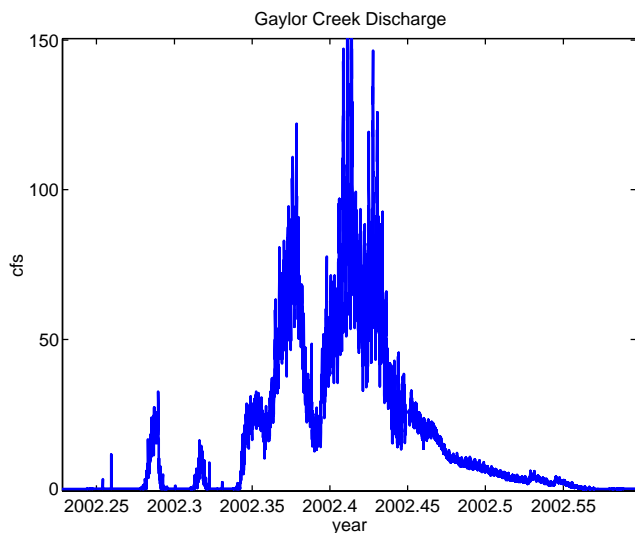
Streamflow record:

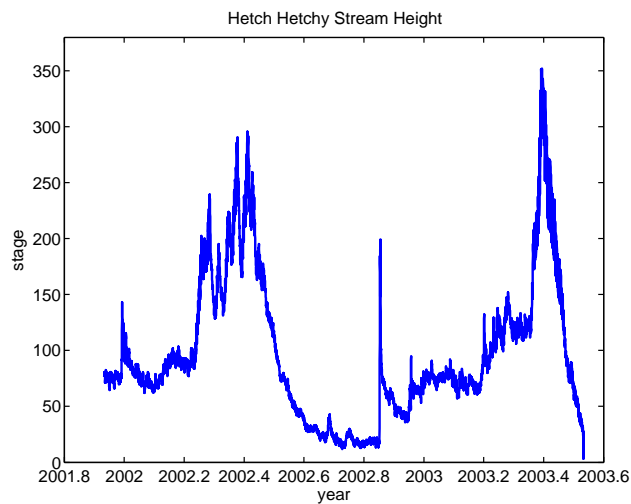
Stage record:

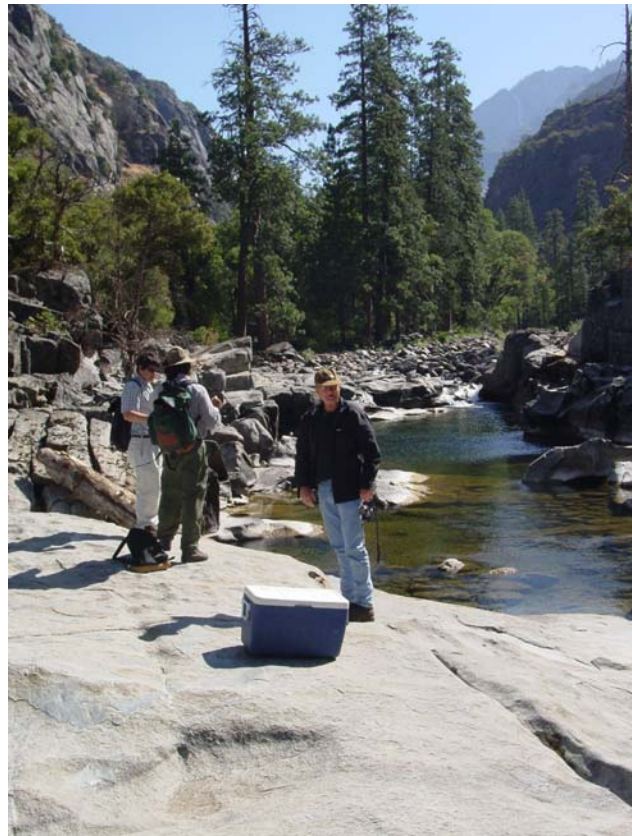
View of instrument site.

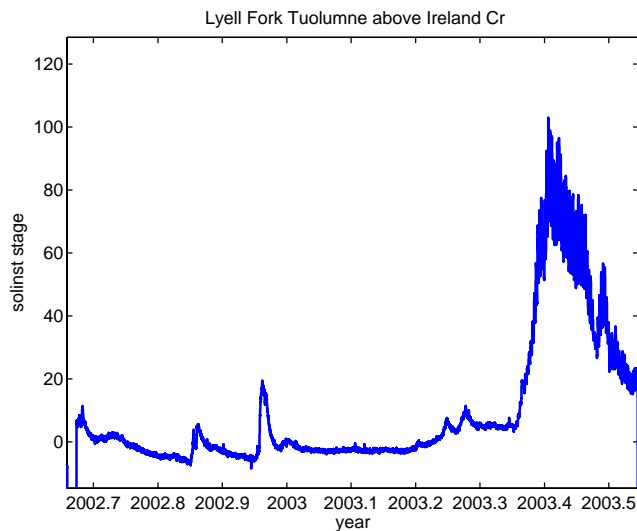
Stage record:

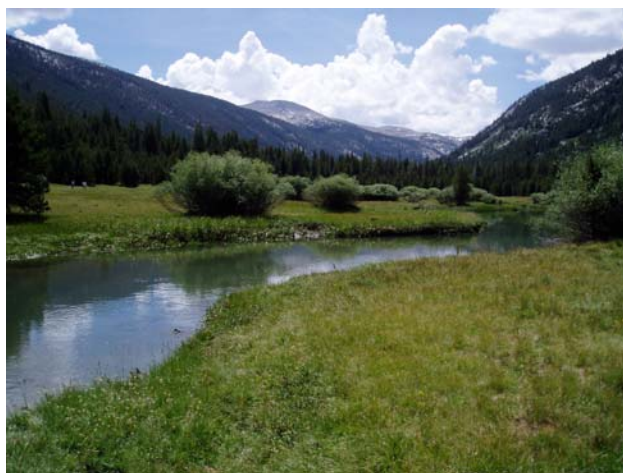
Flow measurement: Typically taken in box-shaped cross-section upstream of instrument.
P7280692

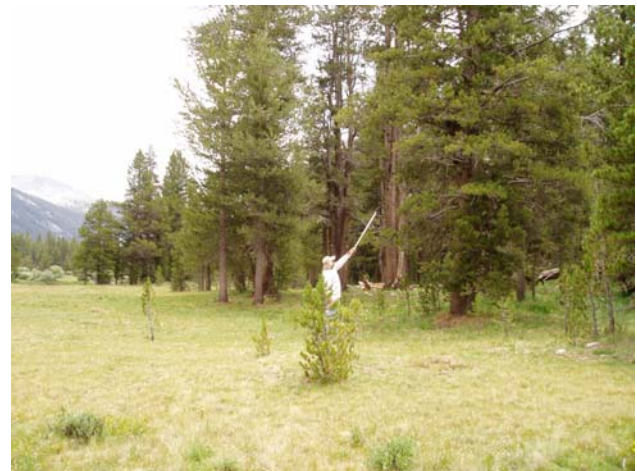
Dan points to the hobo in the tree upstream from the Lyell above Ireland site. You cross two small rivulets of water before finding this tree.
P7180520

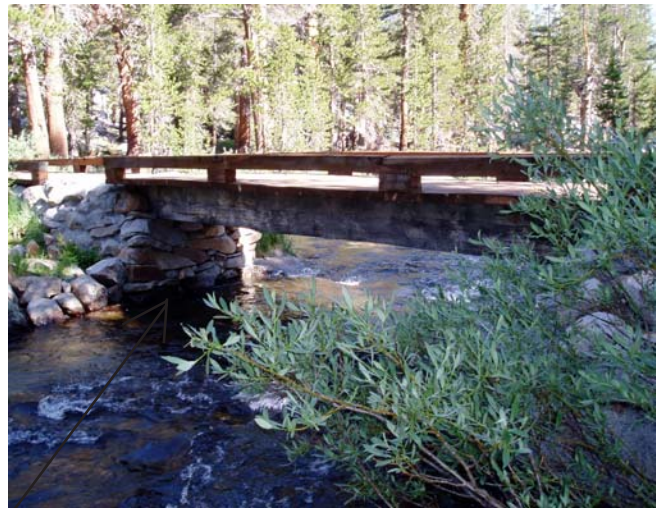
Instrument would be placed near the central pylon under the bridge at river rights (side closer to Donahue Pass). P722_Maclure

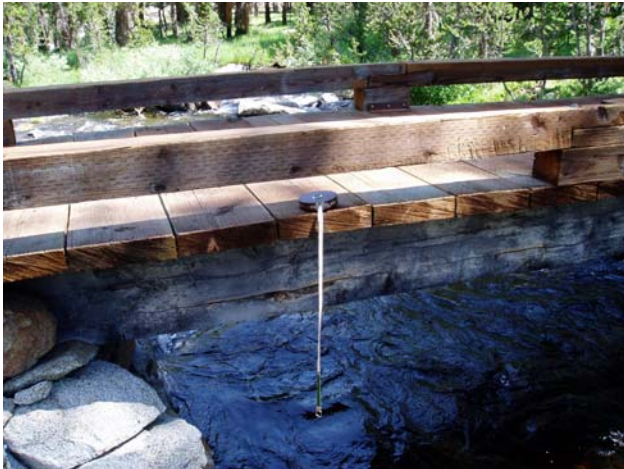
Tapedown taken from upstream side of bridge on river right, near center pylon.P7220600

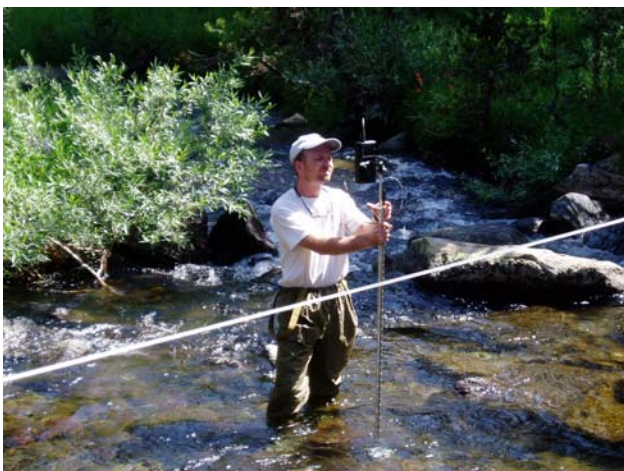
Flow measurement taken just downstream of bridge. Wading will not be possible at high flows.P7220596
