# Test Report

Report No.: HCT18IR-1285RC

Sample Name: Solid-State LiDAR  
Sample Model: HPS-3D SERIES  
Amount of sample: 1pcs  
Sample Received Date: 2018/09/26  
Testing Period: 2018/09/27~2018/09/28

Test Sequence	Test Item
1	IP6X test
2	IPX7 test

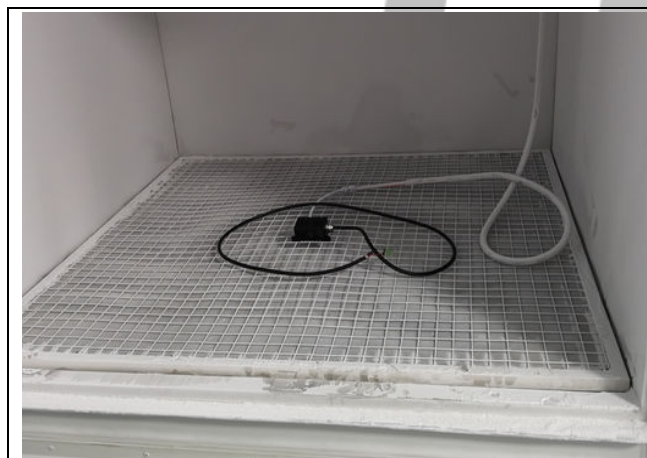
- 1) The Test prober of 1 mm diameter is pushed against any opening of the sample with force of 1 N
- 2) Set the sample in the dust chamber, the pressure inside the enclosure is maintained below the surrounding atmospheric pressure by a vacuum pump (Pump speed: 15 mL/min, less than 40 times of the shell volume per hour; the differential pressure between the containment and the atmosphere: 2 kPa)  
The talcum powder to be used is 2 kg/ m<sup>3</sup> of the test chamber volume;  
Test duration: 8 h

In test

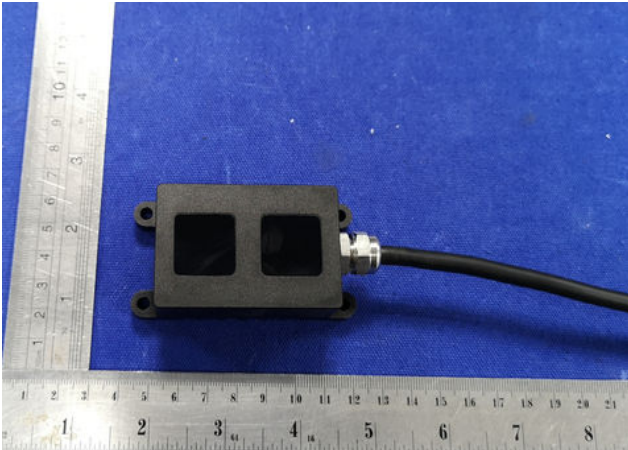
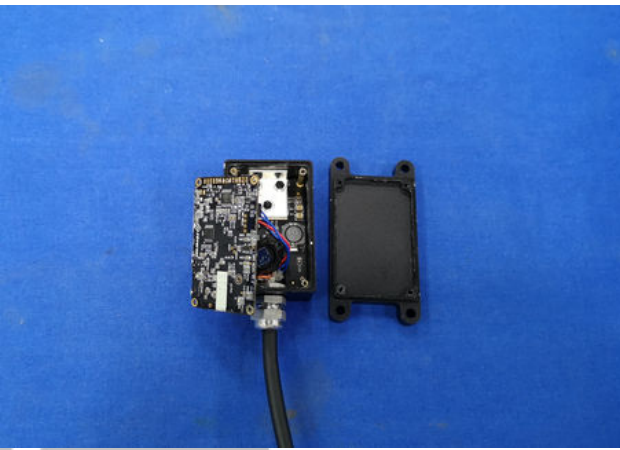
Sample No.	Sample name	Test Results
001	Solid-State LiDAR	No water entered into the sample, the sample passed the IPX7 test.

Before test	After test

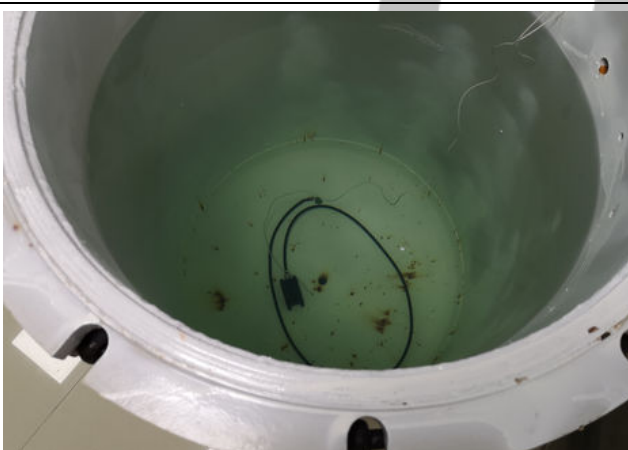
- 1) Depth of water: 1 m
- 2) Test duration: 0.5 h

/
In test	/
