SOCIETY FOR ECOSYSTEM RESTORATION
IN NORTHERN BRITISH COLUMBIA

Restoring Fish Passage in the Fraser Region - 2023

**Prepared for
Ministry of Transportation and Infrastructure**

**Prepared by
Al Irvine, B.Sc., R.P.Bio. and Lucy Schick, B.Sc.
New Graph Environment Ltd.**

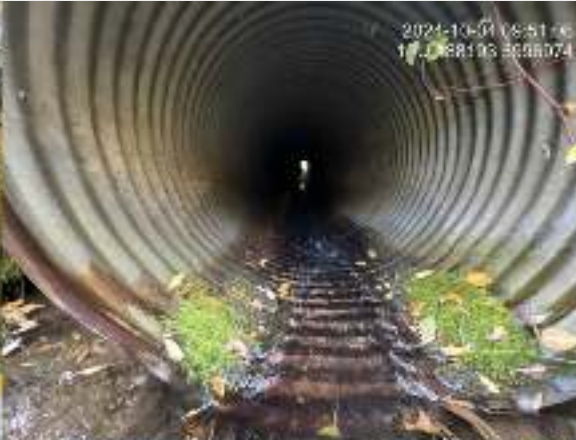
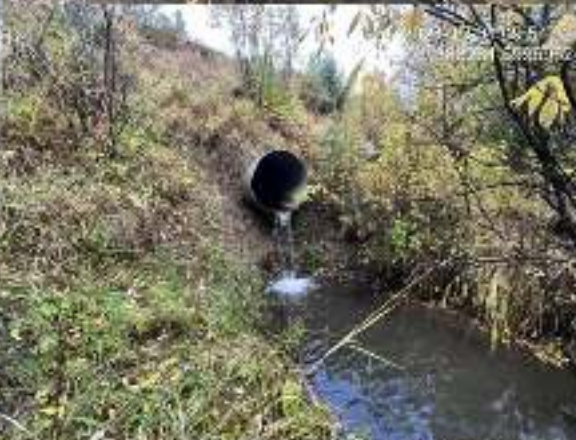
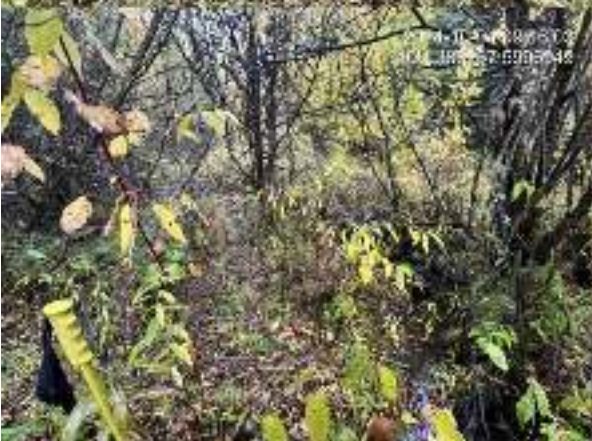
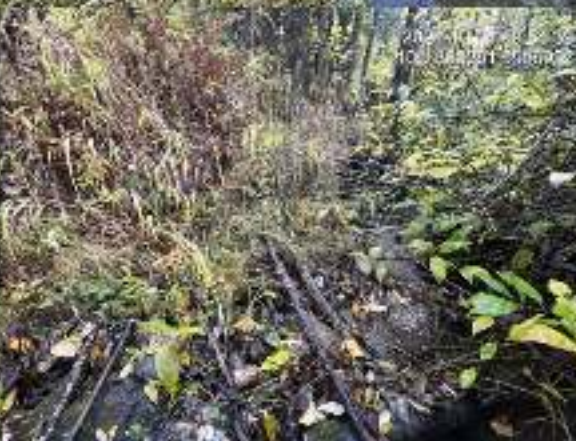
Table 4.14: Summary of fish passage assessment for PSCIS crossing 203297.

Location and Stream Data	Crossing Characteristics
<p>Comments: The culvert was very undersized for the stream, as evidenced by the large outlet drop. The stream had a good amount of flow for the time of year. Habitat was of medium value, with abundant large woody debris creating complex habitat and pools, providing ample cover for fish. Adjacent landowners reported that the stream was previously used as a water source for bottling and distribution across the province. Habitat confirmation was completed upstream and downstream. MoTi chris_culvert_id: 1794199</p>	
<p>Photos: From top left clockwise: Road/Site Card, Barrel, Outlet, Downstream, Upstream, Inlet.</p>

Photos: From top left clockwise: Road/Site Card, Barrel, Outlet, Downstream, Upstream, Inlet.

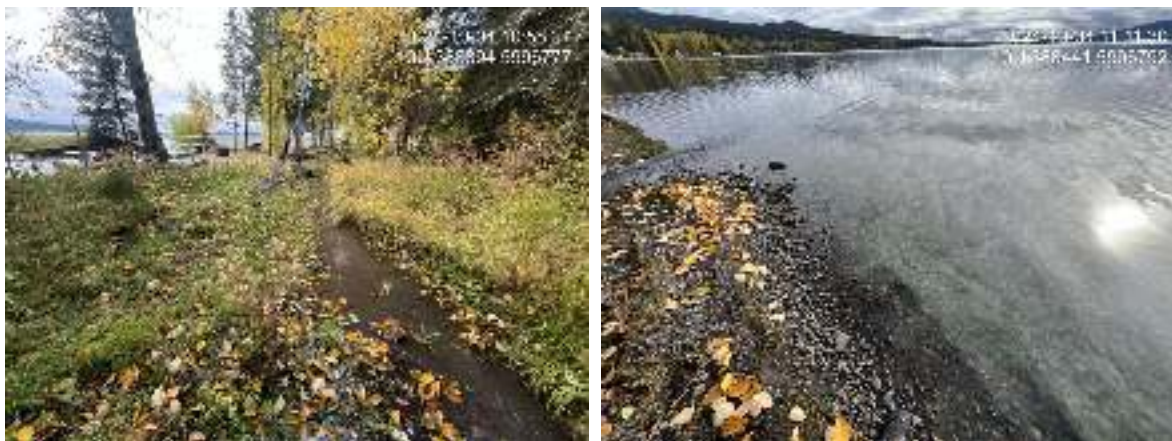
Figure 4.6: Left: Typical habitat downstream of PSCIS crossing 199328. Right: Algal bloom observed downstream of PSCIS crossing 199328 in Fraser Lake.

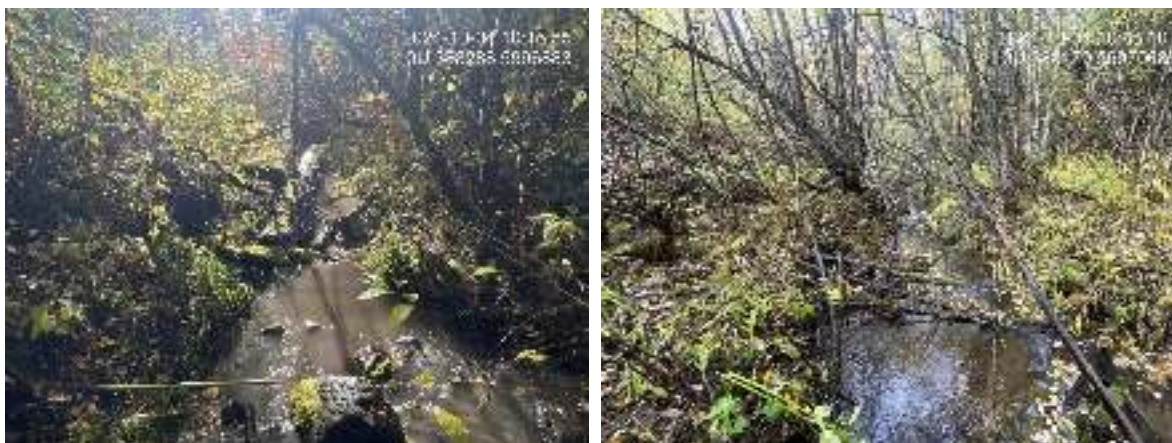
Figure 4.7: Left: Typical habitat upstream of PSCIS crossing 199328 and downstream of PSCIS crossing 199172. Right: Typical habitat upstream of PSCIS crossing 199172.

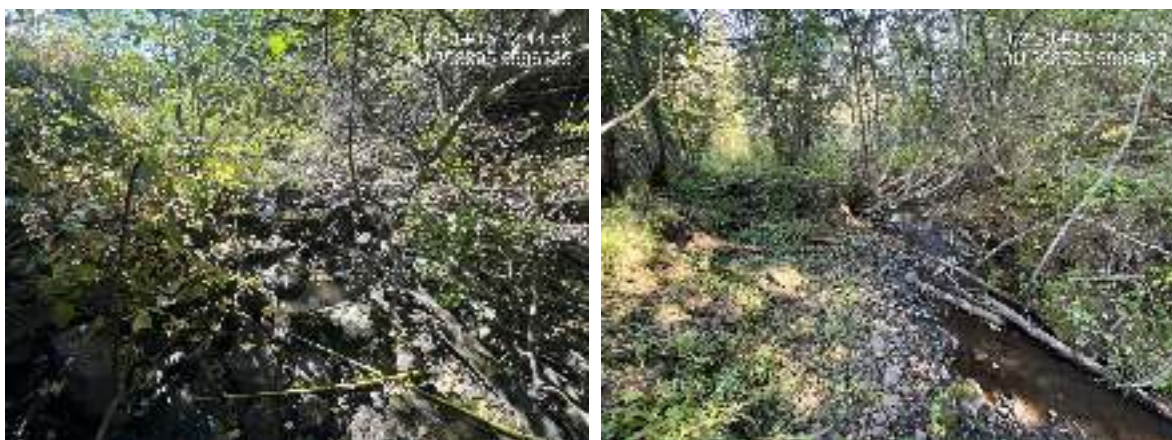
Figure 4.9: Left: Typical habitat downstream of PSCIS crossing 199173. Right: Typical habitat upstream of PSCIS crossing 199173.

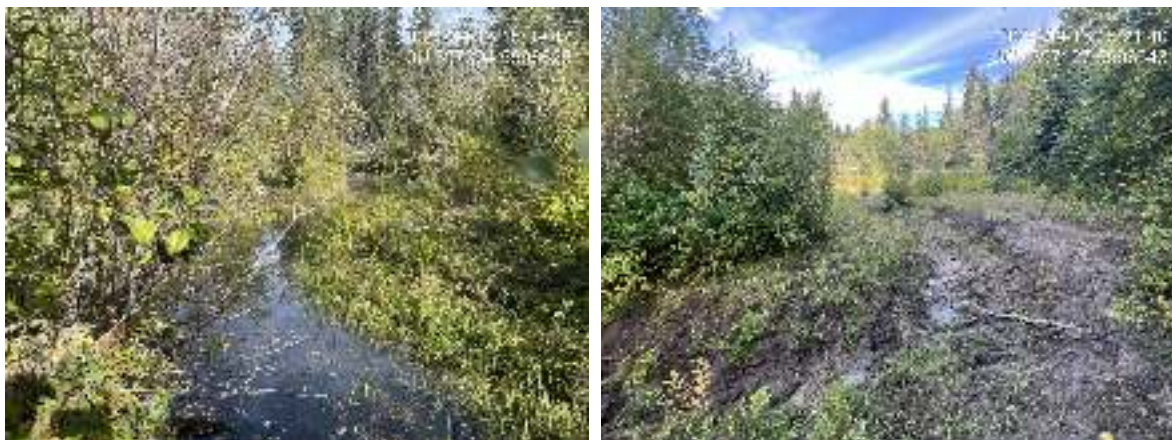
Figure 4.10: Left: Typical habitat downstream of PSCIS crossing 199174. Right: Typical habitat upstream of PSCIS crossing 199174.

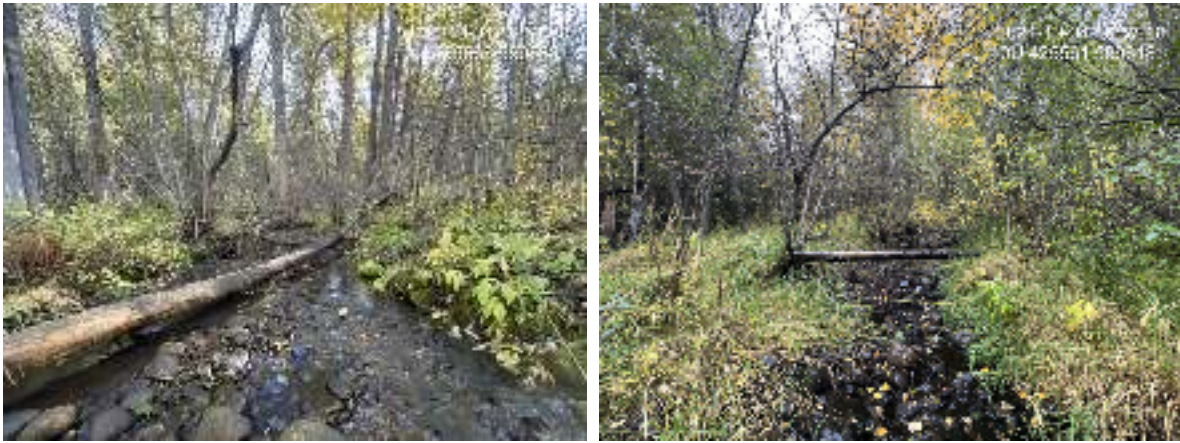
Figure 4.12: Left: Typical habitat downstream of PSCIS crossing 199190. Right: Typical habitat upstream of PSCIS crossing 199190.

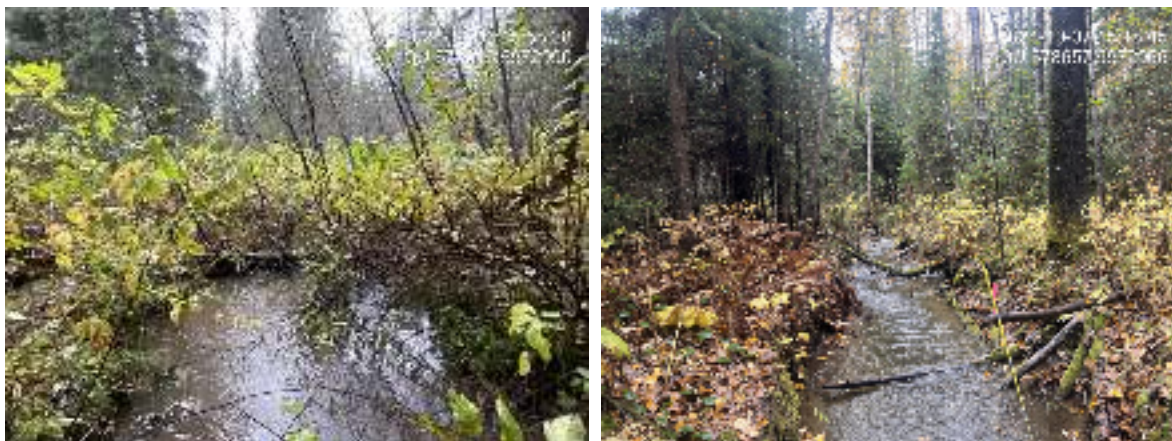
Figure 4.21: Left: Typical habitat downstream of PSCIS crossing 199255. Right: Typical habitat upstream of PSCIS crossing 199255.

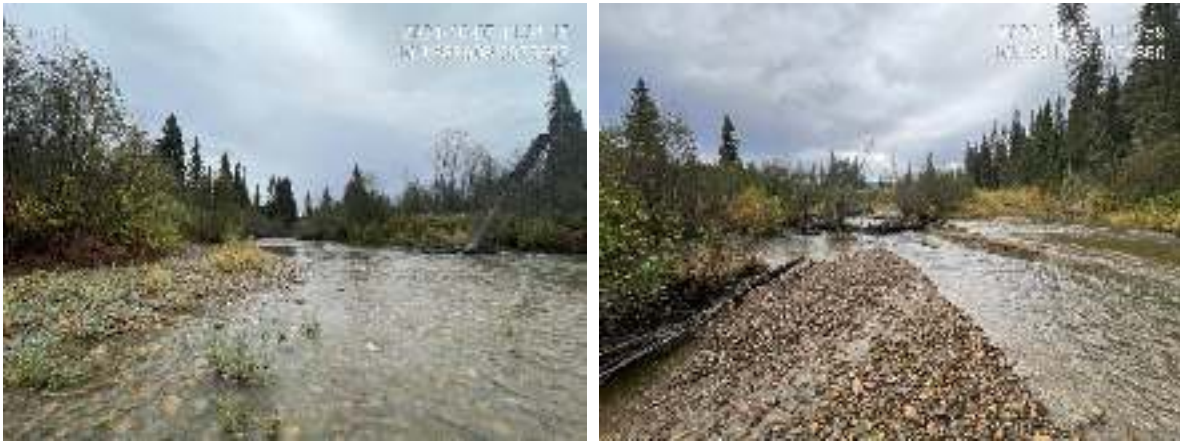
Figure 4.23: Left: Typical habitat downstream of PSCIS crossing 199256. Right: Typical habitat upstream of PSCIS crossing 199256.

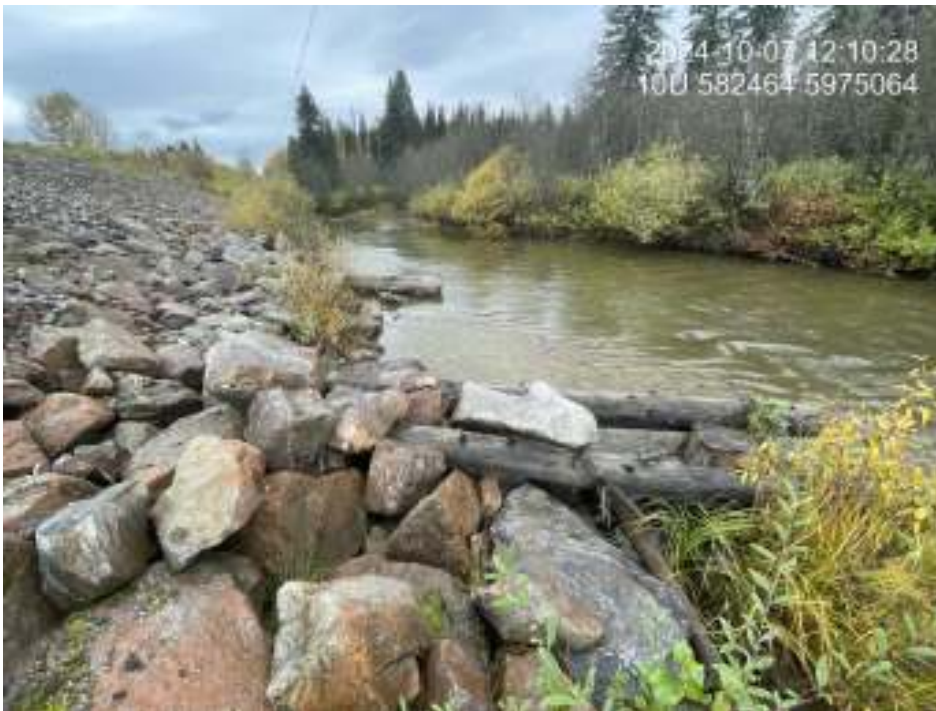
Figure 4.24: Riprapped banks and large wood structures secured with metal wiring located downstream of crossing 199256.

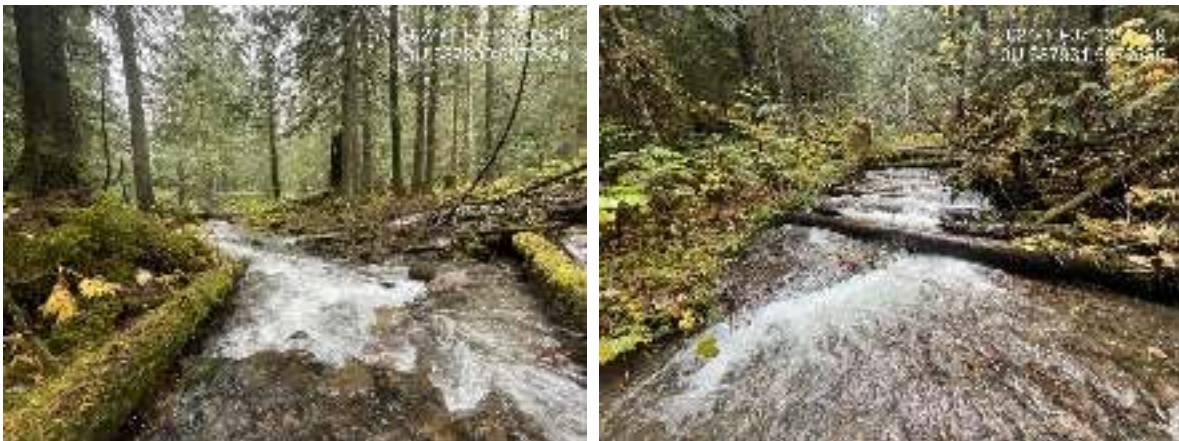
Figure 4.26: Left: Typical habitat downstream of PSCIS crossing 199260. Right: Typical habitat upstream of PSCIS crossing 199260.
