SOCIETY FOR ECOSYSTEM RESTORATION
IN NORTHERN BRITISH COLUMBIA

Restoring Fish Passage in the Fraser Region - 2023

**Prepared for
Ministry of Transportation and Infrastructure**

**Prepared by
Al Irvine, B.Sc., R.P.Bio. and Lucy Schick, B.Sc.
New Graph Environment Ltd.**

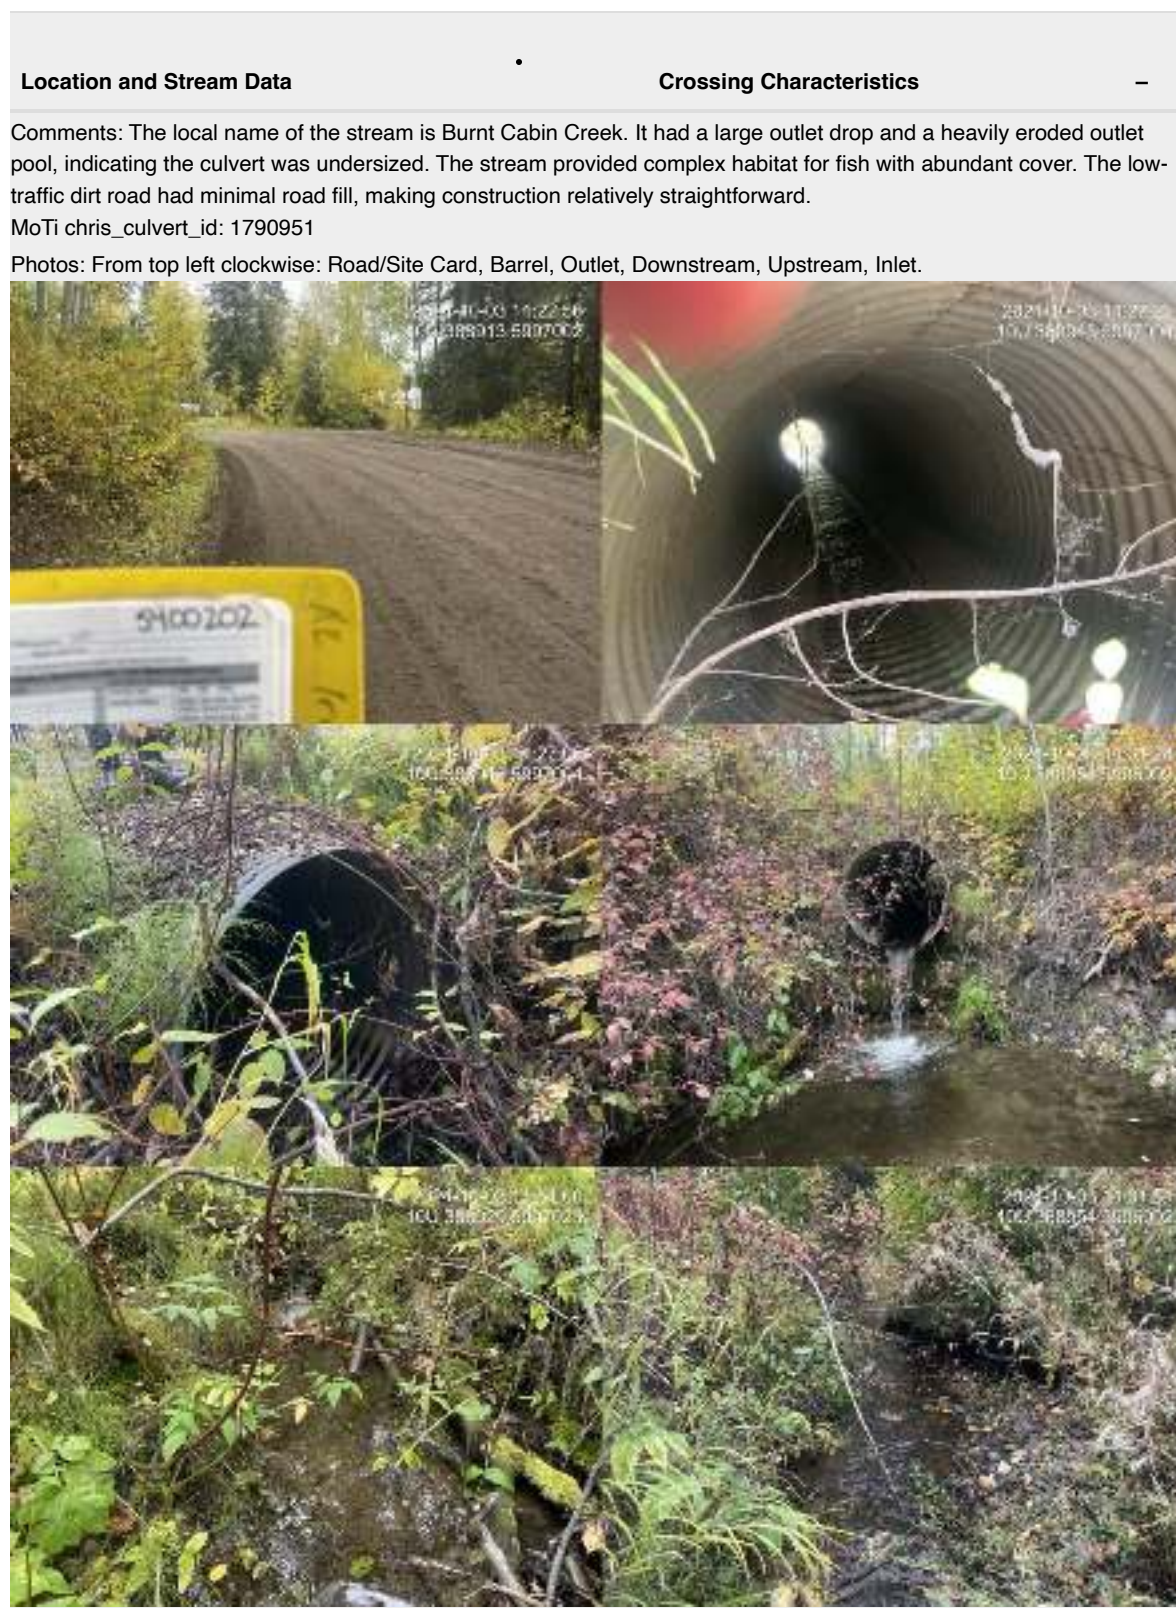
Table 4.10: Summary of fish passage assessment for PSCIS crossing 7622.

Location and Stream Data		Crossing Characteristics	
Date	2024-10-03	Crossing Sub Type	Round Culvert
PSCIS ID	7622	Diameter (m)	1.15
External ID	–	Length (m)	30
Crew	AI SC	Embedded	No
UTM Zone	10	Depth Embedded (m)	–
Easting	388735	Resemble Channel	No
Northing	5997152	Backwatered	No
Stream	Burnt Cabin Creek	Percent Backwatered	–
Road	Stella Road	Fill Depth (m)	2.2
Road Tenure	MoTI	Outlet Drop (m)	1.15
Channel Width (m)	2	Outlet Pool Depth (m)	0.43
Stream Slope (%)	5	Inlet Drop	No
Beaver Activity	No	Slope (%)	5
Habitat Value	Medium	Valley Fill	Deep Fill
Final score	42	Barrier Result	Barrier
Fix type	Replace with New Open Bottom Structure	Fix Span / Diameter	15

Should restoration/maintenance activities proceed, replacement of the Stella Road crossing (7622) with a bridge (15 m span) is recommended. This culvert had a 1.15m outlet drop, very likely inhibiting fish passage. At the time of reporting in 2025, the cost of the work is estimated at \$ 3,000,000.

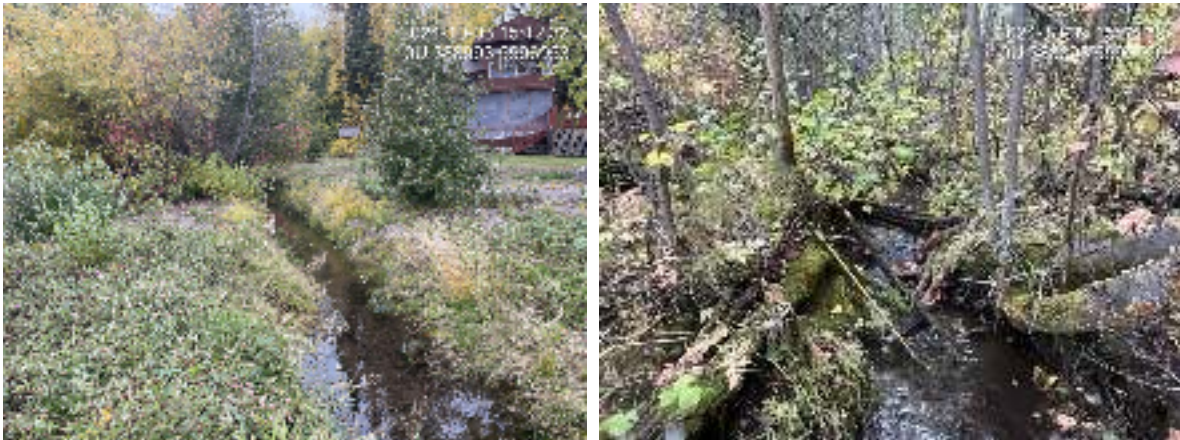
Figure 4.2: Left: Typical habitat downstream of PSCIS crossing 199171. Right: Typical habitat upstream of PSCIS crossing 199171 and downstream of PSCIS crossing 7622.

Should restoration/maintenance activities proceed, replacement of the Gala Bay Road crossing (199171) with a bridge (15 m span) is recommended. This culvert had a 0.9m outlet drop, likely inhibiting fish passage. At the time of reporting in 2025, the cost of the work is estimated at \$ 1,500,000.

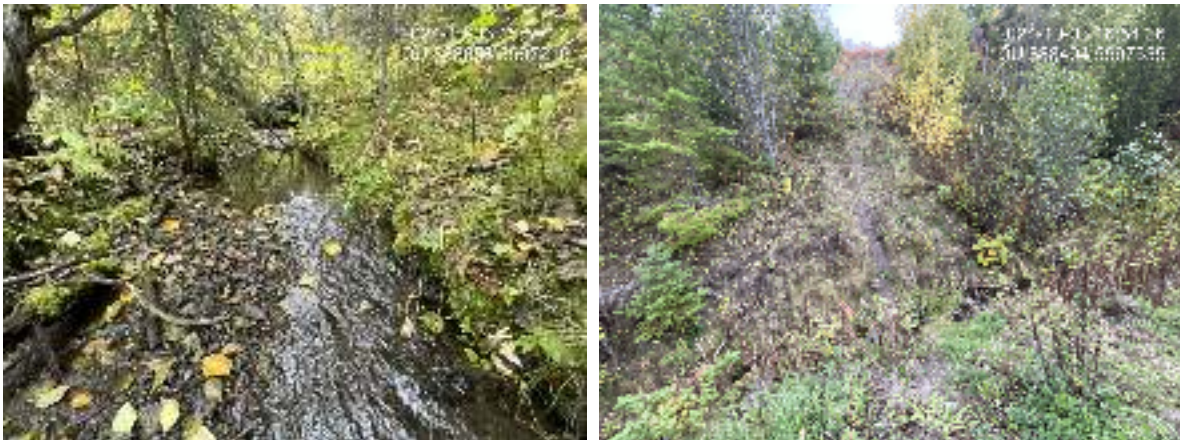
Figure 4.3: Left: Typical habitat upstream of PSCIS crossing 7622. Right: Bank erosion and riparian removal at the pipeline upstream of crossing 7622.

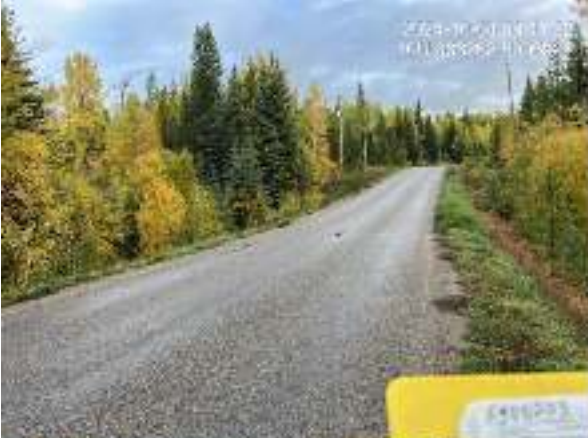
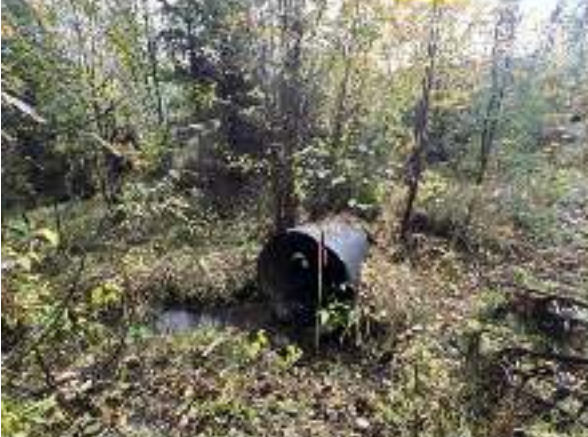
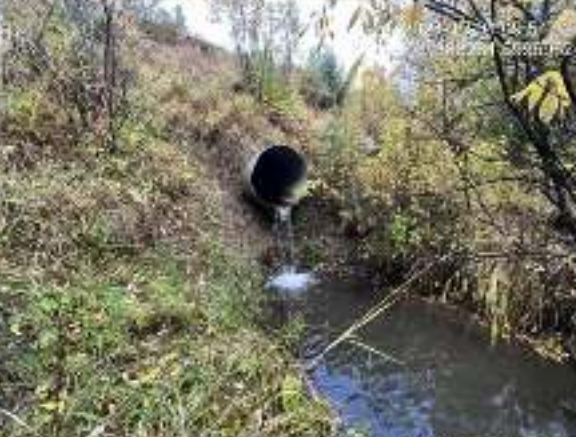
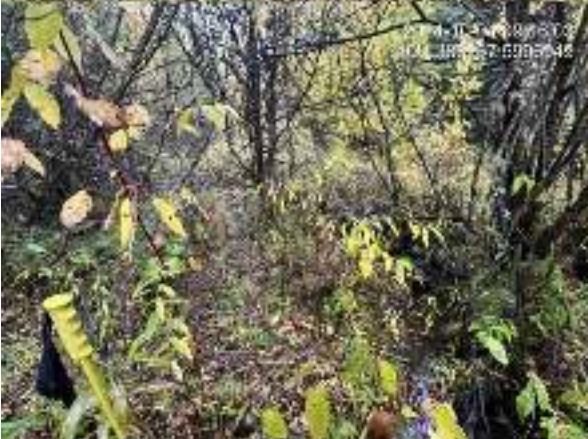
Table 4.16: Summary of fish passage assessment for PSCIS crossing 203297.

Location and Stream Data	Crossing Characteristics
<p>Comments: The culvert was very undersized for the stream, as evidenced by the large outlet drop. The stream had a good amount of flow for the time of year. Habitat was of medium value, with abundant large woody debris creating complex habitat and pools, providing ample cover for fish. Adjacent landowners reported that the stream was previously used as a water source for bottling and distribution across the province. Habitat confirmation was completed upstream and downstream. MoTi chris_culvert_id: 1794199</p> <p>Photos: From top left clockwise: Road/Site Card, Barrel, Outlet, Downstream, Upstream, Inlet.</p>

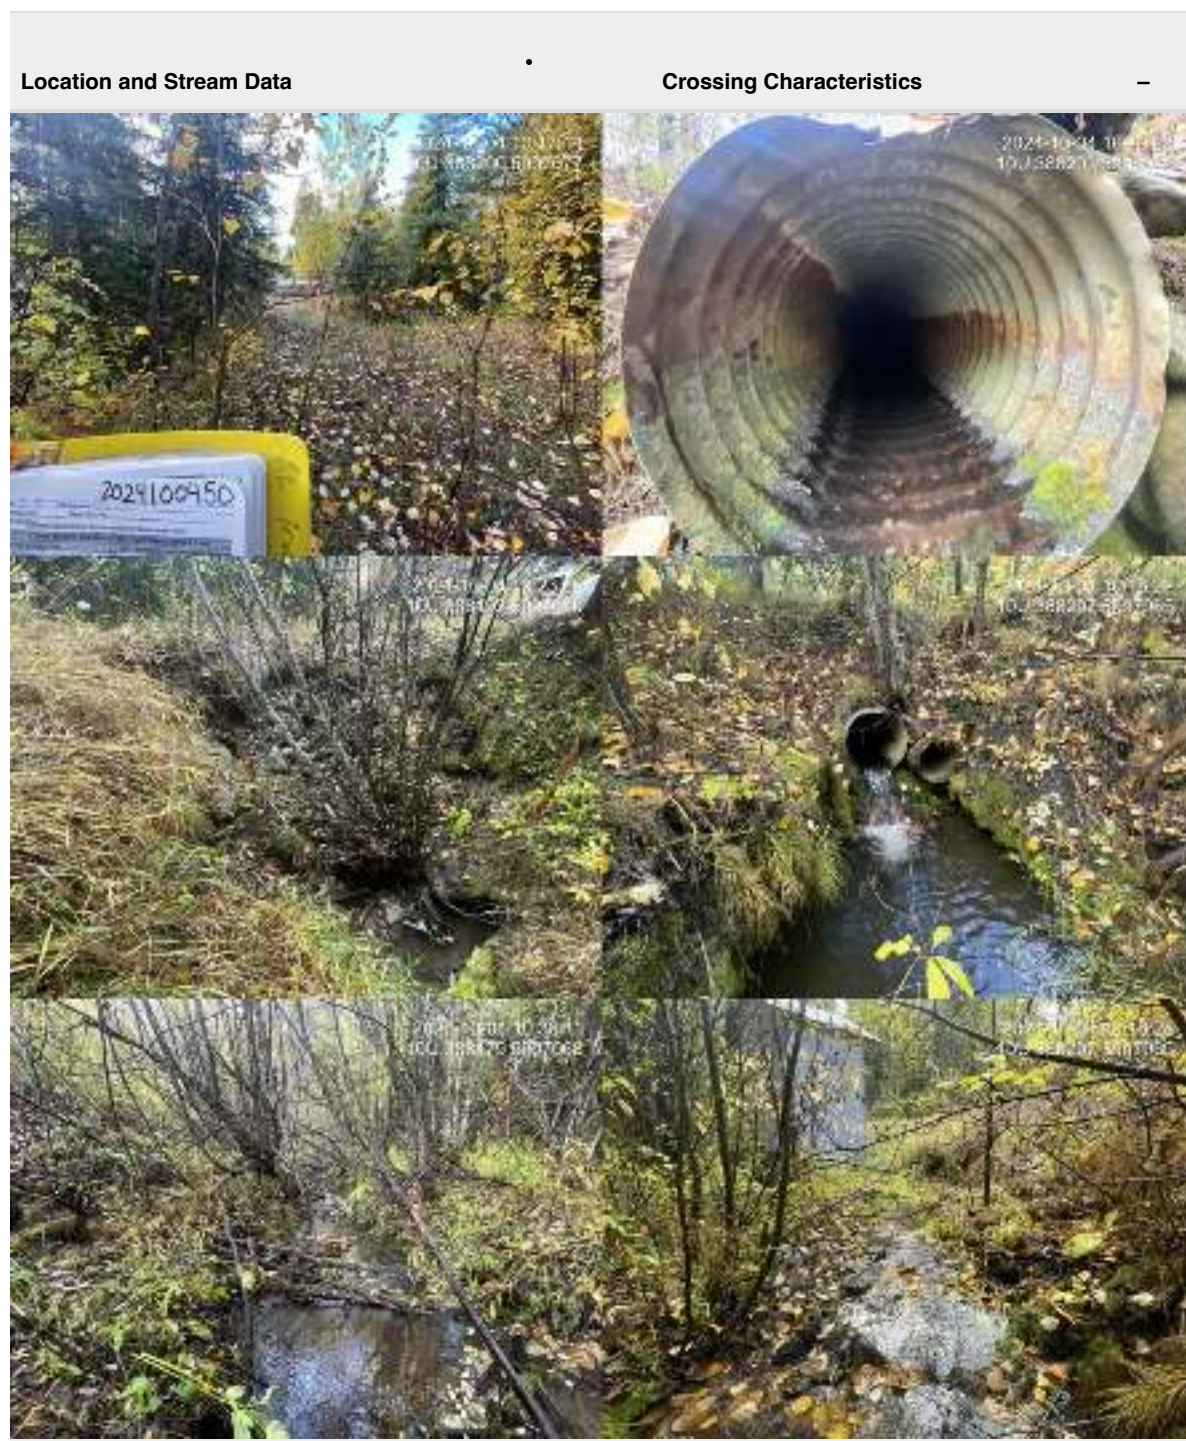
Photos: From top left clockwise: Road/Site Card, Barrel, Outlet, Downstream, Upstream, Inlet.

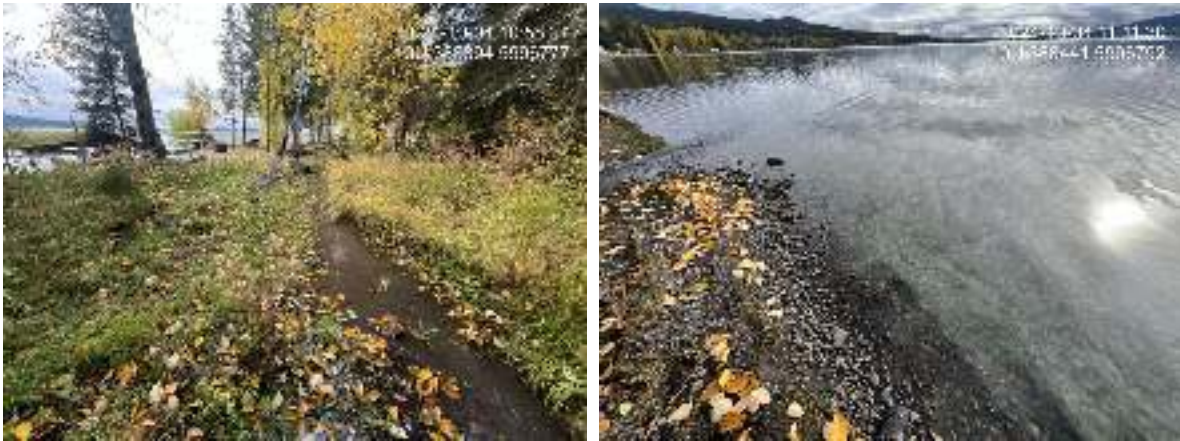
Figure 4.4: Left: Typical habitat downstream of PSCIS crossing 199328. Right: Algal bloom observed downstream of PSCIS crossing 199328 in Fraser Lake.

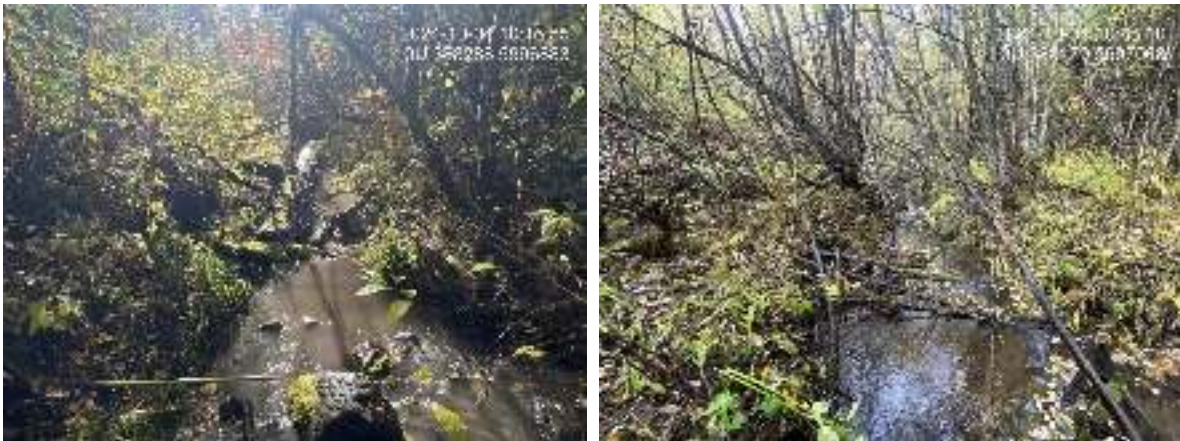
Figure 4.5: Left: Typical habitat upstream of PSCIS crossing 199328 and downstream of PSCIS crossing 199172. Right: Typical habitat upstream of PSCIS crossing 199172.

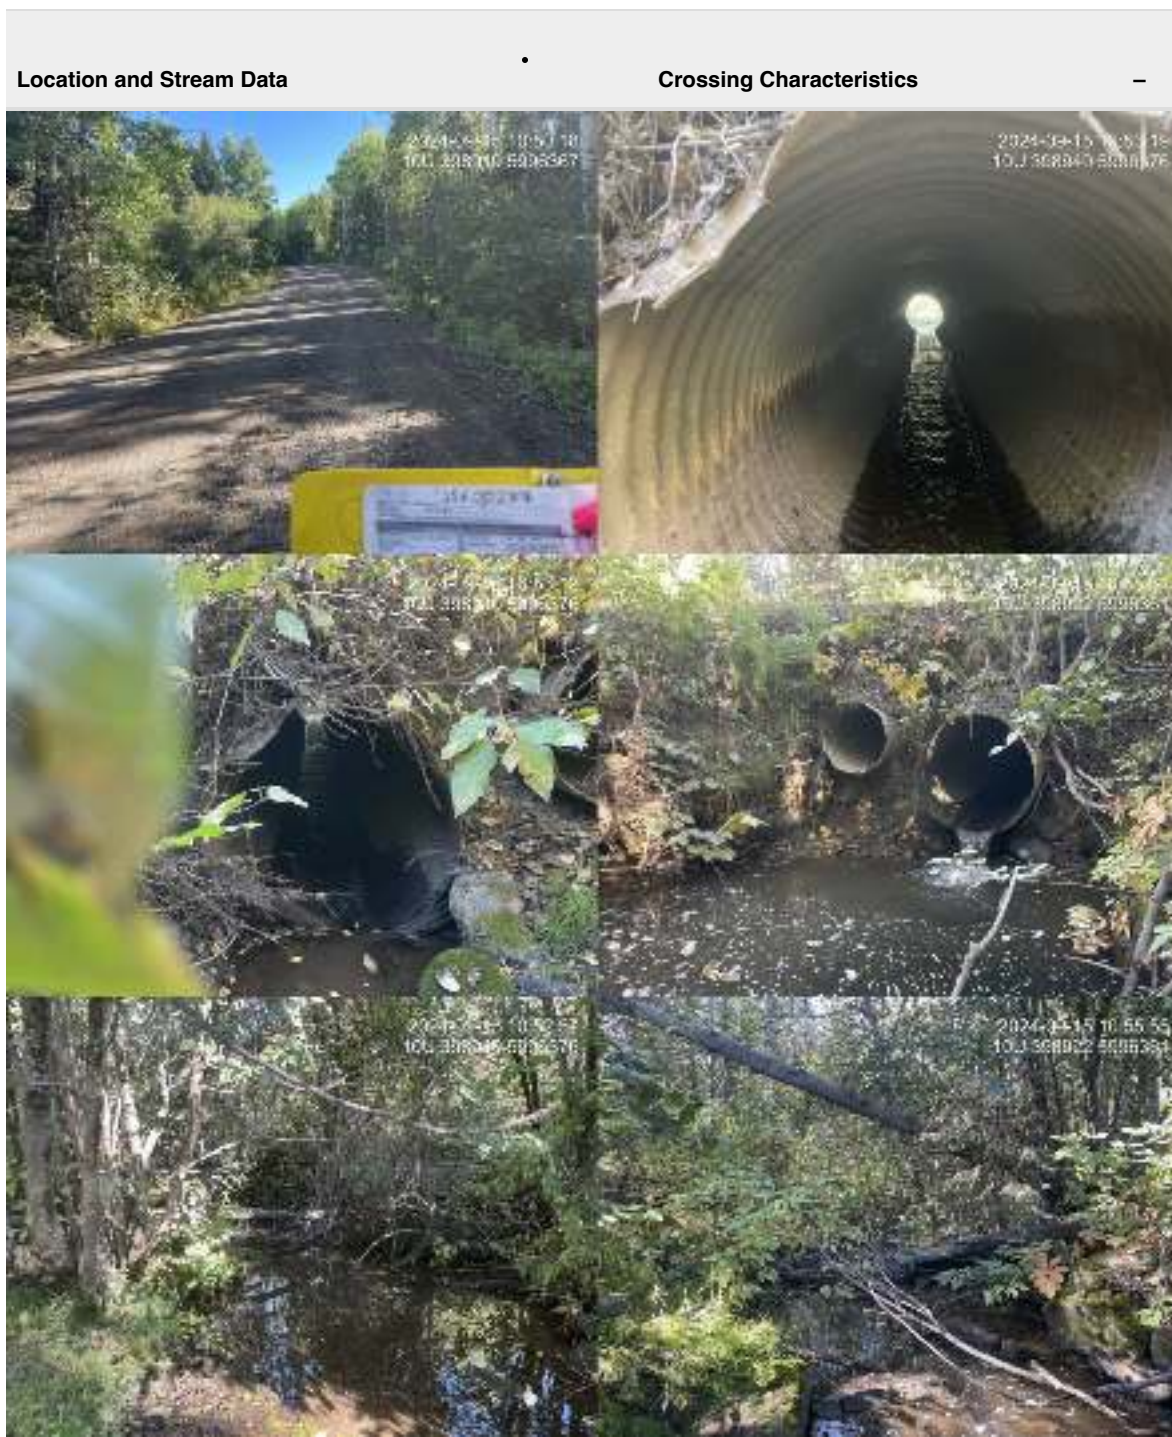
Location and Stream Data		Crossing Characteristics	
Date	2024-09-15	Crossing Sub Type	Round Culvert
PSCIS ID	199173	Diameter (m)	0.9
External ID	–	Length (m)	10
Crew	LS, AI	Embedded	No
UTM Zone	10	Depth Embedded (m)	–
Easting	398923	Resemble Channel	No
Northing	5996362	Backwatered	No
Stream	Tributary To Nechako River	Percent Backwatered	–
Road	Dog Creek Road	Fill Depth (m)	1
Road Tenure	MOTI	Outlet Drop (m)	0.35
Channel Width (m)	3	Outlet Pool Depth (m)	0.7
Stream Slope (%)	4	Inlet Drop	No
Beaver Activity	Yes	Slope (%)	2.5
Habitat Value	Medium	Valley Fill	Deep Fill
Final score	31	Barrier Result	Barrier
Fix type	Replace with New Open Bottom Structure	Fix Span / Diameter	15
Comments: The culvert had a moderate outlet drop with some erosion around the pipe at the outlet. The pipe was in good condition. The stream provided excellent habitat, with several pools and abundant undercut banks. Fish were observed during the assessment (~40-90mm in length). Upstream of the crossing, the stream was channelized with some pockets of gravel suitable for rearing rainbow trout and potentially Chinook. It then transitioned into beaver-impounded wetland areas storing large quantities of water, likely sustaining year-round stream flow at this crossing. There was extensive cattle trampling around the inlet of the pipe and throughout the surveyed upstream area. The crossing was located approximately 150m upstream from the Nechako River mainstem. MoTi chris_culvert_id: 1794340 Photos: From top left clockwise: Road/Site Card, Barrel, Outlet, Downstream, Upstream, Inlet.

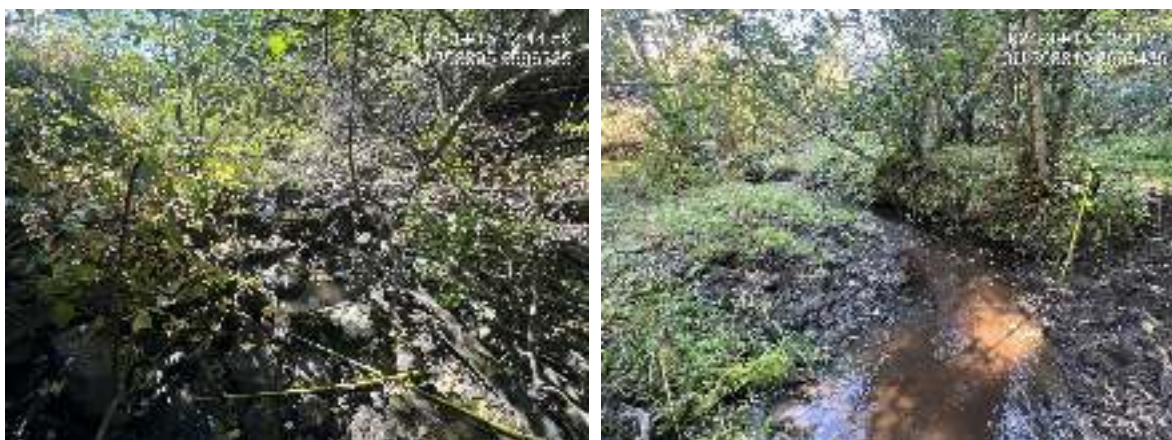
Figure 4.6: Left: Typical habitat downstream of PSCIS crossing 199173. Right: Typical habitat upstream of PSCIS crossing 199173.

Should restoration/maintenance activities proceed, replacement of the Dog Creek Road crossing (199173) with a bridge (15 m span) is recommended. At the time of reporting in 2025, the cost of the work is estimated at \$ 1,500,000.

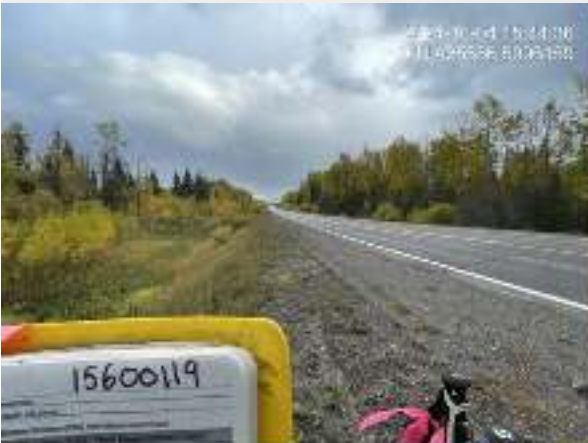
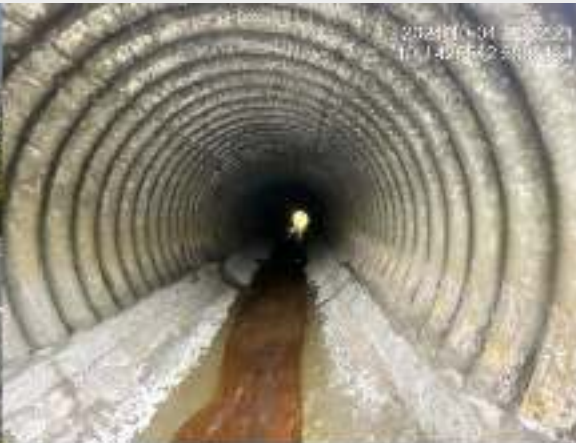
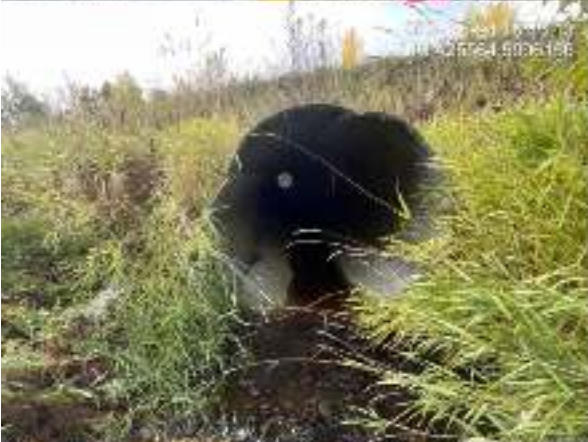
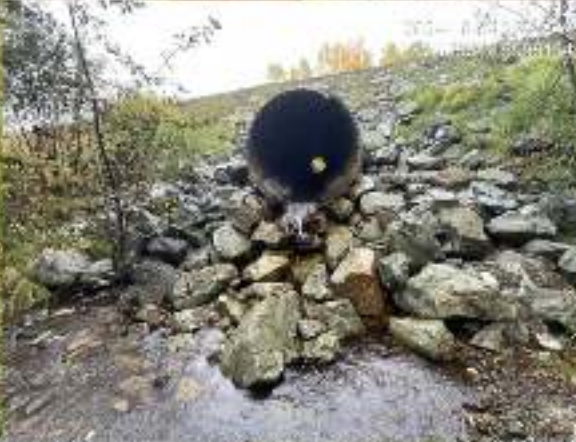
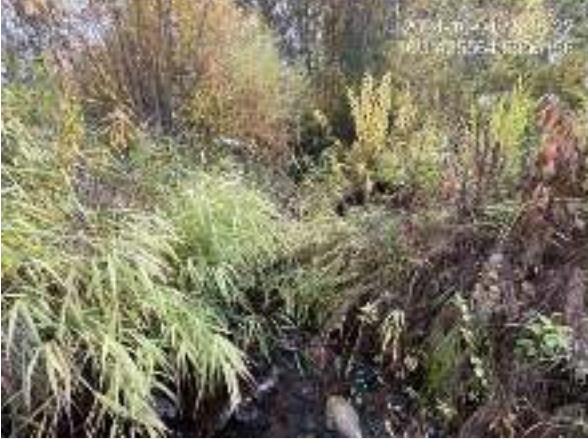
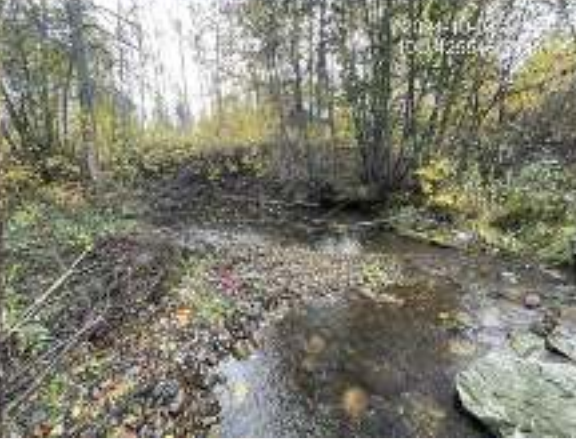
Location and Stream Data	Crossing Characteristics
<p>Comments: The bottom of the culvert had been reinforced with concrete, likely to address holes noted in the previous assessment. A large pile of riprap was placed at the outlet, possibly to reduce the outlet drop, though its placement appeared unusual and could inhibit fish passage. The habitat was high quality, with a large pool just downstream of the culvert and abundant gravels suitable for spawning fish. MoTi chris_culvert_id: 1806163</p> <p>Photos: From top left clockwise: Road/Site Card, Barrel, Outlet, Downstream, Upstream, Inlet.</p>

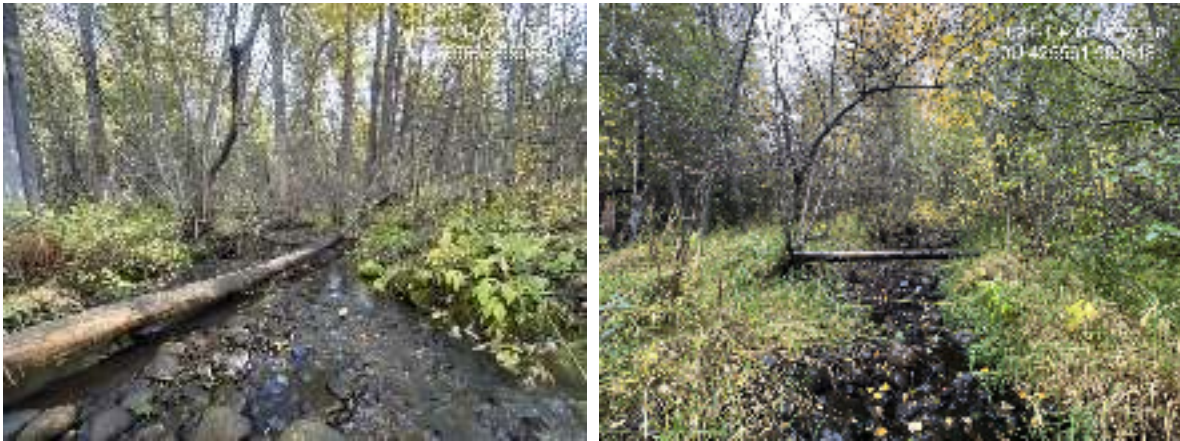
Figure 4.8: Left: Typical habitat downstream of PSCIS crossing 199190. Right: Typical habitat upstream of PSCIS crossing 199190.

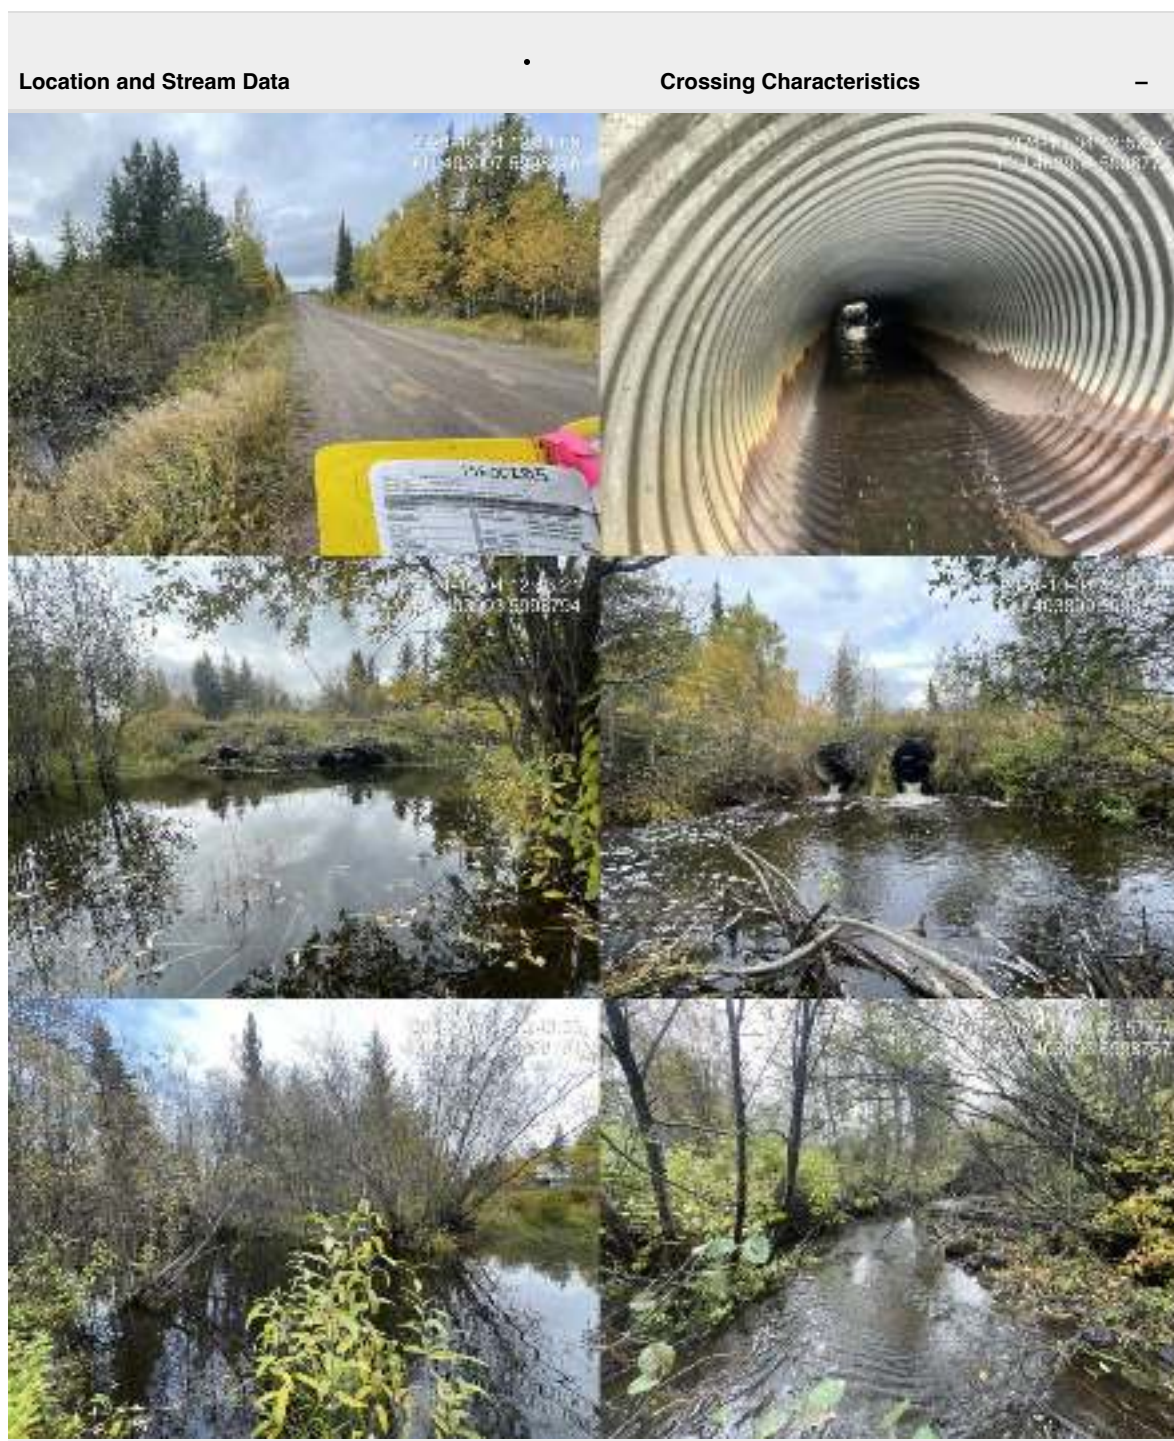
Table 4.29: Summary of fish passage assessment for PSCIS crossing 199204.

Location and Stream Data		Crossing Characteristics	
Date	2024-10-04	Crossing Sub Type	Round Culvert
PSCIS ID	199204	Diameter (m)	3.2
External ID	–	Length (m)	12
Crew	LS	Embedded	No
UTM Zone	10	Depth Embedded (m)	–
Easting	403906	Resemble Channel	No
Northing	5998777	Backwatered	No
Stream	Nine Mile Creek	Percent Backwatered	–
Road	Settlement Road	Fill Depth (m)	0.5
Road Tenure	MOTI	Outlet Drop (m)	0.5
Channel Width (m)	5.5	Outlet Pool Depth (m)	1.4
Stream Slope (%)	0.5	Inlet Drop	No
Beaver Activity	Yes	Slope (%)	2
Habitat Value	Medium	Valley Fill	Deep Fill
Final score	31	Barrier Result	Barrier
Fix type	Replace with New Open Bottom Structure	Fix Span / Diameter	15
Comments: The inlets of both culverts were dammed by a beaver, backing up water to most of the culverts' height. Two pipes, each 1.6m in diameter, were present. A large outlet pool indicated the pipes were likely undersized for the stream. Another beaver dam was being constructed at the outlet of the pool. The dirt road had minimal road fill, making construction relatively straightforward. The road appeared to be used for pipeline access. Outlet pool depth was estimated as it was too deep to wade. Fish approximately 40mm in length were observed downstream during habitat confirmation. MoTi chris_culvert_id: 1793923 Photos: From top left clockwise: Road/Site Card, Barrel, Outlet, Downstream, Upstream, Inlet.

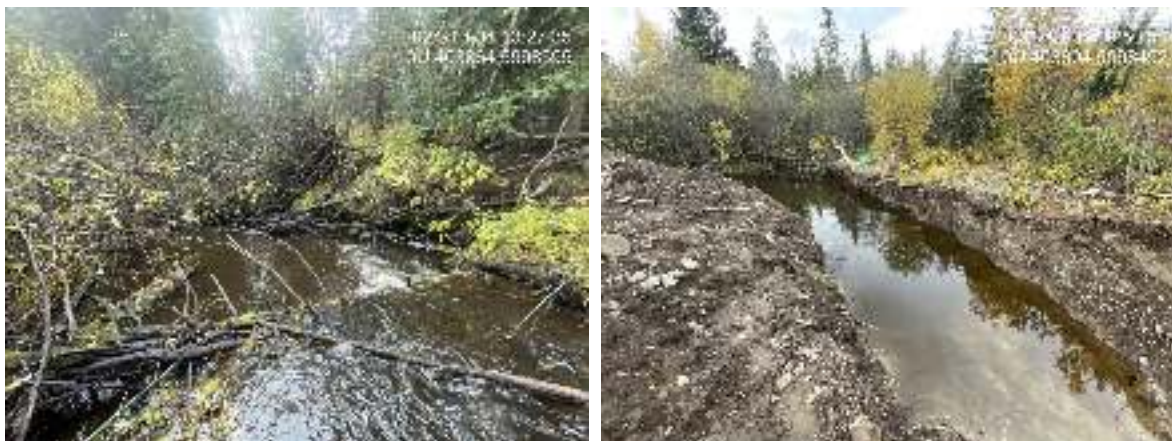
Figure 4.9: Left: Typical habitat downstream of PSCIS crossing 199204. Right: Large, artificially entrenched pool located ~300m downstream of PSCIS crossing 199204.

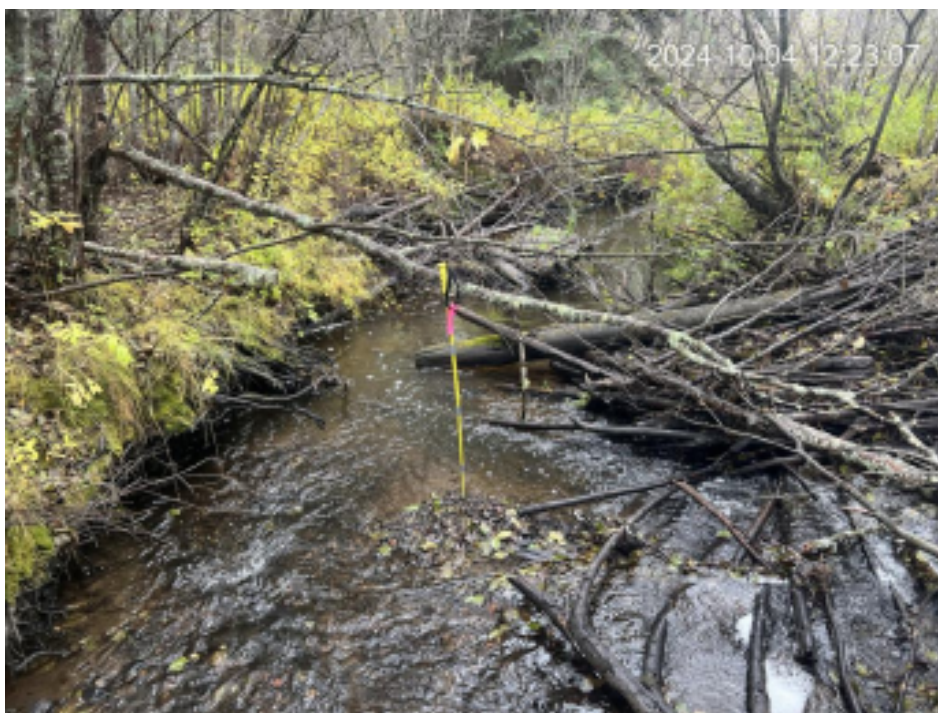
Figure 4.10: Typical habitat upstream of PSCIS crossing 199204.

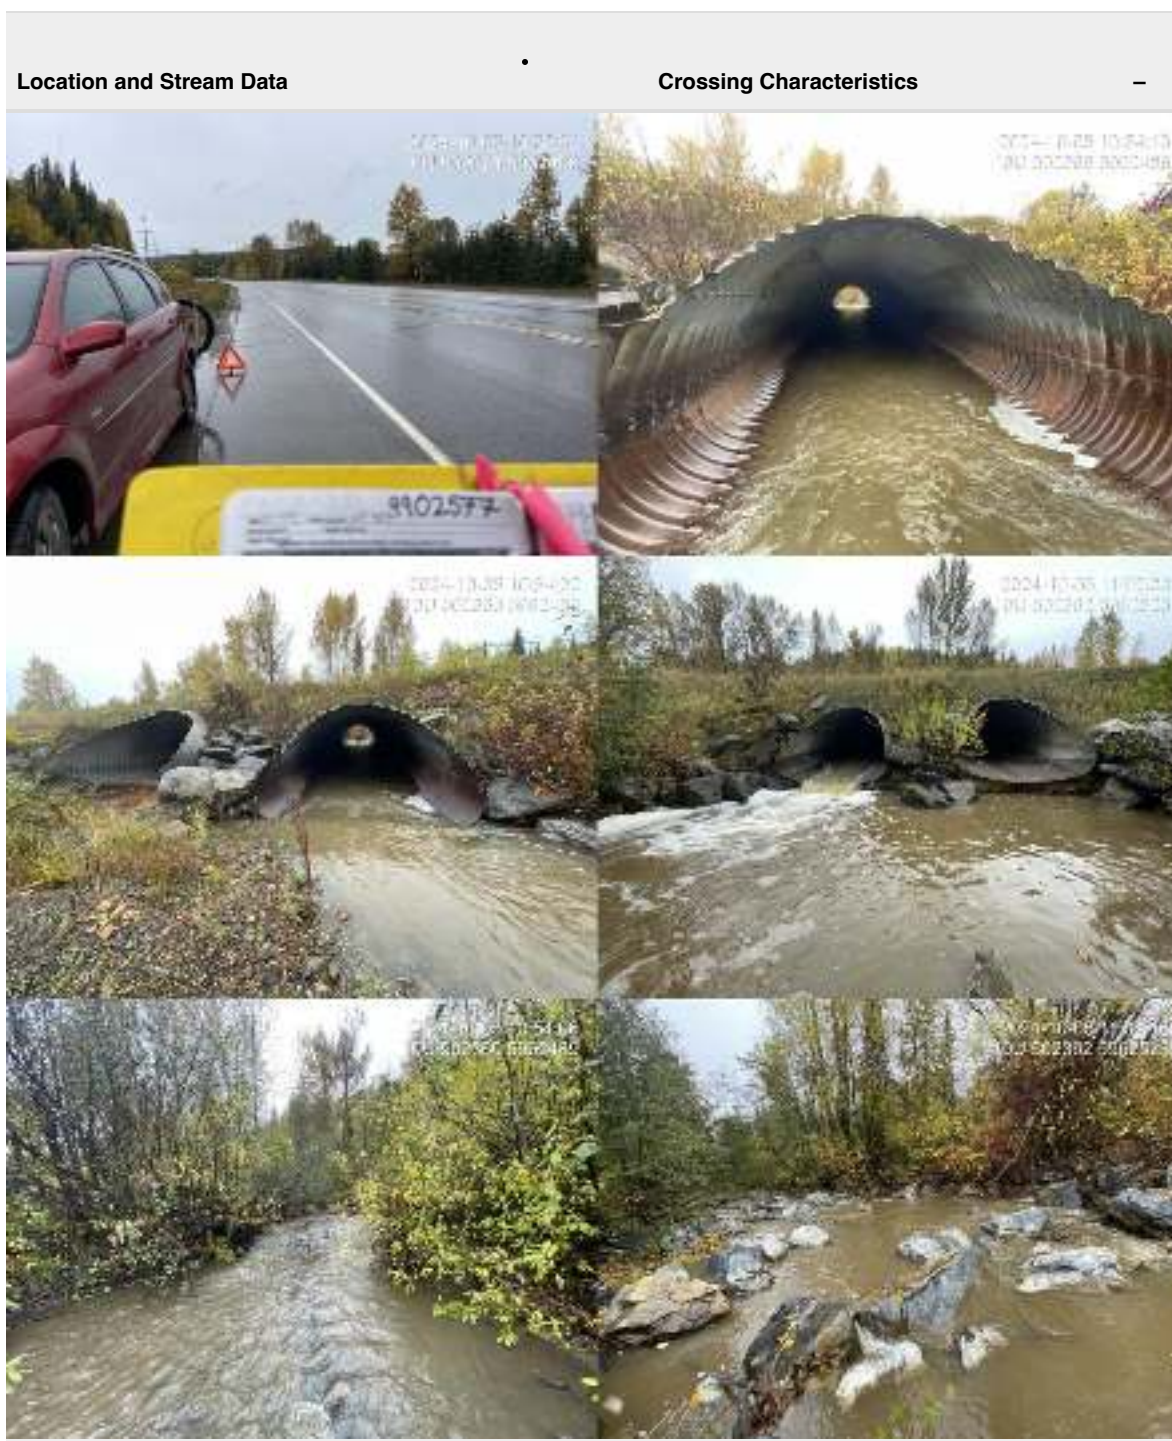
Location and Stream Data		Crossing Characteristics	
Date	2024-10-05	Crossing Sub Type	Oval Culvert
PSCIS ID	199232	Diameter (m)	5.6
External ID	–	Length (m)	25
Crew	LS	Embedded	No
UTM Zone	10	Depth Embedded (m)	–
Easting	502374	Resemble Channel	No
Northing	5962501	Backwatered	No
Stream	Beaverley Creek	Percent Backwatered	–
Road	Highway 16	Fill Depth (m)	1.5
Road Tenure	MOti	Outlet Drop (m)	1.05
Channel Width (m)	9.6	Outlet Pool Depth (m)	0.35
Stream Slope (%)	0.5	Inlet Drop	No
Beaver Activity	No	Slope (%)	2
Habitat Value	Medium	Valley Fill	Deep Fill
Final score	34	Barrier Result	Barrier
Fix type	Replace with New Open Bottom Structure	Fix Span / Diameter	15
Comments: Two pipes, each 2.8m in diameter, were present. The pipe on the north side was not flowing. The gradient directly downstream of the culvert was 3-4% due to boulders placed to create backwatering, which was somewhat functioning, though the culverts were not fully backwatered, but water levels were elevated. The rest of the stream had a gradient of 0.5%. The stream provided good habitat but was fairly channelized due to residential development on both sides. Signs of high flows were evident, with eroding banks. Few pools and limited functional large woody debris were present. MoTi chris_hwy_structure_road_id: 4167 Photos: From top left clockwise: Road/Site Card, Barrel, Outlet, Downstream, Upstream, Inlet.

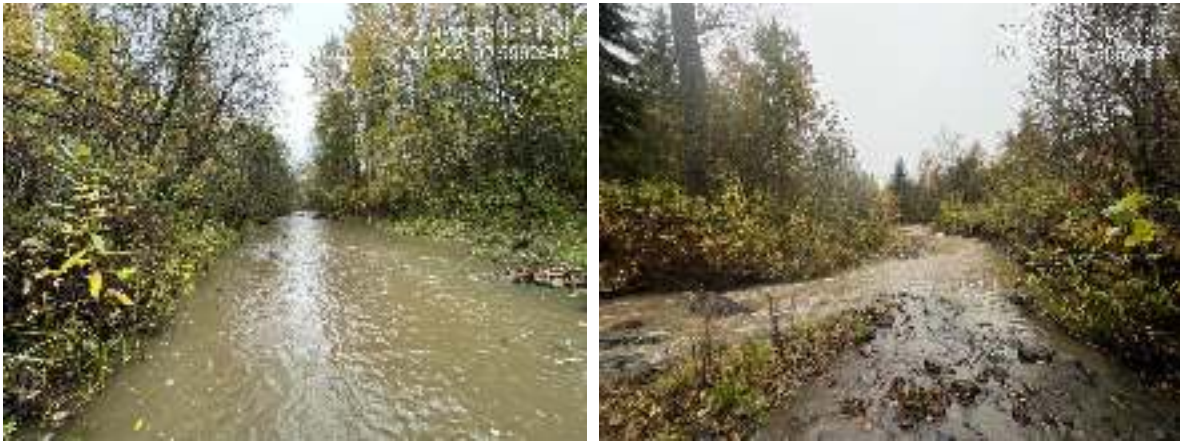
Figure 4.11: Left: Typical habitat downstream of PSCIS crossing 199232. Right: Typical habitat upstream of PSCIS crossing 199232.

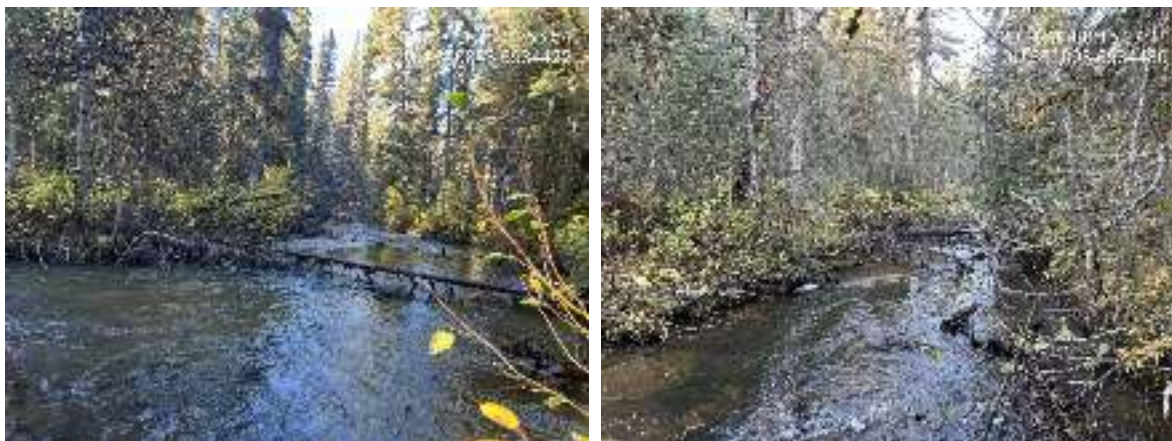
Figure 4.12: Left: Typical habitat upstream of PSCIS crossing 199237 on the west fork on Snowshoe Creek. Right: Typical habitat upstream of PSCIS crossing 199237 on the east fork on Snowshoe Creek.

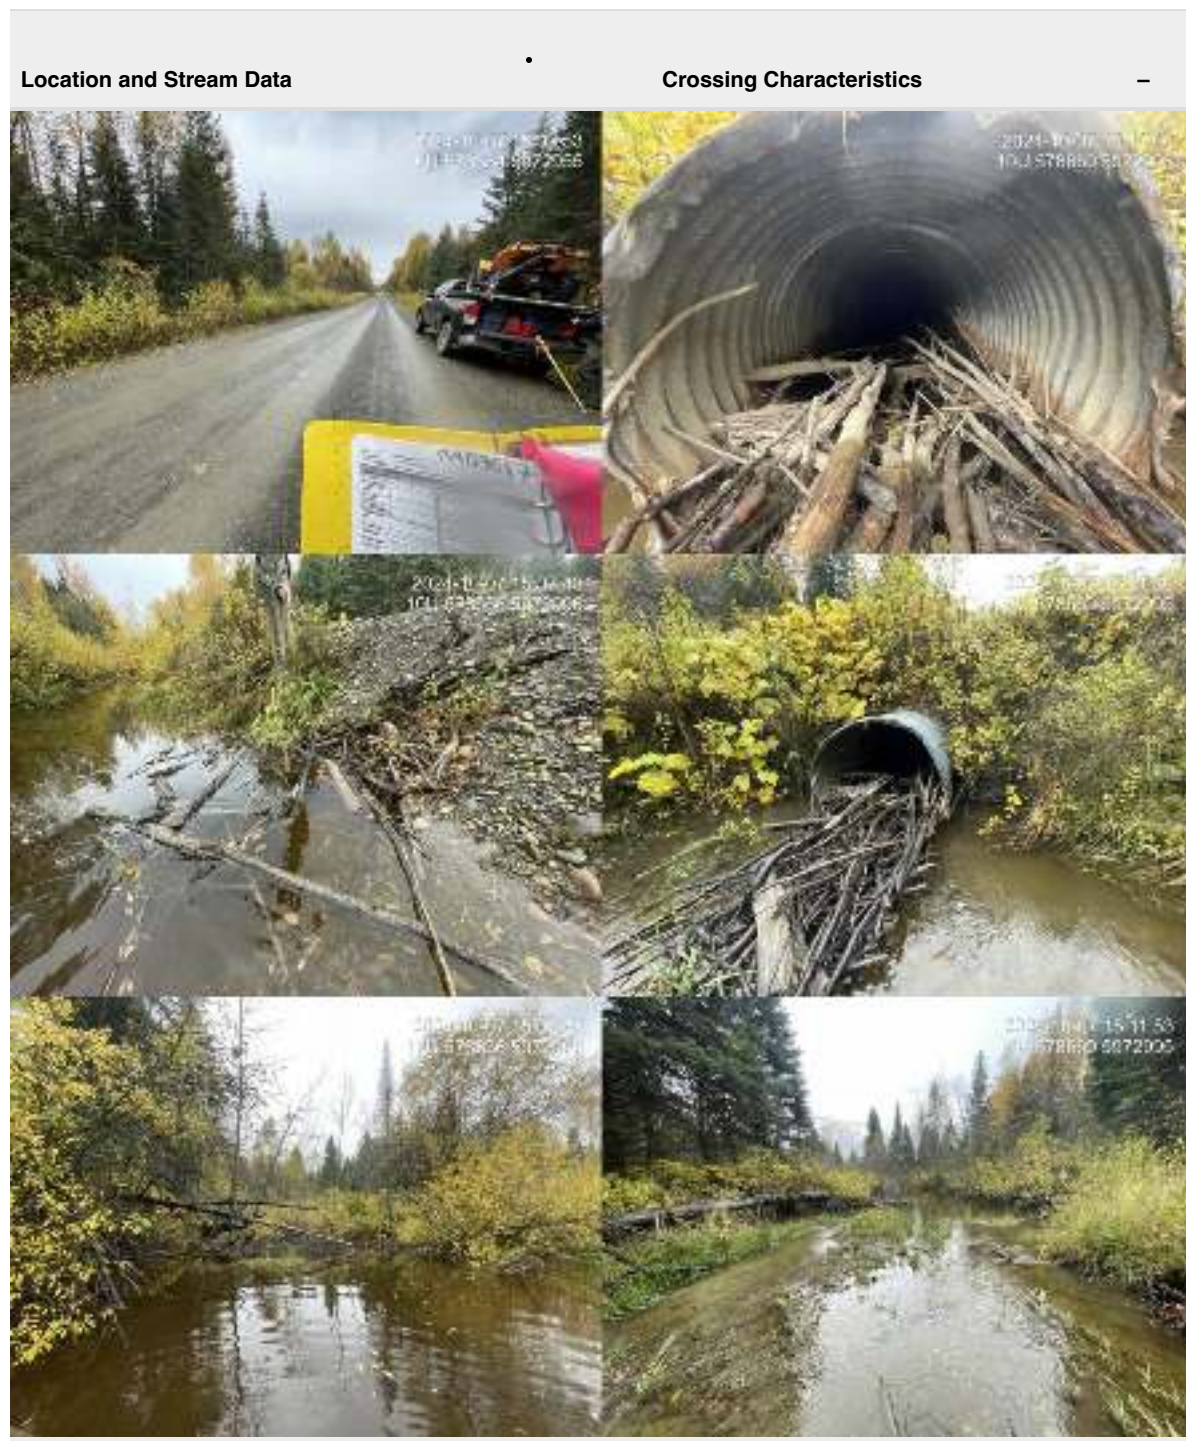
Table 4.41: Summary of fish passage assessment for PSCIS crossing 199255.

Location and Stream Data		Crossing Characteristics	
Date	2024-10-07	Crossing Sub Type	Round Culvert
PSCIS ID	199255	Diameter (m)	1.1
External ID	–	Length (m)	13
Crew	LS	Embedded	No
UTM Zone	10	Depth Embedded (m)	–
Easting	578664	Resemble Channel	No
Northing	5972996	Backwatered	No
Stream	Tributary To Kenneth Creek	Percent Backwatered	–
Road	Bowron FSR	Fill Depth (m)	1.5
Road Tenure	MoF	Outlet Drop (m)	0
Channel Width (m)	10.5	Outlet Pool Depth (m)	0.25
Stream Slope (%)	0.5	Inlet Drop	No
Beaver Activity	Yes	Slope (%)	1.5
Habitat Value	Medium	Valley Fill	Deep Fill
Final score	21	Barrier Result	Barrier
Fix type	Replace with New Open Bottom Structure	Fix Span / Diameter	15
<p>Comments: The inlet of the culvert was completely submerged, with a large beaver pond area just upstream. The outlet was plugged with beaver sticks, and it appeared the beaver had dammed the culvert entirely, creating a large pool at the inlet. Despite this, the culvert still had flow. A beaver dam approximately 0.7m in height was located about 40m downstream. A new culvert had been installed 60m north on the FSR, with flow from that crossing entering the outlet pool from the north. Downstream of the culvert, the stream flowed through the forest with minimal defined channel. Where a defined channel was present, it ranged from 13m wide, but most of the area consisted of 15-17m of wetted forest with some flow. Culvert slope was estimated due to the submerged inlet. Habitat confirmations were conducted upstream and downstream.</p> <p>Photos: From top left clockwise: Road/Site Card, Barrel, Outlet, Downstream, Upstream, Inlet.</p>

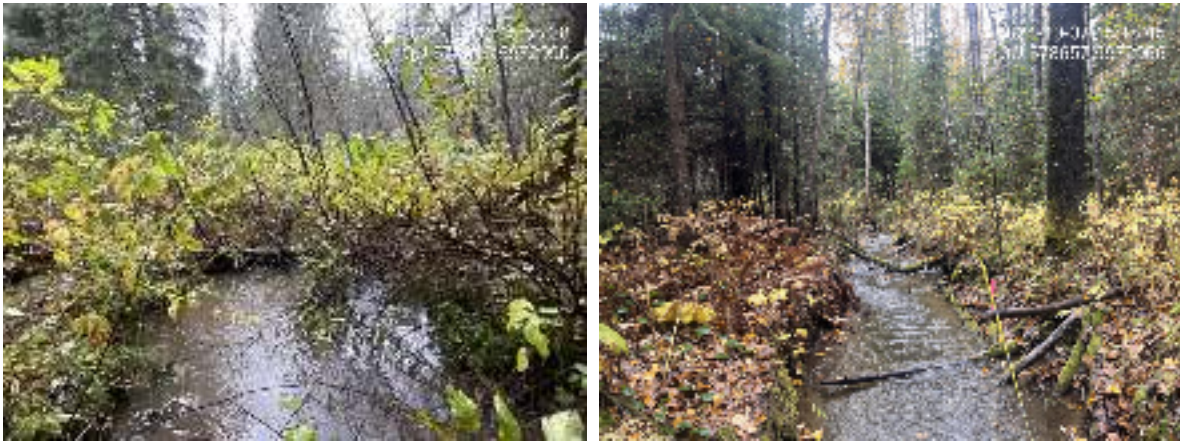
Figure 4.13: Left: Typical habitat downstream of PSCIS crossing 199255. Right: Typical habitat upstream of PSCIS crossing 199255.
