SOCIETY FOR ECOSYSTEM RESTORATION
IN NORTHERN BRITISH COLUMBIA

Restoring Fish Passage in the Fraser Region - 2023

**Prepared for
Ministry of Transportation and Infrastructure**

**Prepared by
Al Irvine, B.Sc., R.P.Bio. and Lucy Schick, B.Sc.
New Graph Environment Ltd.**

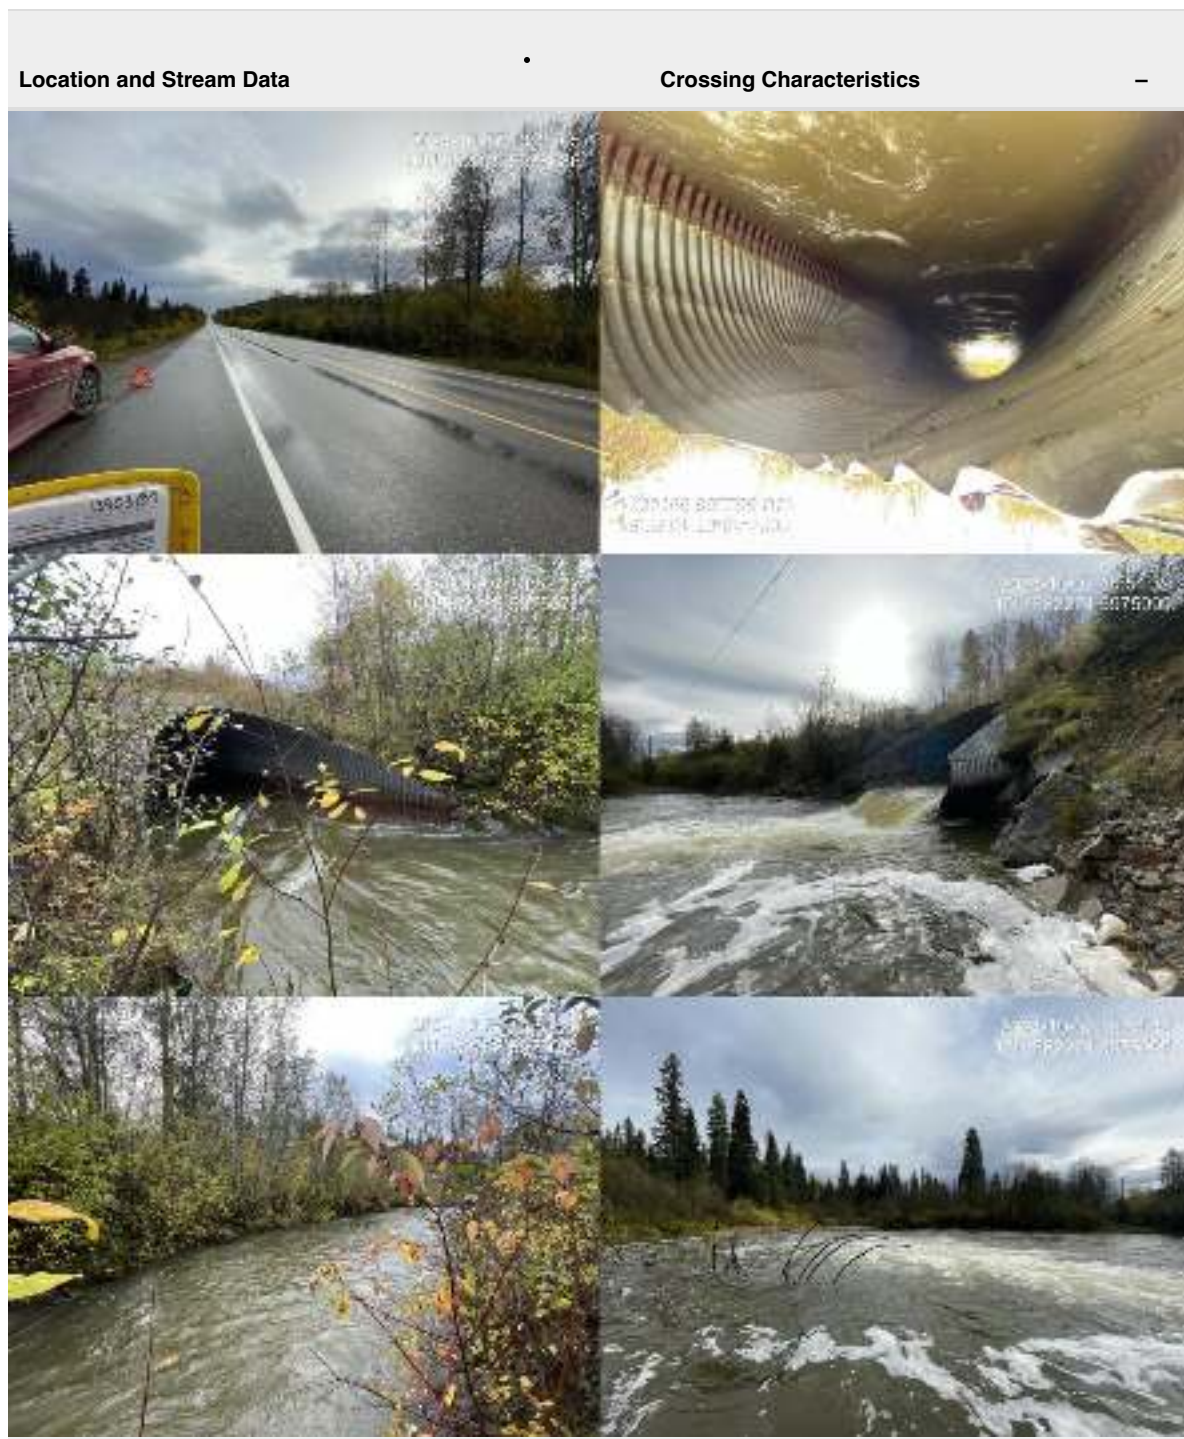
Table 4.45: Summary of fish passage assessment for PSCIS crossing 199256.

Location and Stream Data		Crossing Characteristics	
Date	2024-10-07	Crossing Sub Type	Oval Culvert
PSCIS ID	199256	Diameter (m)	5.5
External ID	–	Length (m)	30
Crew	LS	Embedded	No
UTM Zone	10	Depth Embedded (m)	–
Easting	582279	Resemble Channel	No
Northing	5975090	Backwatered	No
Stream	Kenneth Creek	Percent Backwatered	–
Road	Highway 16	Fill Depth (m)	1.5
Road Tenure	MOTI	Outlet Drop (m)	0.7
Channel Width (m)	19	Outlet Pool Depth (m)	2
Stream Slope (%)	0.5	Inlet Drop	No
Beaver Activity	No	Slope (%)	1
Habitat Value	High	Valley Fill	Deep Fill
Final score	37	Barrier Result	Barrier
Fix type	Replace with New Open Bottom Structure	Fix Span / Diameter	24
<p>Comments: Large multi-plate oval culvert with a substantial 50m-wide outlet pool. The stream had high flow at the time of assessment. Culvert slope and outlet pool depth were estimated as the pool was too deep to wade. Deep pools over 1m, formed by functional large woody debris, provided good overwintering habitat for fish of all ages. Gravels suitable for spawning were present. Downstream of the culvert, the stream ran parallel to the highway with banks reinforced by riprap and large wood secured with metal wiring to create habitat and reduce flow. MoTi chris_hwy_structure_road_id: 3750</p> <p>Photos: From top left clockwise: Road/Site Card, Barrel, Outlet, Downstream, Upstream, Inlet.</p>

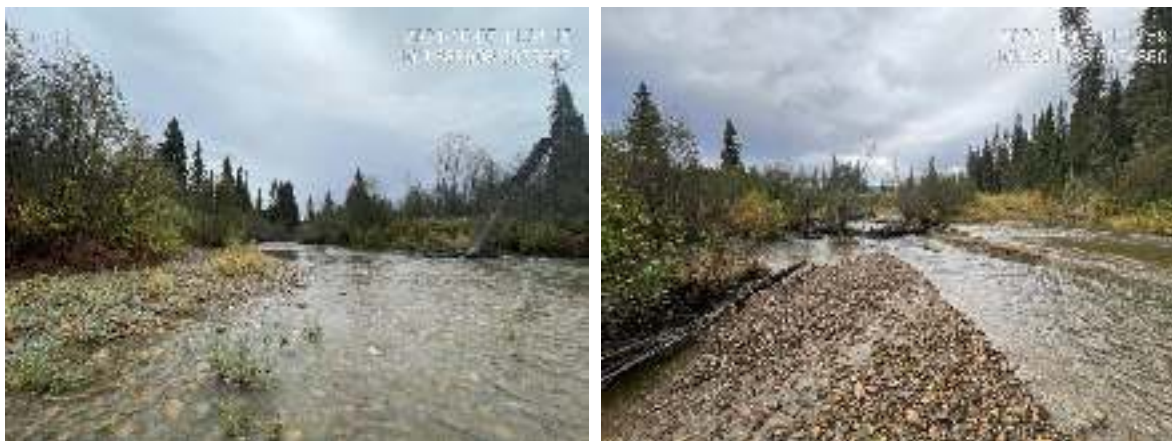
Figure 4.14: Left: Typical habitat downstream of PSCIS crossing 199256. Right: Typical habitat upstream of PSCIS crossing 199256.

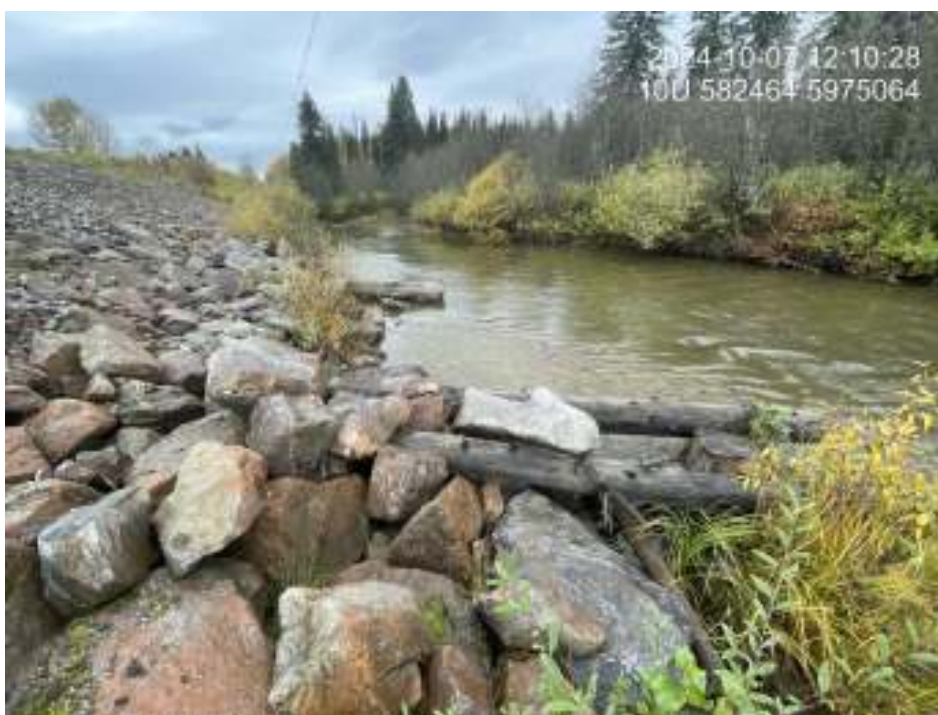
Figure 4.15: Riprapped banks and large wood structures secured with metal wiring located downstream of crossing 199256.

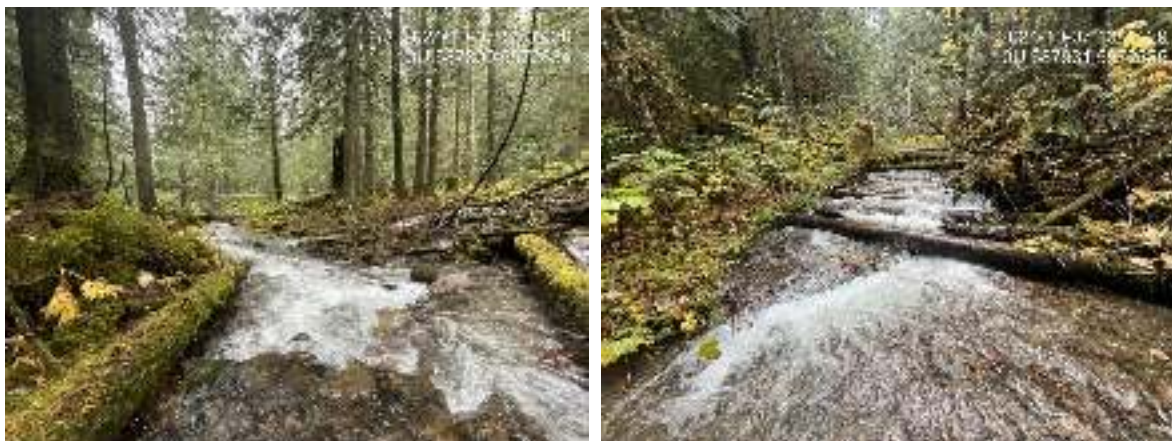
Figure 4.16: Left: Typical habitat downstream of PSCIS crossing 199260. Right: Typical habitat upstream of PSCIS crossing 199260.

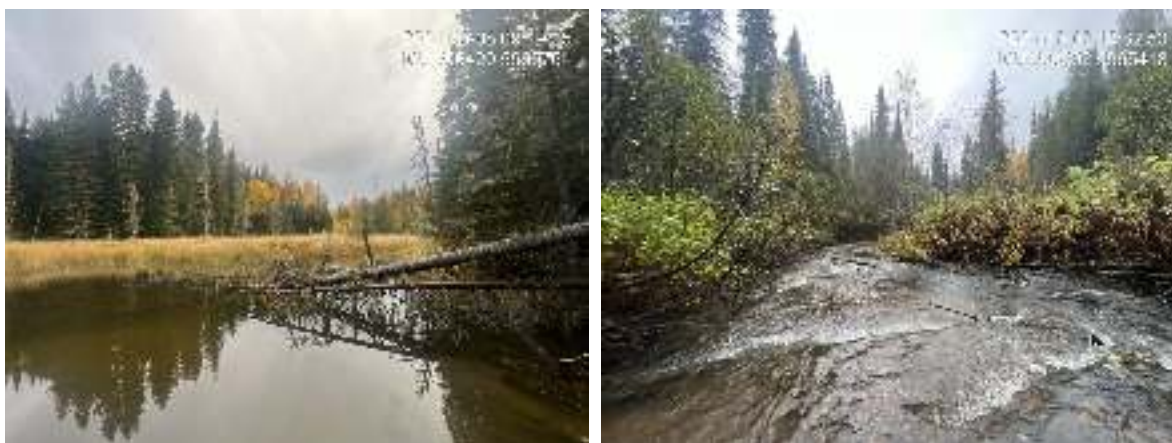
Figure 4.17: Left: Typical habitat upstream of PSCIS crossing 199267. Right: Typical habitat upstream of PSCIS crossing 199267.

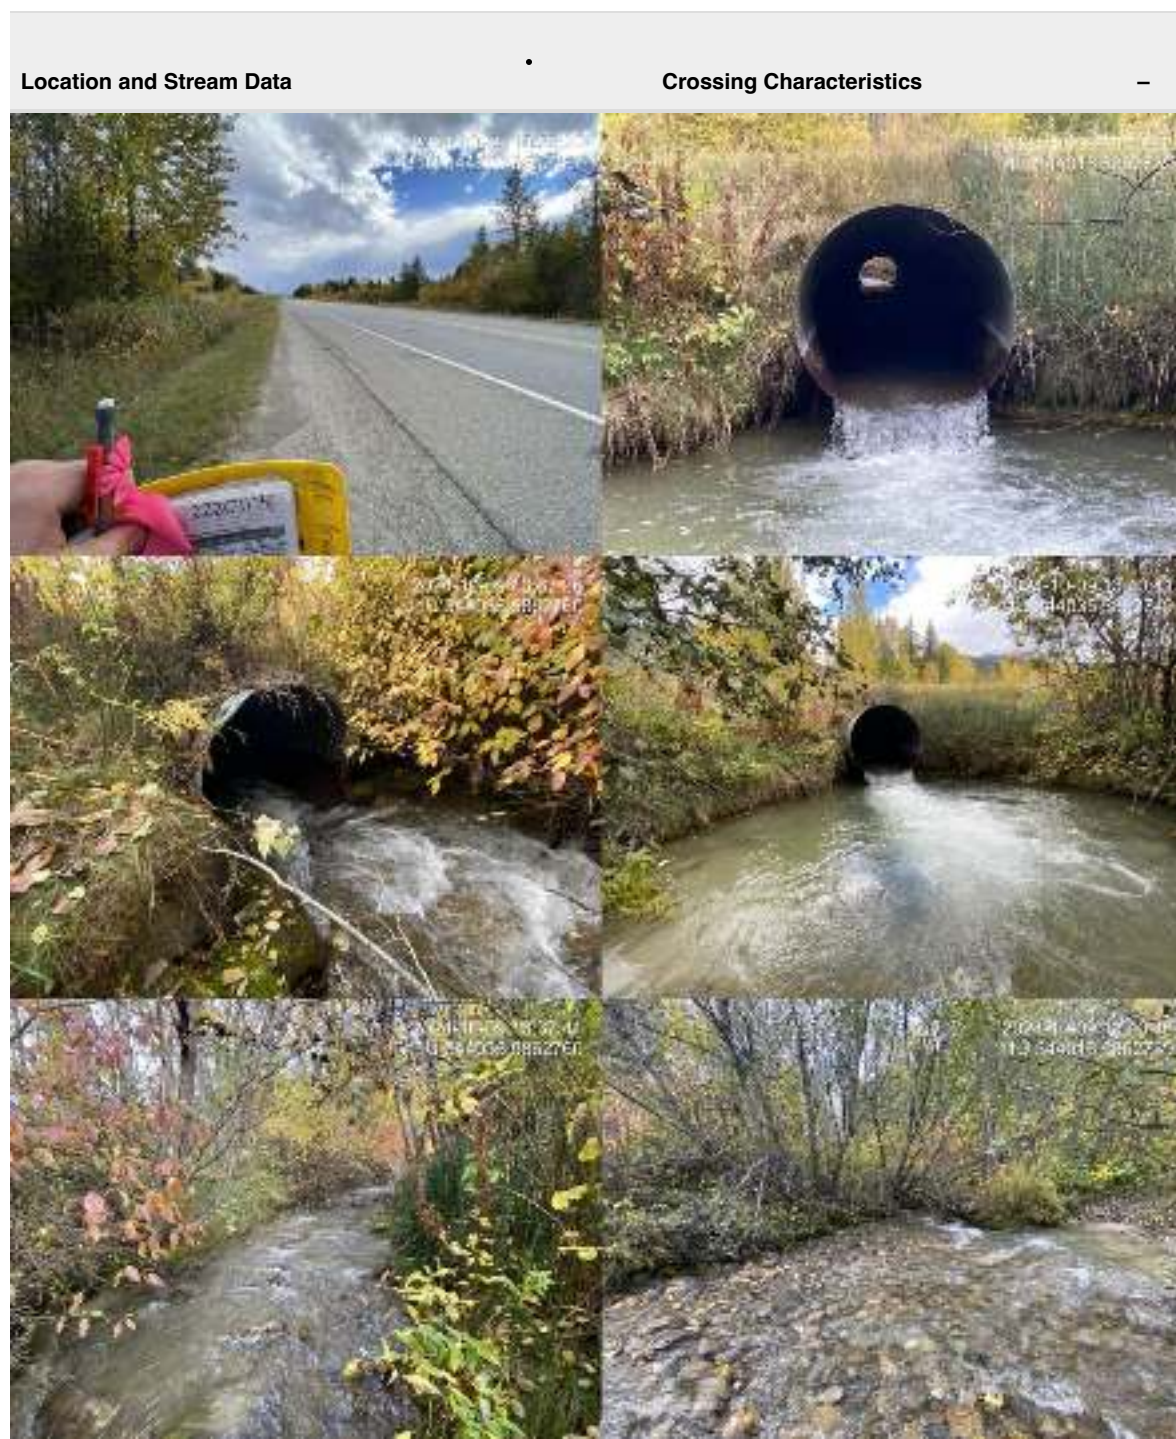
Location and Stream Data		Crossing Characteristics	
Date	2024-10-09	Crossing Sub Type	Round Culvert
PSCIS ID	199278	Diameter (m)	1.4
External ID	–	Length (m)	22
Crew	LS	Embedded	No
UTM Zone	11	Depth Embedded (m)	–
Easting	344031	Resemble Channel	No
Northing	5862744	Backwatered	No
Stream	Teepee Creek	Percent Backwatered	–
Road	Highway 5	Fill Depth (m)	0.7
Road Tenure	MOTI	Outlet Drop (m)	0.4
Channel Width (m)	7	Outlet Pool Depth (m)	1
Stream Slope (%)	2.5	Inlet Drop	No
Beaver Activity	No	Slope (%)	2
Habitat Value	High	Valley Fill	Deep Fill
Final score	34	Barrier Result	Barrier
Fix type	Replace with New Open Bottom Structure	Fix Span / Diameter	15
<p>Comments: A moderate outlet drop was present and would be substantial at lower flows. Flow was steady at the time of assessment. The culvert was in good condition. A large, deep outlet pool indicated the culvert was likely undersized for the stream. Additionally, minimal road fill made this crossing a significant flood hazard, which could wash out Highway 5. Downstream, the stream had frequent pools 0.3-0.5m deep, providing good overwintering habitat for fish, and abundant gravels suitable for spawning. Roughly 150m downstream of the culvert, several cattle pens crossed the stream and appeared to be set up to provide cattle access for drinking. These areas were visibly trampled, with significant loss of riparian vegetation. Upstream, the stream was relatively confined, with only rare pockets of unembedded gravels. Deep pools were present, formed by boulder and large woody debris scour. A salmon point was noted near the pipeline location in FISS. Numerous small steps, ranging from 30-60cm, were present due to the steep, boulder-dominated nature of the stream. Electrofishing would be beneficial for further assessment. The site was a highway crossing, making replacement difficult. A small ford was located approximately 5m downstream of the culvert outlet. MoTi chris_culvert_id: 1467202</p> <p>Photos: From top left clockwise: Road/Site Card, Barrel, Outlet, Downstream, Upstream, Inlet.</p>

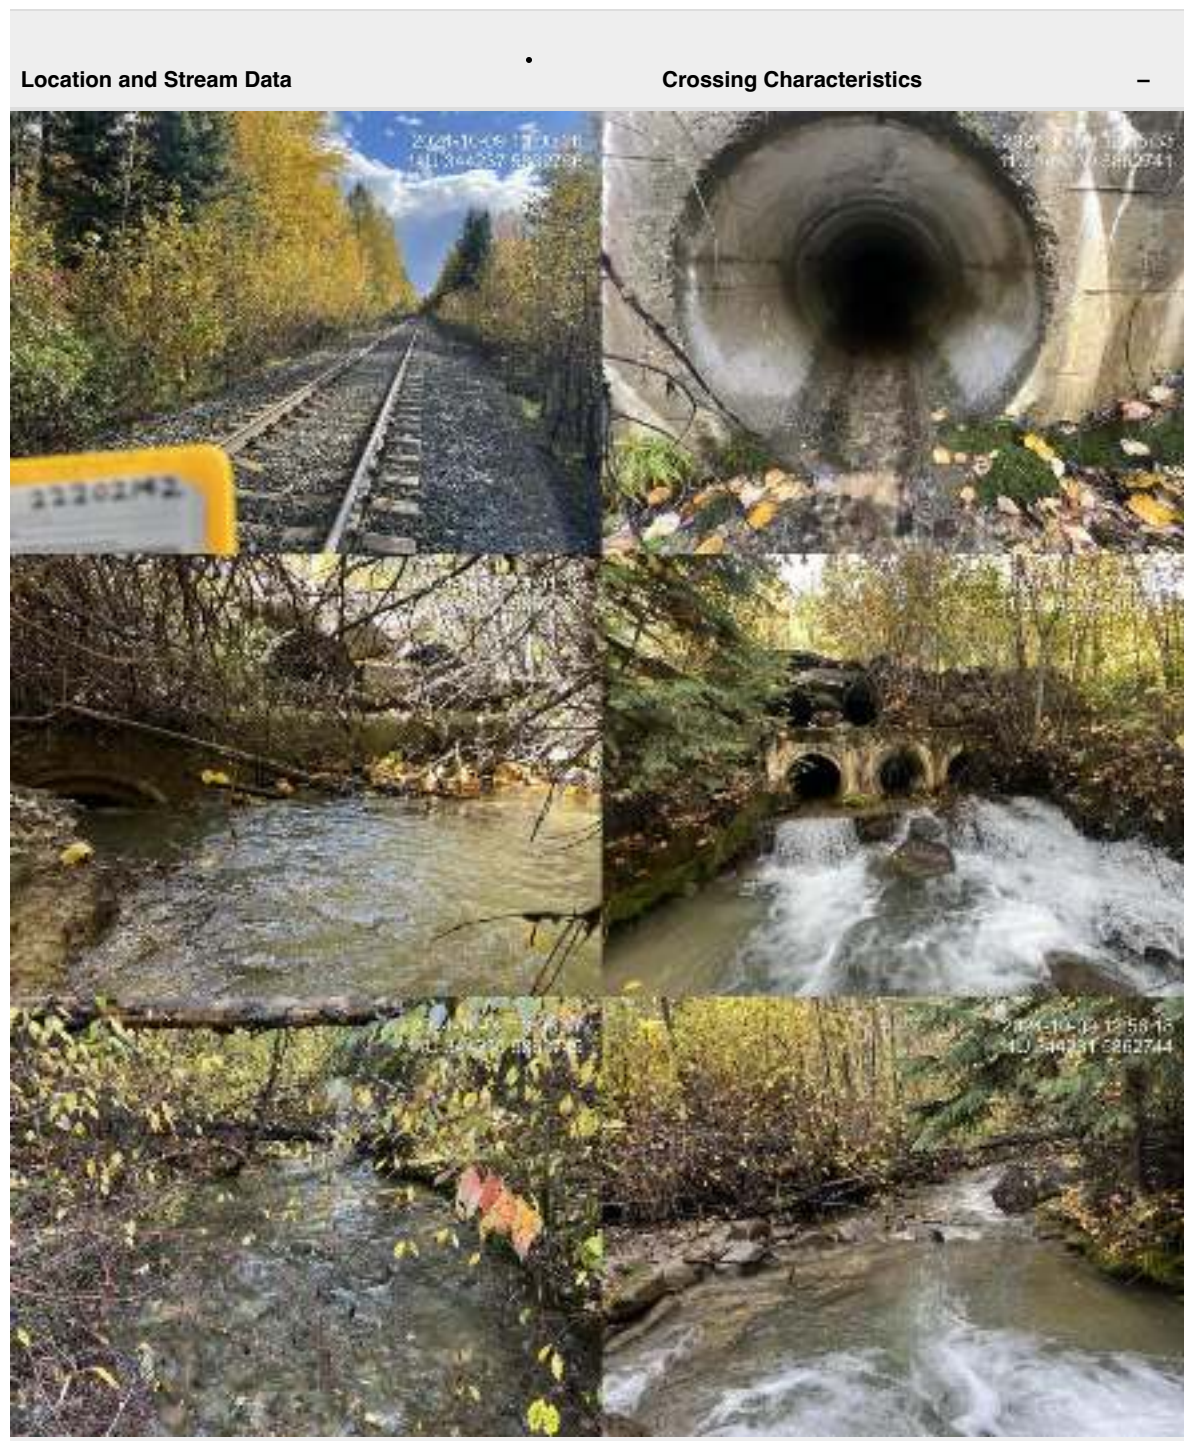
Location and Stream Data		Crossing Characteristics	
Date	2024-10-09	Crossing Sub Type	Round Culvert
PSCIS ID	203302	Diameter (m)	2.7
External ID	–	Length (m)	14
Crew	AI	Embedded	No
UTM Zone	11	Depth Embedded (m)	–
Easting	344222	Resemble Channel	No
Northing	5862742	Backwatered	No
Stream	Teepee Creek	Percent Backwatered	–
Road	Railway	Fill Depth (m)	2
Road Tenure	CN Rail	Outlet Drop (m)	0.75
Channel Width (m)	4.2	Outlet Pool Depth (m)	0.25
Stream Slope (%)	7	Inlet Drop	Yes
Beaver Activity	No	Slope (%)	6
Habitat Value	Medium	Valley Fill	Deep Fill
Final score	36	Barrier Result	Barrier
Fix type	Replace with New Open Bottom Structure	Fix Span / Diameter	15
<p>Comments: Three concrete pipes, each 0.9m in diameter, were present, along with two 0.9m corrugated overflow pipes above. A stamp on the structure indicated it was built in 1944. All three concrete pipes were clogged at the inlet, ranging from 80% to 100% clogged with debris. This was a known fish-bearing stream, with a salmon point documented ~100m downstream in the FISS database. At this location, the stream was a mid-sized, steeper cobble-boulder step-pool system with only rare pockets of unembedded gravels. Deep pools were present, formed by boulder and large woody debris scour. Numerous small steps, ranging from 30-60cm, were present due to the steep, boulder-dominated nature of the stream. Downstream of the highway crossing, the stream had a lower gradient with frequent pools 0.3-0.5m deep, providing good overwintering habitat for fish and abundant gravels suitable for spawning.</p> <p>Photos: From top left clockwise: Road/Site Card, Barrel, Outlet, Downstream, Upstream, Inlet.</p>

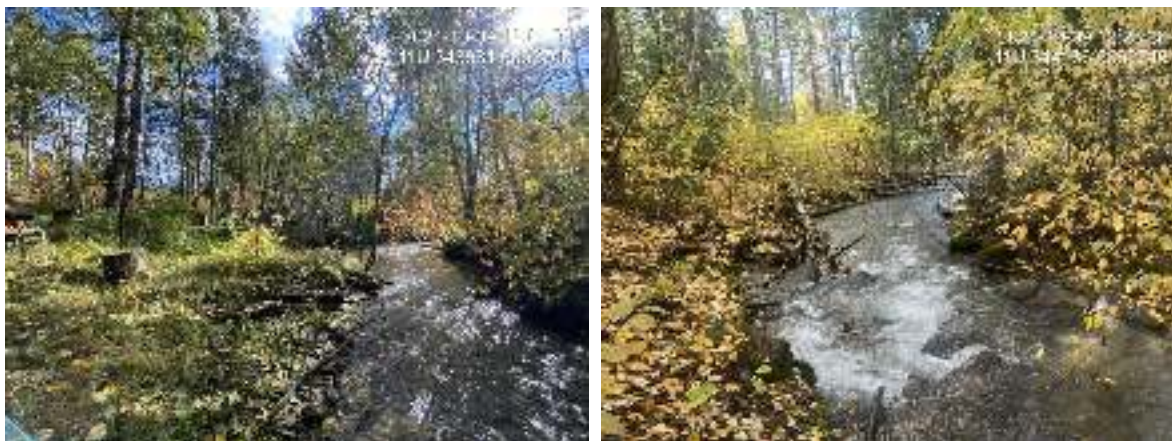
Figure 4.18: Left: Typical habitat downstream of PSCIS crossing 199278. Right: Typical habitat upstream of PSCIS crossing 199278 and downstream of PSCIS crossing 203302.

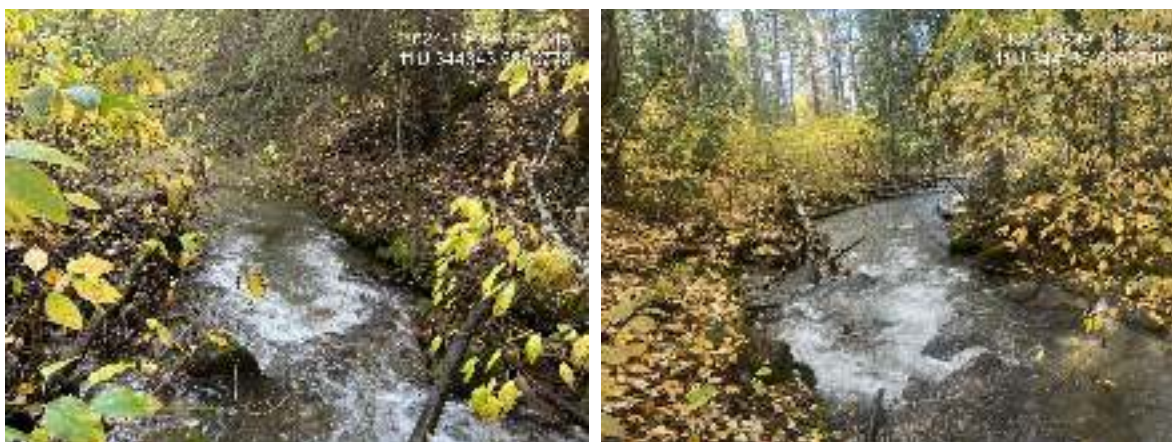
Figure 4.19: Left: Typical habitat upstream of PSCIS crossing 203302. Right: Typical habitat upstream of PSCIS crossing 199278 and downstream of PSCIS crossing 203302.

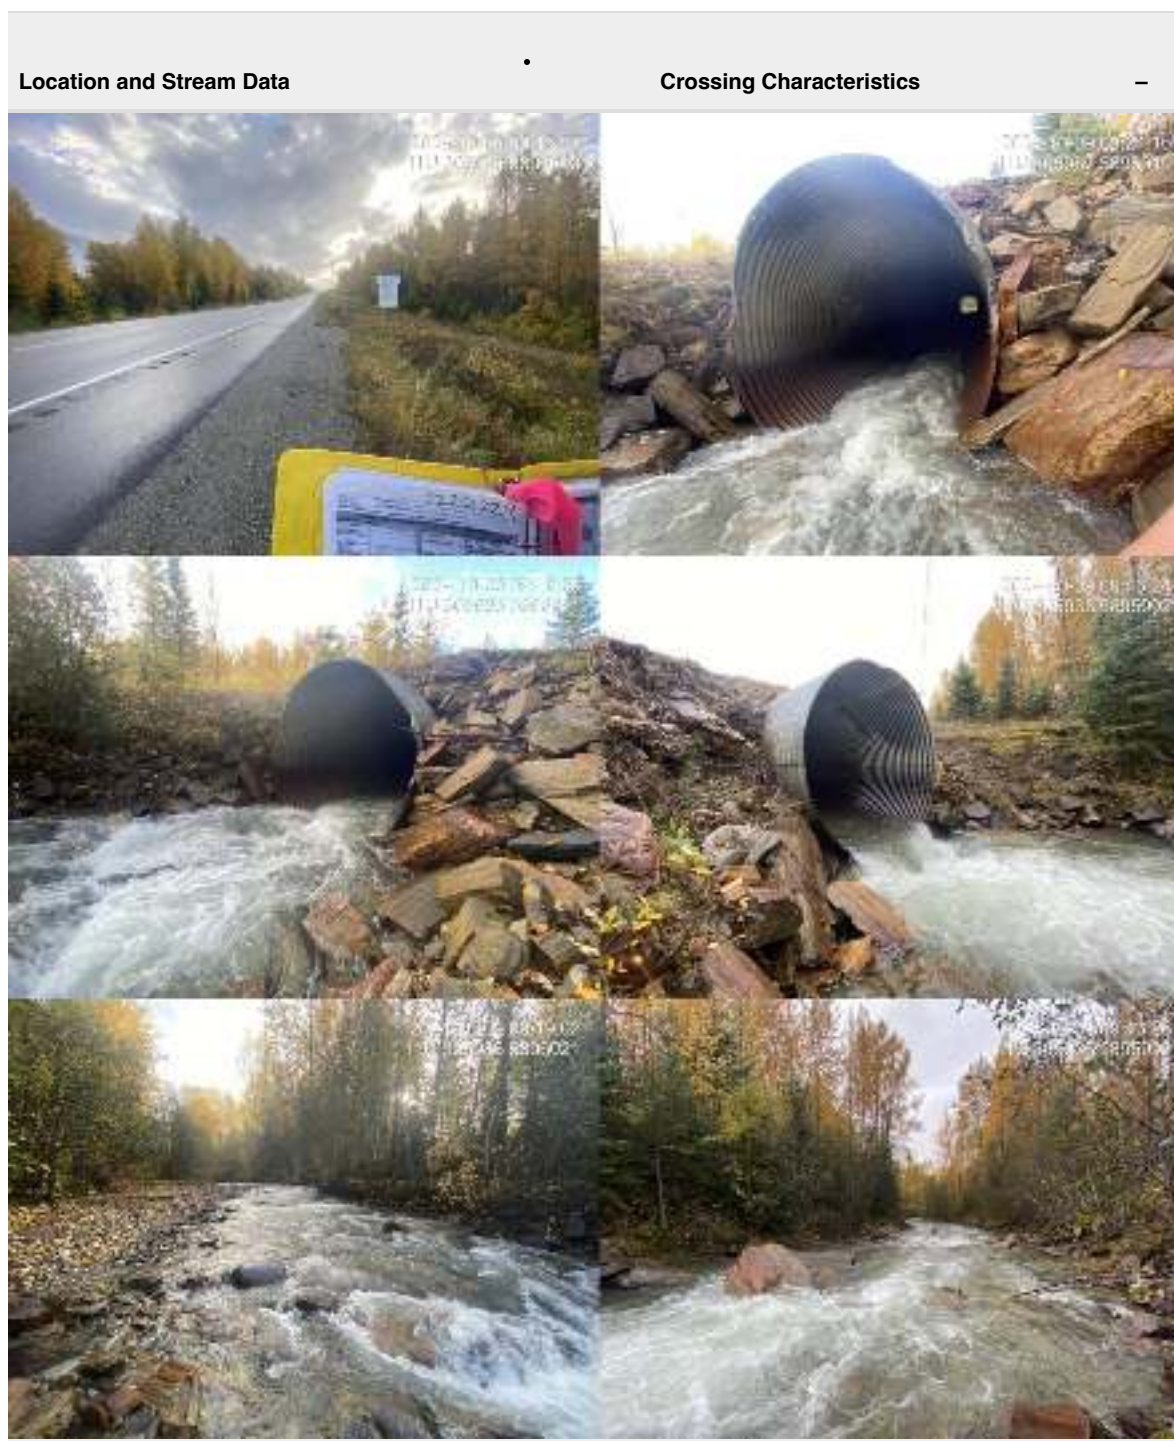
Table 4.62: Summary of fish passage assessment for PSCIS crossing 199282.

Location and Stream Data		Crossing Characteristics	
Date	2024-10-09	Crossing Sub Type	Round Culvert
PSCIS ID	199282	Diameter (m)	4
External ID	–	Length (m)	52
Crew	LS	Embedded	No
UTM Zone	11	Depth Embedded (m)	–
Easting	305946	Resemble Channel	No
Northing	5896010	Backwatered	No
Stream	Holliday Creek	Percent Backwatered	–
Road	Highway 16	Fill Depth (m)	2
Road Tenure	MOTI	Outlet Drop (m)	0.8
Channel Width (m)	16	Outlet Pool Depth (m)	0.5
Stream Slope (%)	3	Inlet Drop	No
Beaver Activity	No	Slope (%)	2
Habitat Value	High	Valley Fill	Deep Fill
Final score	37	Barrier Result	Barrier
Fix type	Replace with New Open Bottom Structure	Fix Span / Diameter	21
Comments: A significant outlet drop was present. Flow was high at the time of assessment, and at lower flows, the outlet drop would be even more substantial. Although the culvert was large, it was still likely undersized for the stream. The stream was a large glaciated system with a cobble-boulder substrate and an intact mixed riparian zone, primarily deciduous. Occasional large woody debris features created deep pool habitats and pockets of gravels were present suitable for spawning salmonids. A fish (~60mm) was observed during habitat confirmation. MoTi chris_hwy_structure_road_id: 29925 Photos: From top left clockwise: Road/Site Card, Barrel, Outlet, Downstream, Upstream, Inlet.

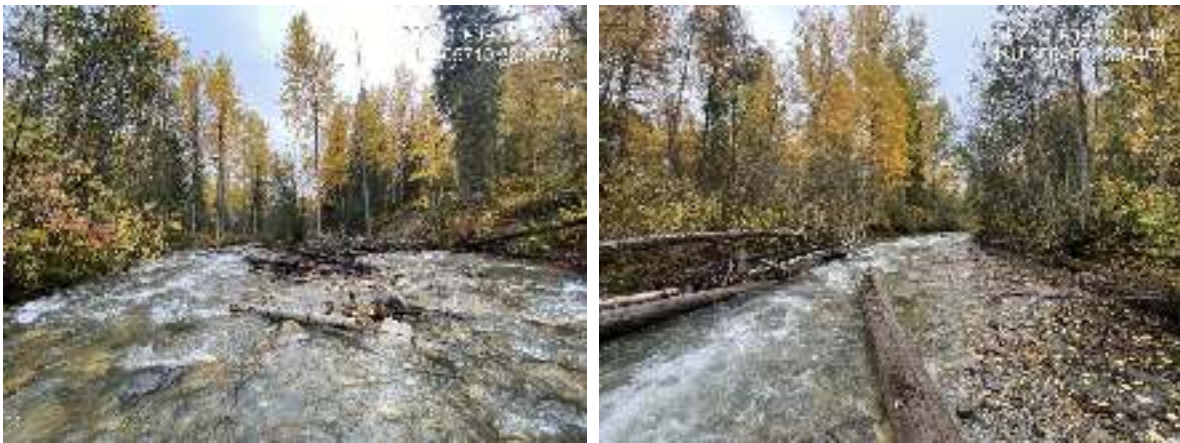
Figure 4.20: Left: Typical habitat downstream of PSCIS crossing 199282. Right: Typical habitat upstream of PSCIS crossing 199282.
