SOCIETY FOR ECOSYSTEM RESTORATION
IN NORTHERN BRITISH COLUMBIA

Restoring Fish Passage in the Peace Region - 2024

PEA-F24-F-3944-DCA

DRAFT Version 0.1.1 2025-04-24

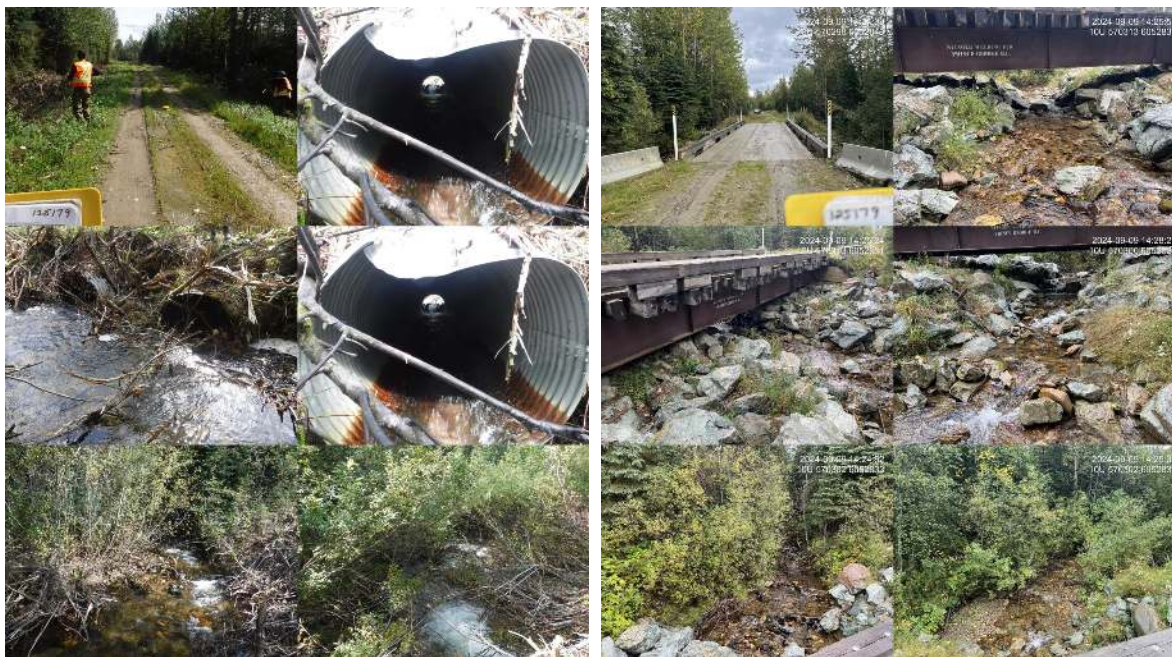
Riparian Notes	There did not appear to have been any riparian planting conducted during construction, with only herbaceous regrowth observed, including grasses and fireweed. The site could have been planted with willow whips to provide cover and food.
Flow Depth Notes	Flow depth was comparable to sections downstream, with measured depths ranging from 5–20cm. At the observed flow levels during the survey, migration was not likely hindered.
Stability Notes	The structure and extensive rock riprap appeared fully stable, with no evidence of slumping or instability.
Revegetation Notes	As noted in the riparian section, the construction footprint was vegetated primarily with herbaceous plants where rock was not present.

variable	value
Cover Notes	Due to the extensive rock placement within the construction footprint, there was no overhanging vegetation cover. However, occasional pieces of riprap and boulder lines within the channel provided some boulder and step-pool habitat. The larger substrate was providing fish habitat, as observed during electrofishing.
Maintenance Notes	It appears that no maintenance is required at this time.

Fish passage at crossing 125179 was restored in the summer of 2022 with a 15m steel girder permanent bridge with modular timber decks. Partial funding for the project was provided by FWCP through coordination from SERNbc. Effectiveness monitoring at the site was conducted in 2024 with the structure in stable condition with no maintenance required at the time of reporting. Lessons learned from the work - to be leveraged towards future projects - include reducing the amount of

Figure 5.2: Left: Photos of crossing 125179 in 2019. Right: Photos of crossing 125179 in 2024.

Resampling of fish at the restoration and reference sites in future years is recommended to build our understanding of fish use, movement and health in the subject streams. Acquisition of additional aerial imagery in the future is also recommended so that imagery and elevation models can be compared with data collected immediately following replacement (2022) to evaluate stream morphology changes and riparian recovery since construction.

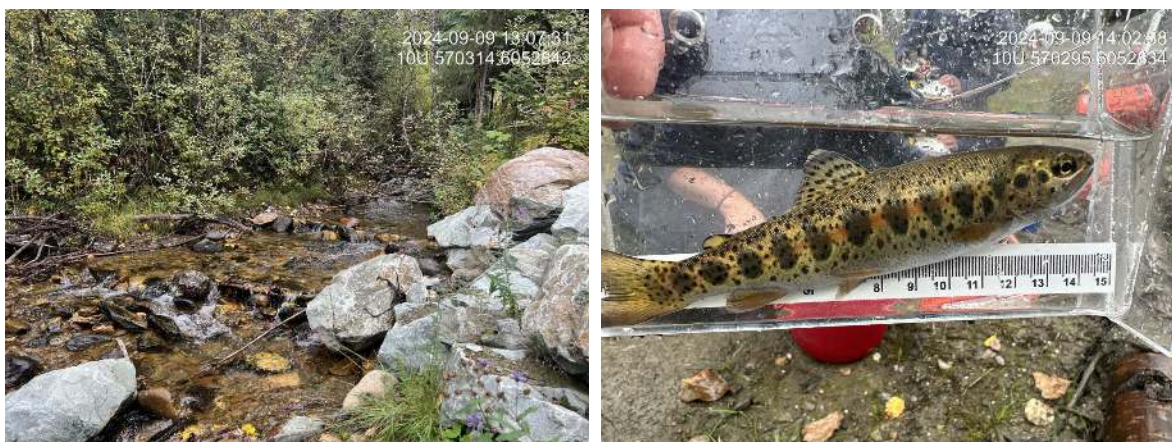
Figure 5.3: Left: Typical habitat electrofished upstream of PSCIS crossing 125179. Right: Rainbow trout captured upstream of PSCIS crossing 125179.

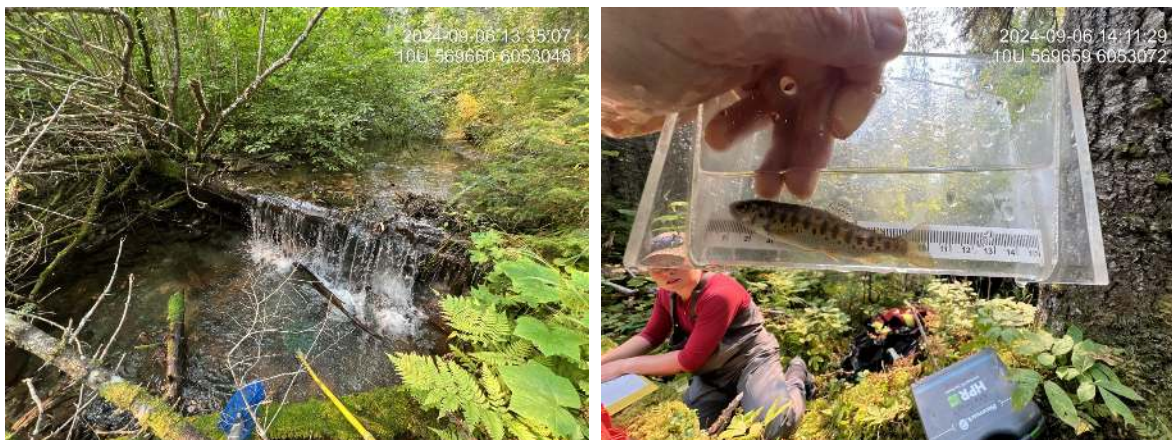
Figure 5.4: Left: Typical habitat electrofished upstream of PSCIS crossing 125180. Right: Rainbow trout captured upstream of PSCIS crossing 125180.

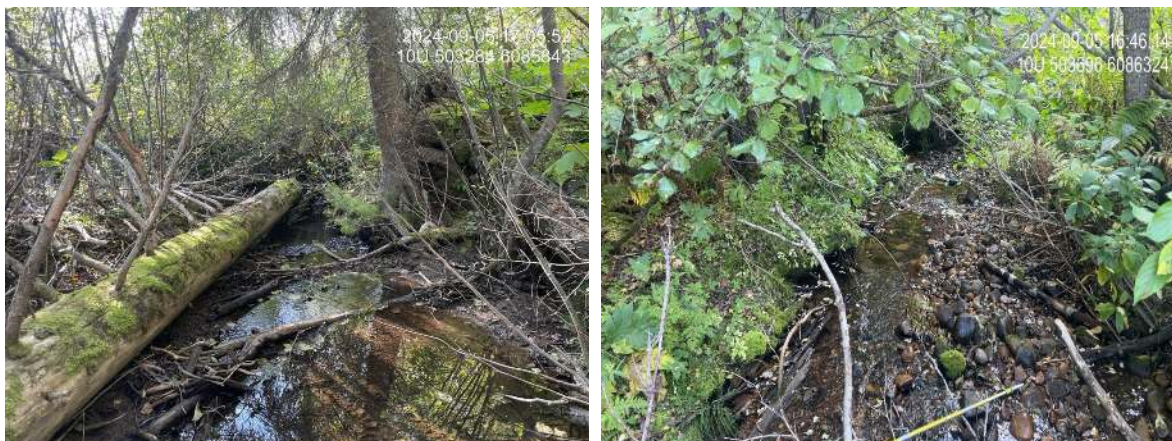
The stream was surveyed downstream from crossing 198669 for 250m , to the confluence with McLeod Lake. The stream had frequent pools, good cover, and abundant gravels, providing medium value habitat for overwintering and spawning fish. Beaver activity was visible and fish were observed the entire length of the survey (Figure [5.5](#)). The average channel width was 3.4m, the average wetted width was 1.5m, and the average gradient was 1.6%. The dominant substrate was cobbles with gravels sub-dominant. Total cover amount was rated as abundant with undercut banks dominant. Cover was also present as small woody debris, large woody debris, deep pools, and overhanging vegetation.

The stream was surveyed upstream from crossing 198669 for 550m (Figure [5.5](#)). Abundant gravels were present throughout the lower section, providing suitable spawning habitat. Near the powerline corridor, substrate composition transitioned to predominantly fines. Approximately 100m upstream of the transmission line, a 1.2m high beaver dam created a backwatered area. Numerous fish, ranging from 40-120mm, were observed throughout the surveyed section up to the beaver dam. Upstream of the impounded area, the stream returned to predominantly gravel substrates with frequent pools up to 40cm deep. The dominant substrate was gravels with fines sub-dominant. The average channel width was 3.7m, the average wetted width was 2.4m, and the average gradient was 2.5%. Total cover amount was rated as moderate with undercut banks dominant. Cover was also present as small woody debris, large woody debris, deep pools, and overhanging vegetation. The habitat was rated as medium value for salmonid spawning and rearing.

Figure 5.5: Left: Typical habitat downstream of PSCIS crossing 198669. Right: Typical habitat upstream of PSCIS crossing 198669.

Should restoration/maintenance activities proceed, replacement of the Hart Highway crossing with a bridge (4.5 m span) is recommended. At the time of reporting in 2025, the cost of the work is estimated at \$ 1,500,000.

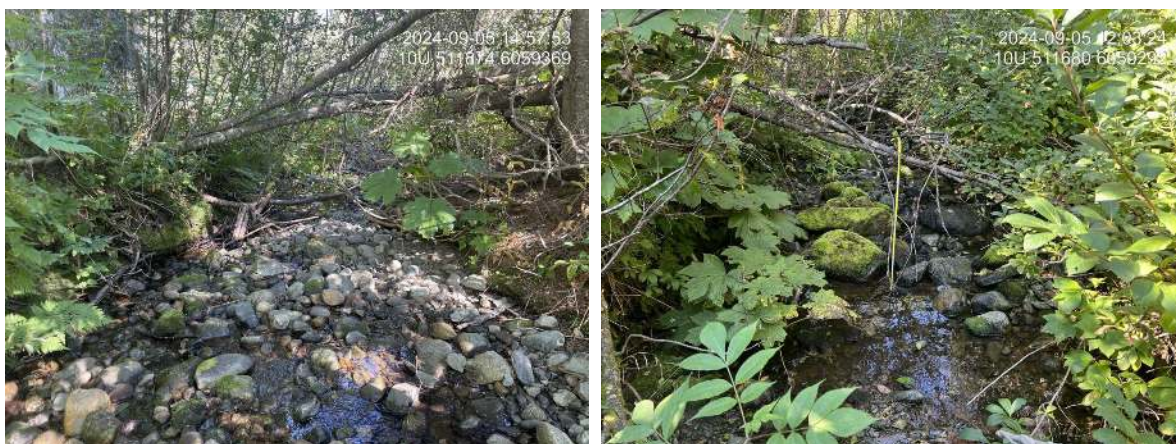
The stream was surveyed upstream from crossing 198692 for 500m . The stream was noted as having significant flow for the time of year. The habitat was rated as medium value, with patches of gravel suitable for spawning resident rainbow trout and bull trout present (Figure [5.7](#)). The stream narrowed into a canyon approximately 150m upstream of Kerry FSR (Figure [5.8](#)). The average channel width was 4m, the average wetted width was 1.5m, and the average gradient was 5%. The dominant substrate was cobbles with gravels sub-dominant. Total cover amount was rated as abundant with undercut banks dominant. Cover was also present as small woody debris, large woody debris, deep pools, and overhanging vegetation.

Figure 5.7: Left: Typical habitat downstream of PSCIS crossing 198692. Right: Typical habitat upstream of PSCIS crossing 198692.

If there are no plans for further logging in the area, removing the crossing and deactivating the road should be considered as a fish passage remediation option. If logging activities are planned to continue and restoration/maintenance activities proceed, replacement of the Kerry Lake FSR

crossing with a bridge (15 m span) is recommended. At the time of reporting in 2025, the cost of the work is estimated at \$ 450,000.

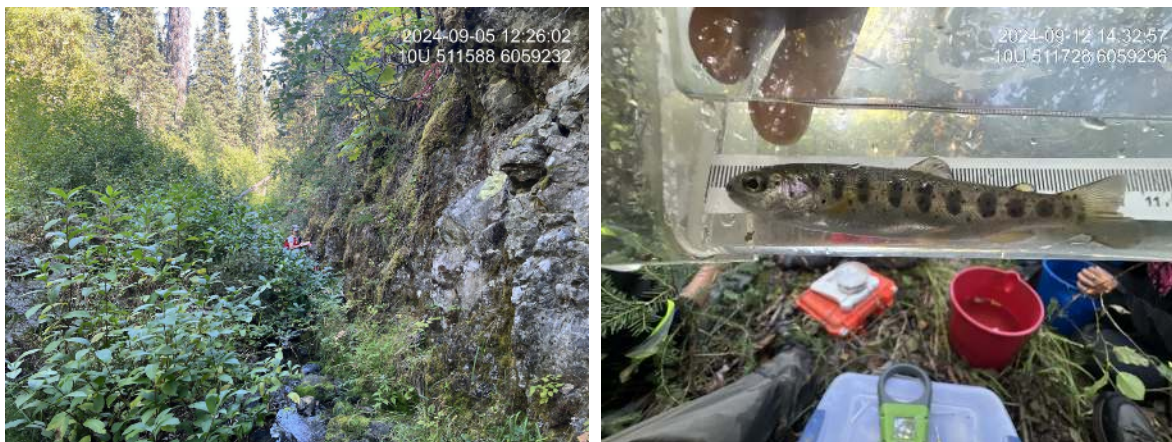
Figure 5.8: Left: Canyon located approximately 150m upstream of PSCIS crossing 198692. Right: Rainbow trout captured upstream of PSCIS crossing 198692.
