IRF GLOBAL R2T Conference
November 19-22, 2019 – Las Vegas, NV USA

Rail Defect Detection Technology: A Review of the Current Methods and an Acoustic Based Method Proposed for High-Speed-Rail

¹Lei Jia; ¹Ming Zhu, Ph.D.; ²Ryan J. Sherman, Ph.D., P.E.; ¹Jee Woong Park, Ph.D.; ¹Yingtao Jiang, Ph.D.;
¹Hualiang Teng, Ph.D.

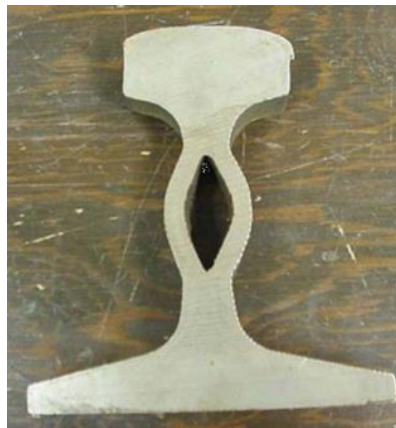
Inappropriate cooling can also cause a longitudinal seam or shrinkage cavity in the middle of the web, which may lead to a defect known as piped rail (Figure 1). Once development begins, the defect will grow vertically towards the two sides of the rail. Axle loading will then cause the defect to develop in a horizontal direction, resulting in a huge cavity inside the web (Office of Railroad Safety, 2015).

Figure 1. Piped rail originated from web split (Office of Railroad Safety, 2015)

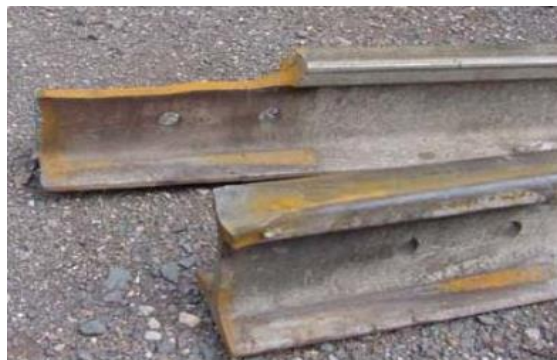
Rail bases at grade crossings are vulnerable to corrosion from asphalt-based acidic filled materials. Most of the corrosion fatigue originates at the web-to-head connection which causes rail separating at the head-to-web joint (Figure 2). Further, improper canting of the rail, gravel in crossings, or excessive speeds on curves can cause accelerated defect development. Similar cracking can also be found in the head fillet area at the jointed rail end, which is usually caused by an extreme stress condition (Office of Railroad Safety, 2015).

Figure 2. Head and web separation moving into the web (Office of Railroad Safety, 2015)

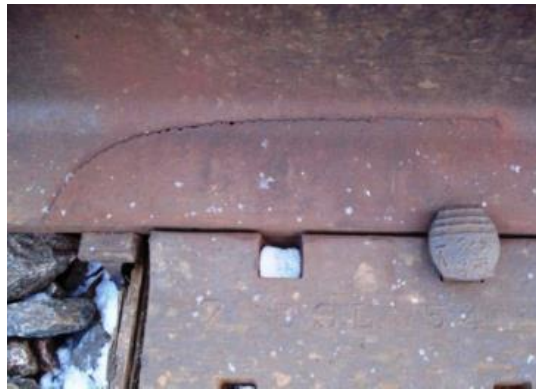
A base break can be generated during rail installation. Base breaks can be divided into two failure types: broken base and base fracture. A broken base commonly generates in the lower flange area, and has a curved shaped, such as “half-moon” break (Figure 3). A base fracture is usually developed from a breach or gap, and cause a perceptible dent. The failure is typically due to a seam, segregation, or improper bearing on the tie plate. Defect development in the transverse direction can be relatively slow before the defect extends into the rail surface. However, sudden rapid failure may still occur with little transverse defect development (Office of Railroad Safety, 2015).

Figure 3. Half-moon-shaped broken base (Office of Railroad Safety, 2015)
