# Monotonic Overload and Embrittlement

Brett A. Miller, IMR Test Labs

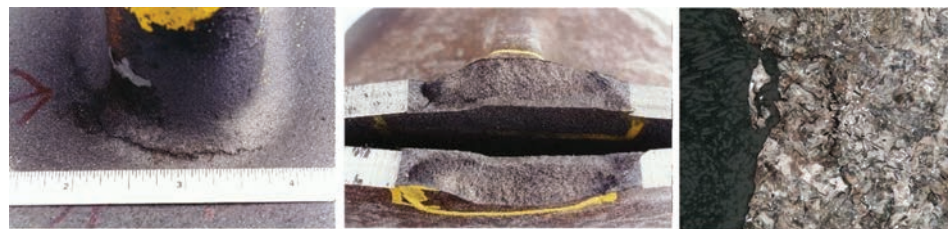
**Fig. 5** Cracking in a truck transmission housing (Example 3). (a) Typical crack at a stiffening rib. (b) An opened crack at a stiffening rib exhibited brittle features. (c) Longitudinal metallographic cross section showing secondary brittle cracking along the graphite flakes. 2% nital etch. Original magnification: 59×

Both halves of a gray cast iron transmission housing from a 50 ton dump truck contained

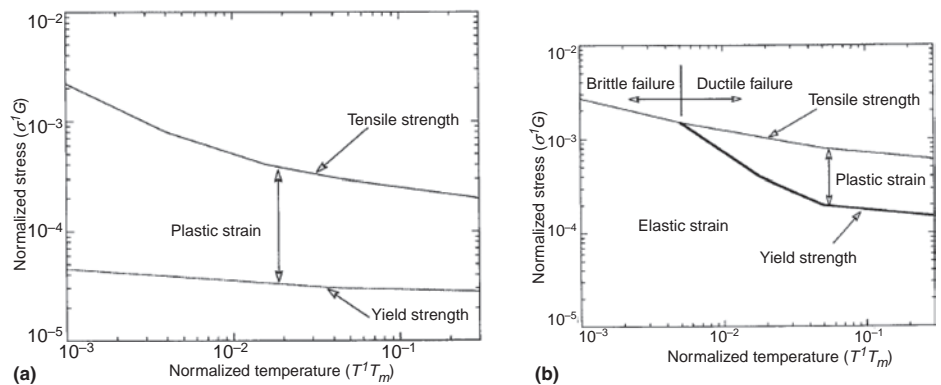
**Fig. 17** Simplified deformation behavior (Ashby) maps of unalloyed annealed metals with (a) face-centered cubic crystal structure and (b) body-centered cubic crystal structure. Engineering alloys may behave somewhat differently than unalloyed metals, but these general trends are relatively consistent (see text). Source: Ref 2

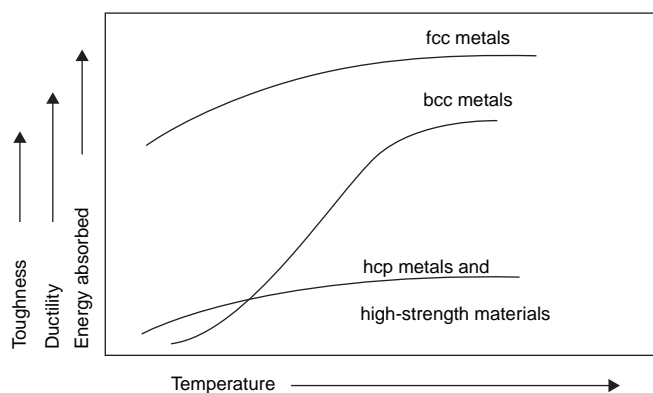
**Fig. 18** Effect of temperature on toughness and ductility of face-centered cubic (fcc), body-centered cubic (bcc), and hexagonal close-packed (hcp) metals

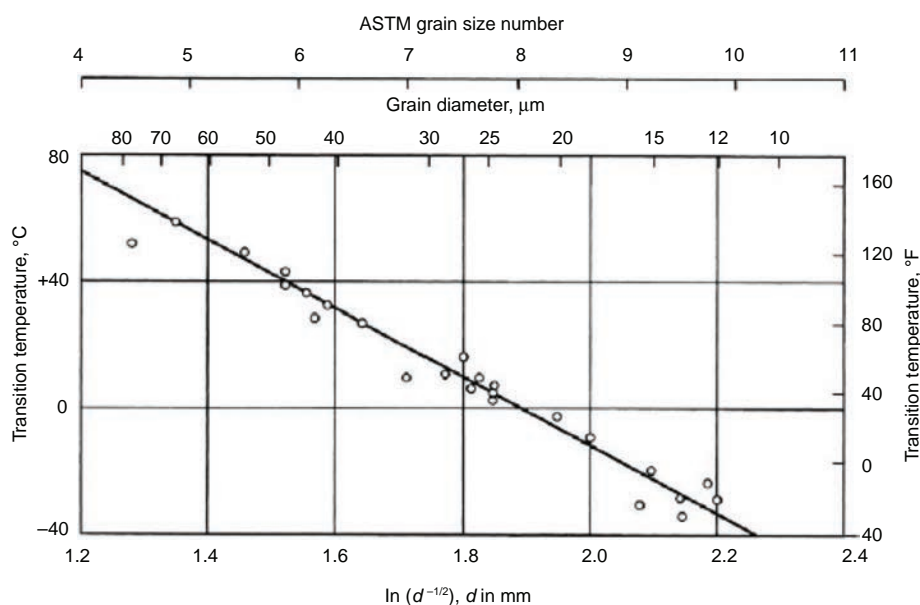
**Fig. 19** Effect of grain size on the ductile-to-brittle transition temperature of 0.11% C mild steel. Source: Ref 3

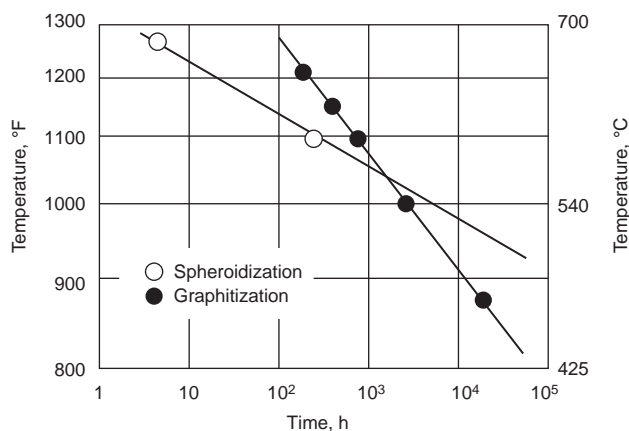
**Fig. 28** Temperature-time plot of pearlite decomposition by spheroidization and graphitization. The curve for spheroidization is for conversion of one-half of the carbon in  $0.15\%$  C steel to spheroidal carbides. The curve for graphitization is for conversion of one-half of the carbon in aluminum-deoxidized  $0.5\%$  Mo cast steel to nodular graphite.

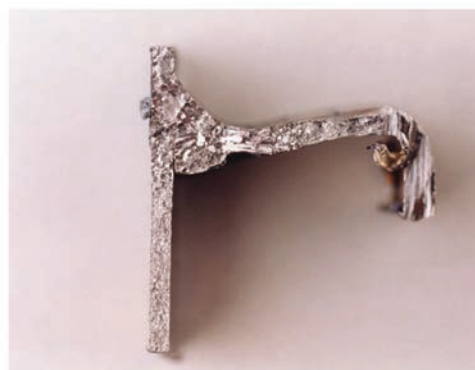
A welded ferritic stainless steel heat exchanger cracked prior to service. The sheet steel weld joint design is depicted in Fig. 38(a). The welding filler metal was identified as an austenitic stainless steel, and the joining method was gas tungsten arc welding.

**Fig. 38** Cracking of a welded ferritic stainless steel heat exchanger (Example 22). (a) Diagram showing the heat-exchanger weld joint design. GTAW, gas tungsten arc weld. (b) Transverse crack that occurred through the weld. Original magnification: 5.9×. (c) Metallographic profile of the weld near the cracking, showing melt-through, grain growth, and precipitation. Original magnification: 8.9×. (d) Grain-boundary precipitates in the weld zone. Original magnification: 119×. (c) and (d) were etched with Vilella's reagent followed by electrolytic etching in 10% oxalic acid.

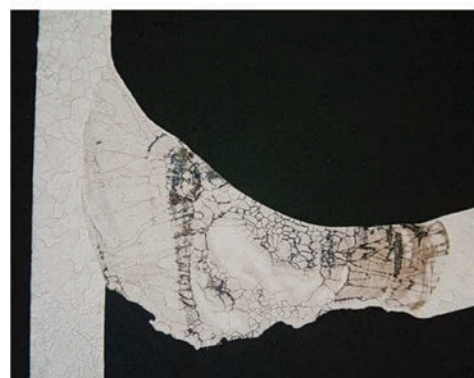
(b)

Relatively high heat input during welding was suggested by the extent of the oxide or heat tint discoloration. The underside of the weld joint contained melt-through. The crack surface after excision is shown in Fig. 38(b). The fracture surface had a faceted appearance, with significantly larger facets within the weld and HAZs. Grain growth is not uncommon in arc welding of ferritic stainless steels.

It was concluded that the heat exchanger cracked due to weld cold cracking or postwelding brittle overload, which occurred via flexure during fabrication. The brittle nature of the weld was likely due to a combination of high residual stresses, a mixed microstructure, inclusions, and gross grain coarsening. These synergistic factors resulted from extreme heat input during fillet welding. It was recommended that the welding variables such as voltage, amperage, and travel speed be altered to substantially reduce the heat input.
