Hydrogen Damage and Embrittlement

Revised by Ockert J. Van Der Schijff, Noah Budiansky, and Ronald M. Latanision, Exponent Inc.

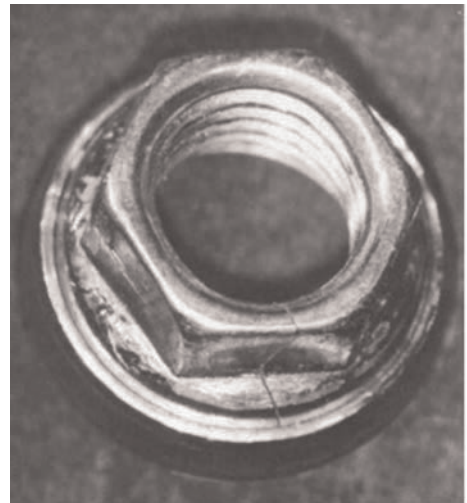
Fig. 1 Cadmium-plated AISI 8740 steel nut that failed by hydrogen embrittlement. Failure occurred seven days after installation on an aircraft wing structure. See also Fig. 2. Original magnification: 5×. Courtesy of Lockheed-Georgia Company

In one hydrogen-damage failure caused by improper baking after electroplating, several cadmium-plated American Iron and Steel Institute (AISI) 8740 steel nuts cracked in seven days after installation on an aircraft wing structure (Fig. 1). Examination of the fracture surface (Fig. 2) showed predominantly intergranular fracture typical of hydrogen embrittlement. The nuts had not been baked for a sufficient time; thus, hydrogen picked up during the plating process was not given sufficient time to diffuse out of the components.

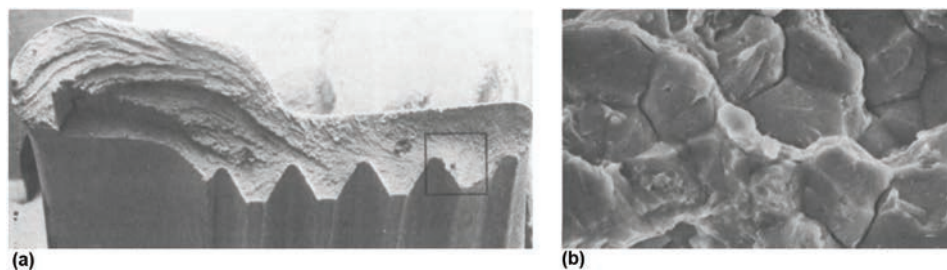
Fig. 2 Fracture surface of failed cadmium-plated nut in Fig. 1. (a) Macrograph of fracture surface. Original magnification: 15 \times . (b) Scanning electron micrograph of the area in the box in (a) showing typical intergranular fracture. Original magnification: 3950 \times . Courtesy of Lockheed-Georgia Company

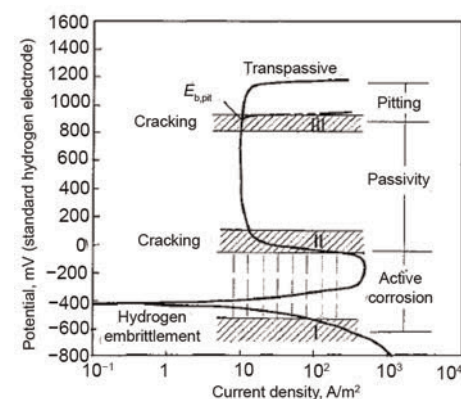
Fig. 3 Potential ranges of environmentally assisted cracking by (I) hydrogen embrittlement, (II) cracking of unstable passive film, and (III) cracking initiated at pits near the pitting potential. Vertical dashed lines define potential range over which nonpassivating films may crack under stress. Source: Ref 9

Regardless of the definition, environmental factors causing the cracking must be properly evaluated, and obviously, in-service conditions may involve more environmental factors than hydrogen charging during manufacturing. Therefore, the electrochemical definition of hydrogen embrittlement (Fig. 3) has more specificity for complex environmental conditions in service.

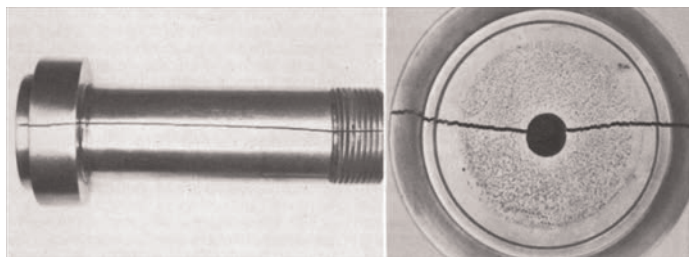
Fig. 4 Two views of a fracture from hydrogen embrittlement of a type 431 stainless steel mushroom-head closure. This is not typical; hydrogen embrittlement cracking on cylinders is usually circumferential.

A hydrogen-assisted crack is usually a single crack that shows no significant branching (Fig. 4). The crack path can be either intergranular or transgranular, and the crack path sometimes changes from one to the other as it propagates. Intergranular fracture becomes more likely at higher strength and with impurities. When transgranular fracture from hydrogen occurs in less ductile (body-centered cubic, or bcc) alloys, the mechanisms may be brittle cleavage or quasi-cleavage. In more ductile low-strength steels or face-centered cubic (fcc) alloys, fracture may be by dimpled microvoid coalescence. Therefore, the results of metallographic and electron fractographic examinations should be carefully interpreted for failure analysis. Examination at low magnification should precede examination at higher magnifications. Examination of the fracture surface at high magnifications (1000× or more) may yield clues on the potential mechanisms of intergranular fracture in the grain boundaries. Often, an originally brittle crack may transition into ductile behavior as the crack propagates. These different zones (i.e., brittle, transition zone with a mix of brittle and ductile features, and finally a completely ductile tearing zone) can be clearly distinguished during fractographic examination.

For example, consider the type 431 stainless steel mushroom-head closure shown in two views in Fig. 4 that fractured in service at a hydrogen pressure of 3×10^8 Pa (3000 atm). Fracture occurred at room temperature after miscellaneous chemical service that included exposures to hydrogen at temperatures from ambient to 350 °C (660 °F). The fracture surface displayed areas of both transgranular cleavage, as shown in the stereo pair of Fig. 5, and intergranular separation, as shown in the stereo pair of Fig. 6, which is characteristic of hydrogen embrittlement of high-stress steels. Debris from the final reaction to which the part was exposed has resulted in artifacts on the transmission electron microscopy replicas, but there appears to be no evidence of grain-boundary corrosion in Fig. 6. This is an important finding, in that it differentiated this intergranular fracture, which was caused by hydrogen embrittlement, from similar ones produced by SCC. Only by meticulous fractographic examination can clues be gained that make it possible to distinguish between these two fracture mechanisms.

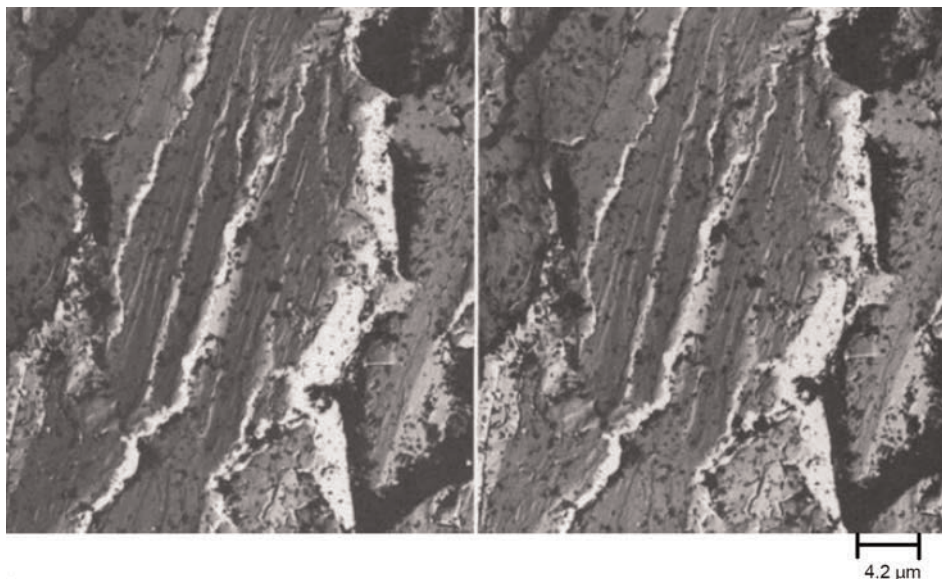
Fig. 5 Transgranular cleavage in an area of the surface of the hydrogen embrittlement fracture of the type 431 stainless steel mushroom-head closure shown in Fig. 4. See also Fig. 6. When viewed in three dimension, this stereo pair shows a massive ridge running from top to bottom at the left, with pronounced cleavage steps on its right-hand slope. The corrosion debris remaining from service and extracted by the replica may be seen projecting from the surface. Transmission electron microscopy; original magnification: 2400×

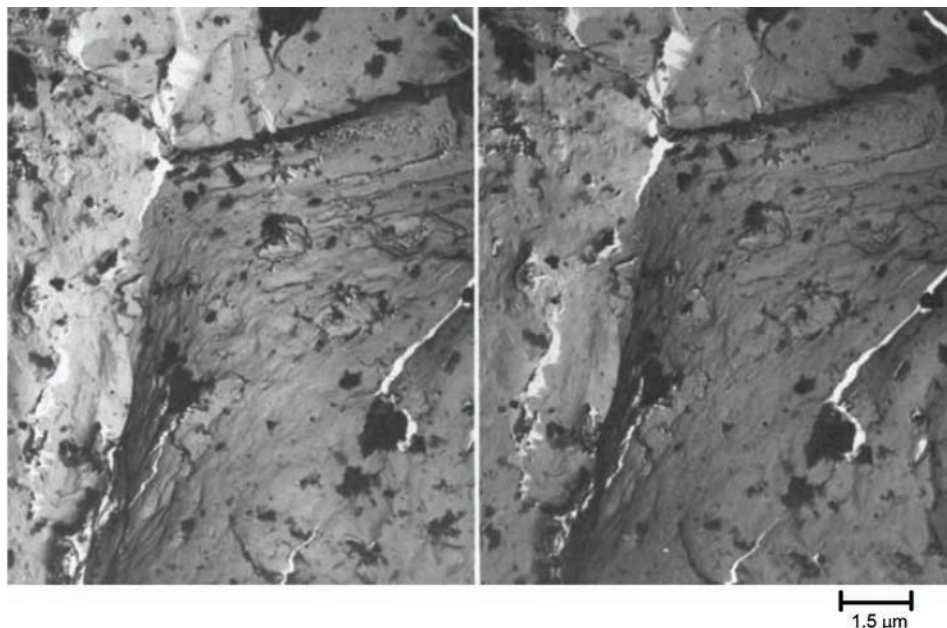
Fig. 6 Intergranular separation in an area of the surface of the hydrogen embrittlement fracture of the type 431 stainless steel mushroom-head closure of Fig. 4 and 5. When viewed in three dimension, the somewhat rounded separated-grain surfaces show cavities akin to dimples in appearance but more probably sites of previous intergranular inclusions. The corrosion debris may be seen projecting from the fracture surfaces. Transmission electron microscopy; original magnification: 6600 \times

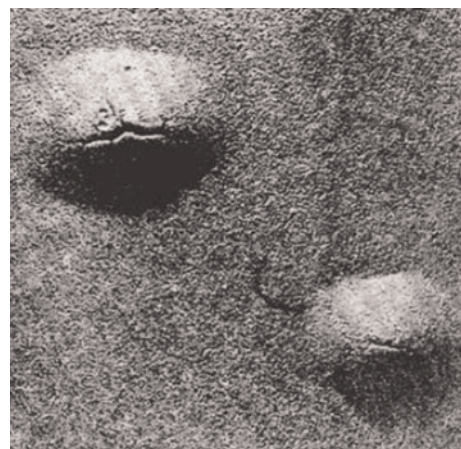
Fig. 7 Hydrogen-induced blistering in a 9.5 mm ($\frac{3}{8}$ in.) thick carbon steel plate (ASTM A285, grade C) that had been in service one year in a refinery vessel. Original magnification: 1.5 \times

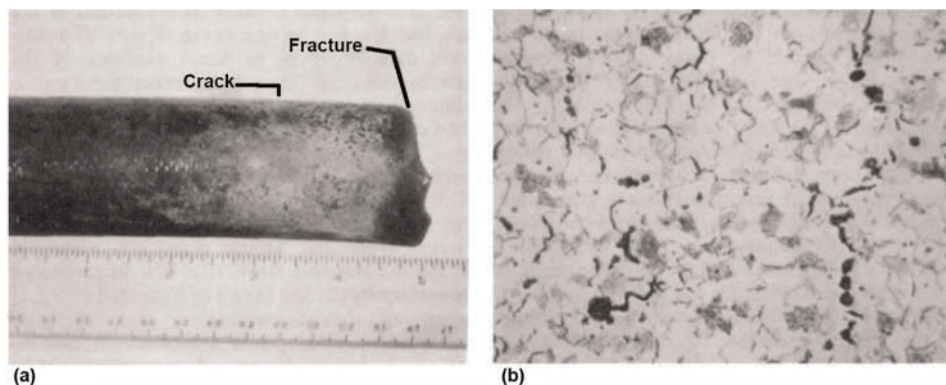
Fig. 9 Section of ASTM A106 carbon steel pipe with wall severely damaged by hydrogen attack. The pipe failed after 15 months of service in hydrogen-rich gas at 34.5 MPa (5000 psig) and 320 °C (610 °F). (a) Overall view of failed pipe section. (b) Microstructure of hydrogen-attacked pipe near the midwall. Hydrogen attack produced grain-boundary fissures that are radially aligned.

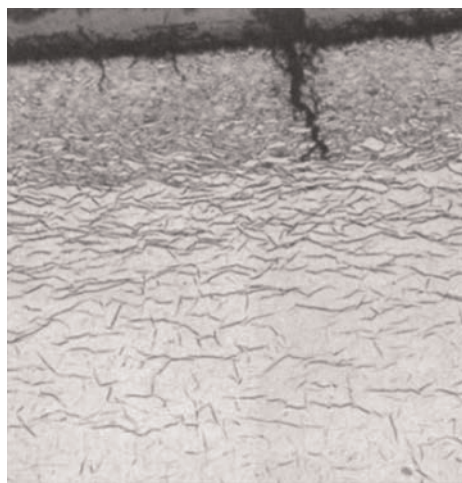
Fig. 10 Severely hydrided unalloyed titanium
