Forms of Corrosion

Michael Cooney and Richard Hoffman, R.A. Hoffmann Engineering, P.C.

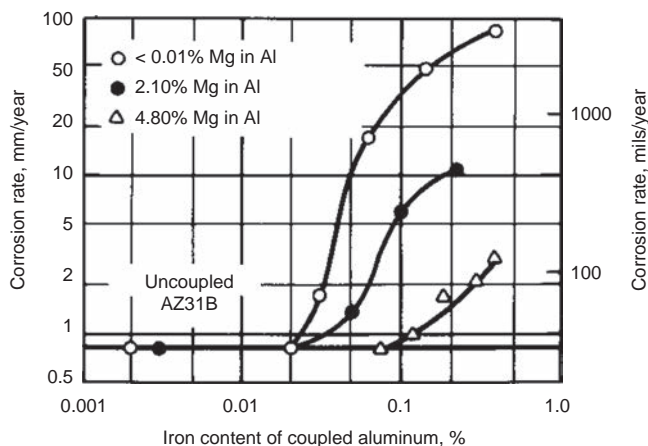
Fig. 7 Corrosion rates in 3% NaCl solution of magnesium alloy AZ31B coupled with aluminum containing varying amounts of iron and magnesium. The corrosion rate of uncoupled AZ31B is shown for comparison.

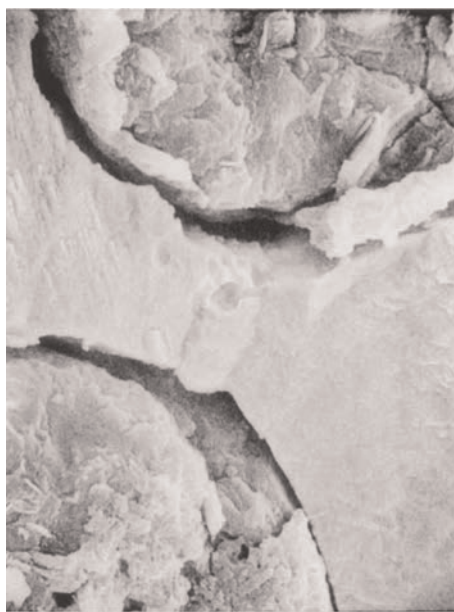
Fig. 8 Scanning electron micrograph of ductile cast iron graphite nodules and ferritic phase after corrosion tests. Note the loss of material at the interface of the nodule. Original magnification: 2000 \times . Source: Ref 11, 12

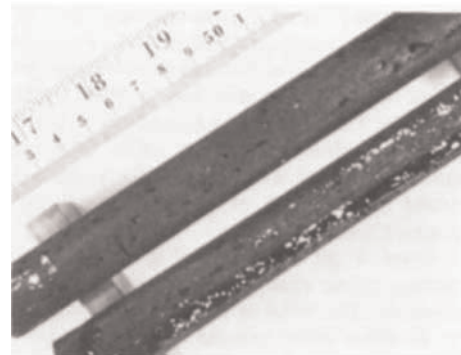
Fig. 9 Uniform corrosion of steel tubes in boiler feedwater containing oxygen (O_2) and a chelating water-treating chemical

The carbon steel tubes shown in Fig. 9 have been severely reduced, revealing a lacelike pattern of total metal loss. These steel tubes are from a boiler feedwater heater feeding a deaerator. As part of the boiler-water treatment

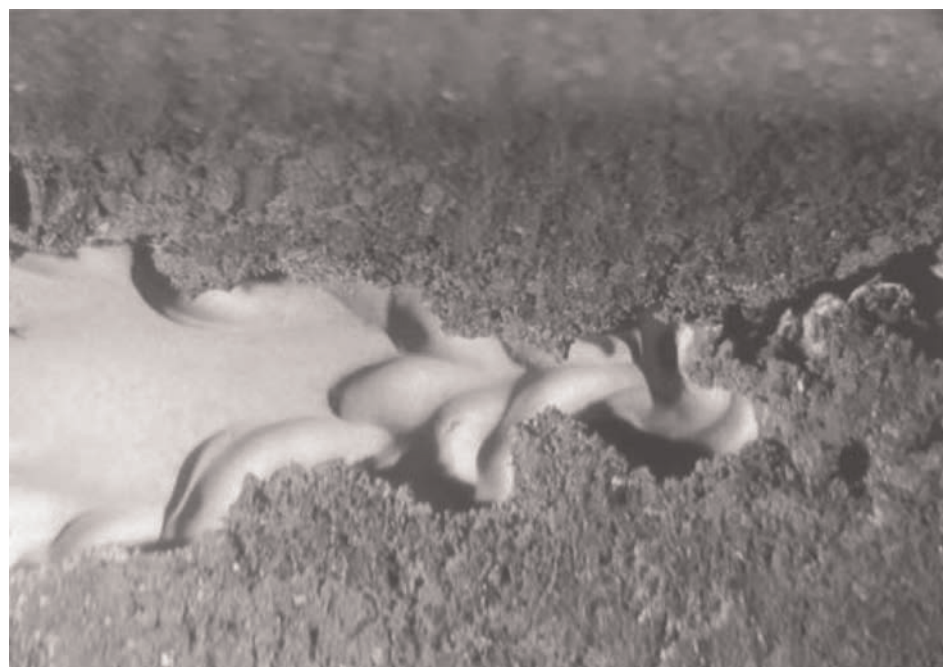
Fig. 12 Micrograph of 19 mm (0.75 in.) copper piping in a closed-loop water system with microbiologically induced corrosion and erosion of the weak oxide layer. Original magnification: 20 \times . Courtesy of MDE Engineers, Inc.

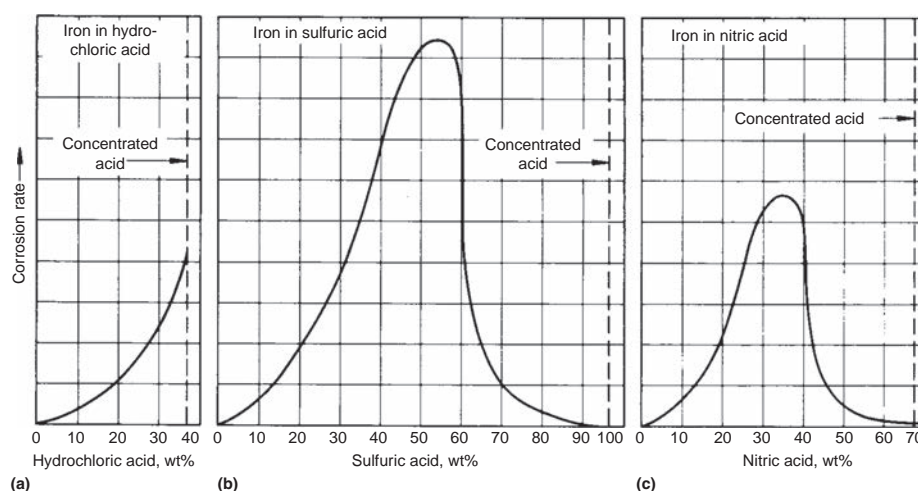
Fig. 13 Effect of acid concentration on the corrosion rate of iron completely immersed in aqueous solutions of three inorganic acids at room temperature. It should be noted that the scales for corrosion rate are not the same for all three charts. As discussed in the text, the corrosion rate of iron (and steel) in nitric acid in concentrations of 70% or higher, although low compared to the maximum rate, is sufficient to make it unsafe to ship or store nitric acid in these metals. Source: Ref 12

The rate of corrosion of a given metal usually increases as the concentration of the corrodent increases, as shown in Fig. 13(a) for the corrosion of iron in hydrochloric acid. However, corrosion rate does not always increase

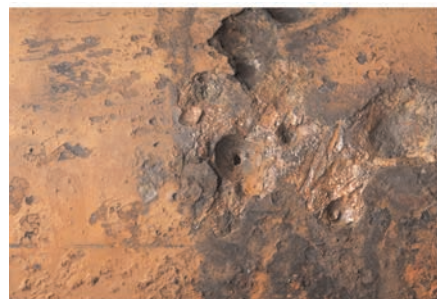
Fig. 19 Oxygen pitting along the outside-diameter surface of boiler tubes from a fire-tube boiler. (a) Through-wall pitting due to oxygen pitting. (b) Oxygen pitting had penetrated approximately 80% of the boiler tube wall thickness on this sample.

product, and the corrosion product was primarily composed of an iron oxide. This was confirmed with energy-dispersive x-ray spectroscopy. The depth of the pitting was greater than 80% of the original wall thickness on the tubes where leakage had not occurred. The through-wall pitting location on the failed boiler tube is shown in Fig. 19.

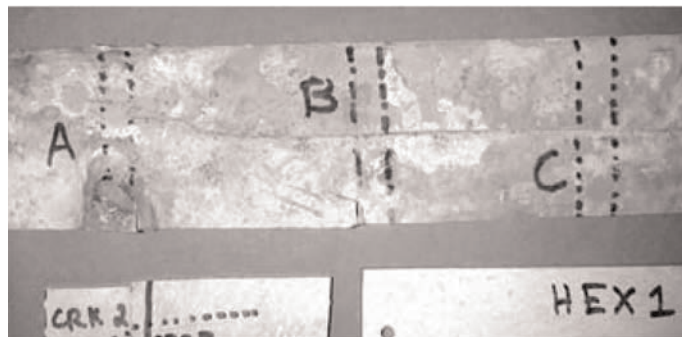
Fig. 27 Cracking in a 5083 aluminum alloy ship hull caused by sensitization. Courtesy of MDE Engineers, Inc.

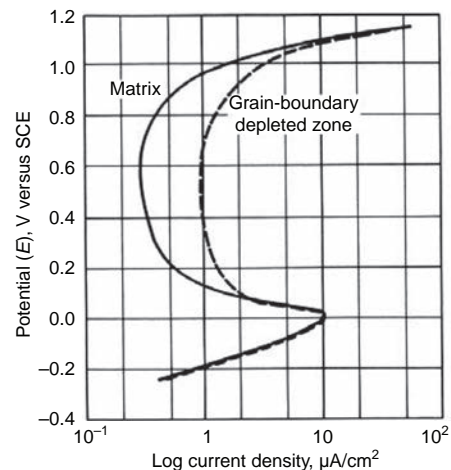
Fig. 30 Anodic polarization behavior of an active-passive alloy with grain-boundary depleted zones. SCE, saturated calomel electrode

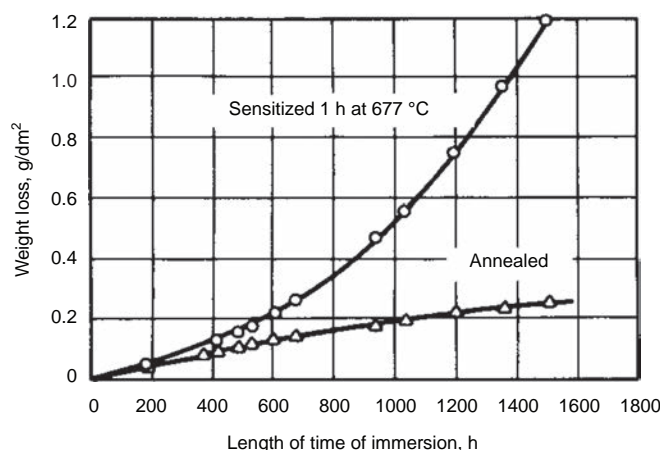
Fig. 31 Corrosion of type 304 steel in inhibited boiling 10% (H_2SO_4). Inhibitor: 0.47 g Fe^{3+} /L of solution added as $\text{Fe}_2(\text{SO}_4)_3$. Source: Ref 30

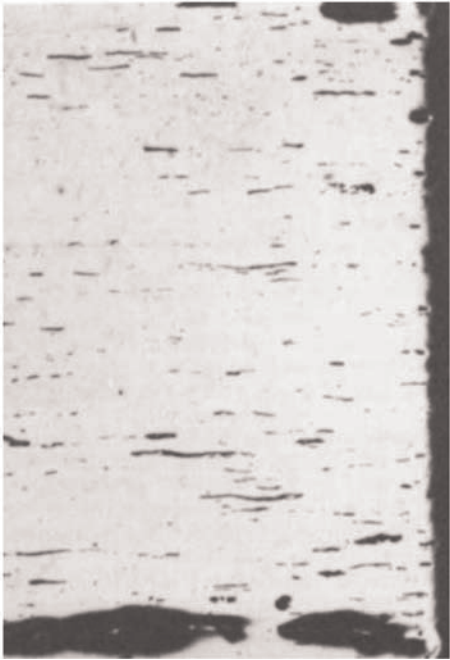
Fig. 33 Unetched section through a type 303 stainless steel valve exposed to an acidic soft drink in a vending machine. Micrograph shows localized corrosion along manganese sulfide stringer inclusions at the end-grain surface. Original magnification: 100×

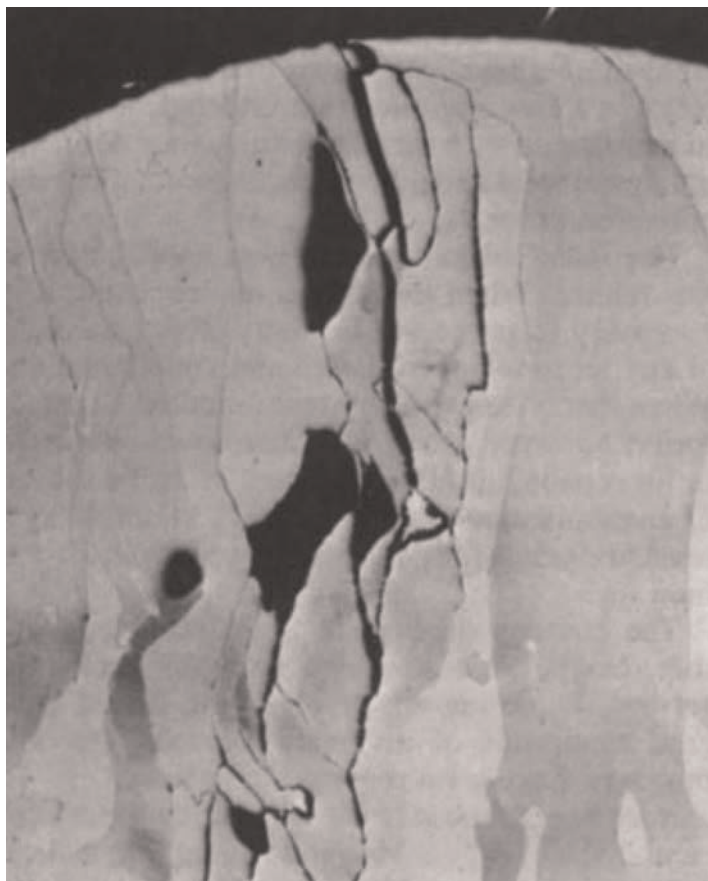
Fig. 35 Intergranular corrosion of a contaminated E-Brite ferritic stainless steel weld. Electrolytically etched with 10% oxalic acid. Original magnification: 200×

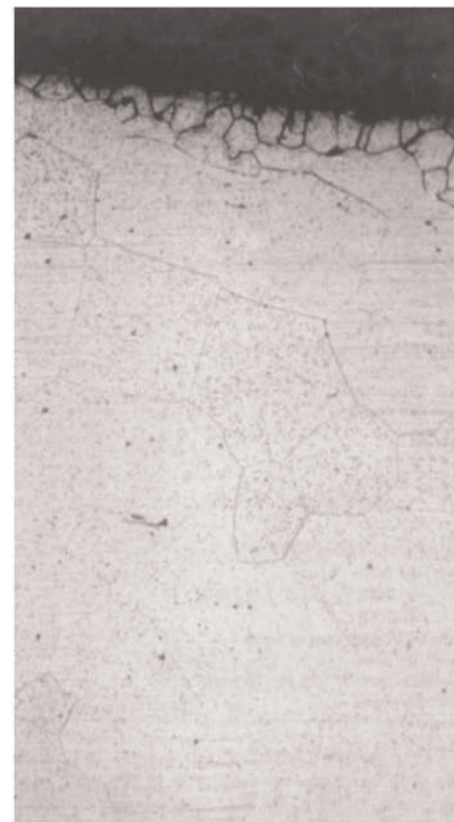
Fig. 36 Intergranular corrosion of the inside surface heat-affected zone of E-Brite stainless steel adjacent to the weld fusion line. Electrolytically etched with 10% oxalic acid. Original magnification: 100×

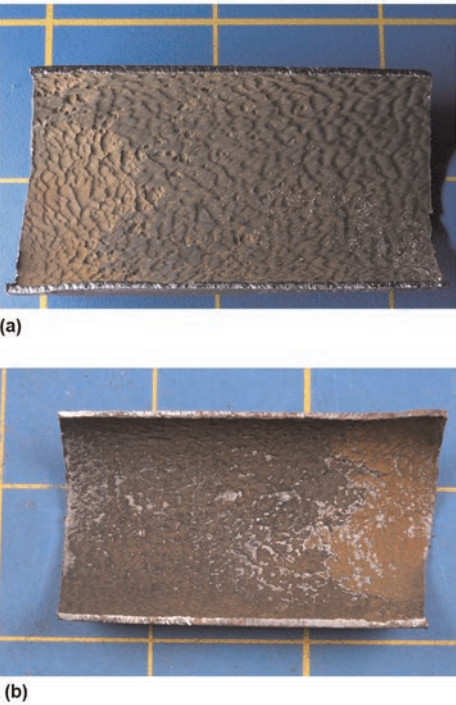
Fig. 52 Carbon steel pipe sections exhibiting surface pattern (scalloped, orange-peel) typically observed on components subject to deterioration due to flow-accelerated corrosion
