Campaign 3

Problems & Resolutions

UF Stan Mayfield Biorefinery Pilot Plant

Prepared by Joe Sagues, Director of Operations

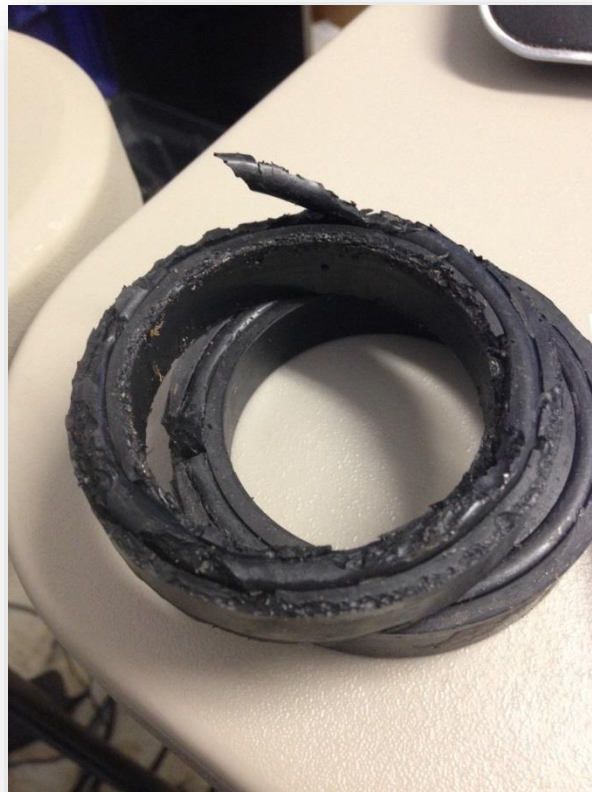
Prior to Campaign 3, the four polypak seals (item 104) to hold back pressure for the blow back dampner had become damaged/deformed. Also, the packing gland plate (item 51) had become warped. The likely cause of this was an accidental over-greasing, and a subsequent accidental improper re-installation of seals after inspection. The seals expand once they are hot and experiencing an applied force, so during operation the chamber pressure spiked and caused damage to seals. This led to a delayed response in the dampner. The delayed response eventually led to a lost plug and system depressurization.

Damaged seals.

New seals and better procedures. The seals were ordered after Campaign 2, but the lead time was long since they are custom.

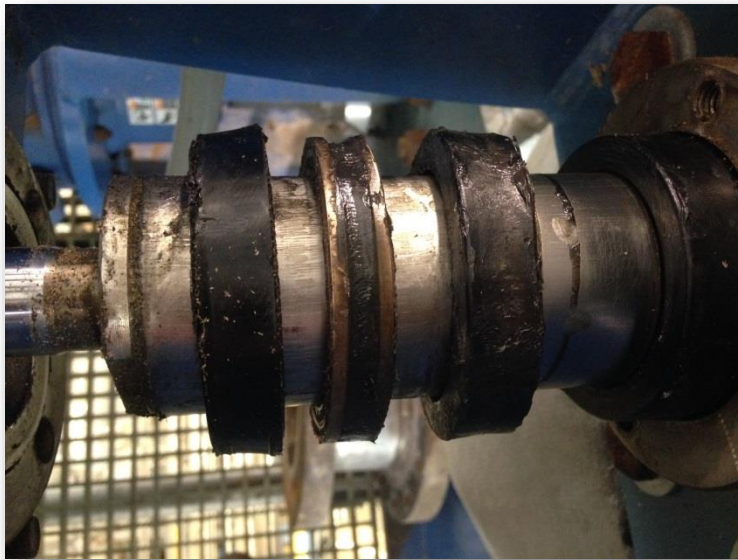
Seal orientation.

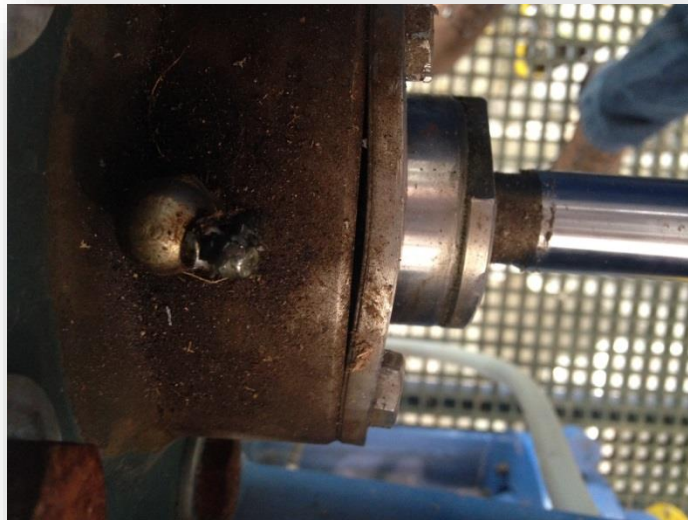
Warped gland plate.
