Campaign 1

Problems & Resolutions

UF Stan Mayfield Biorefinery Pilot Plant

Campaign Date: June 2014

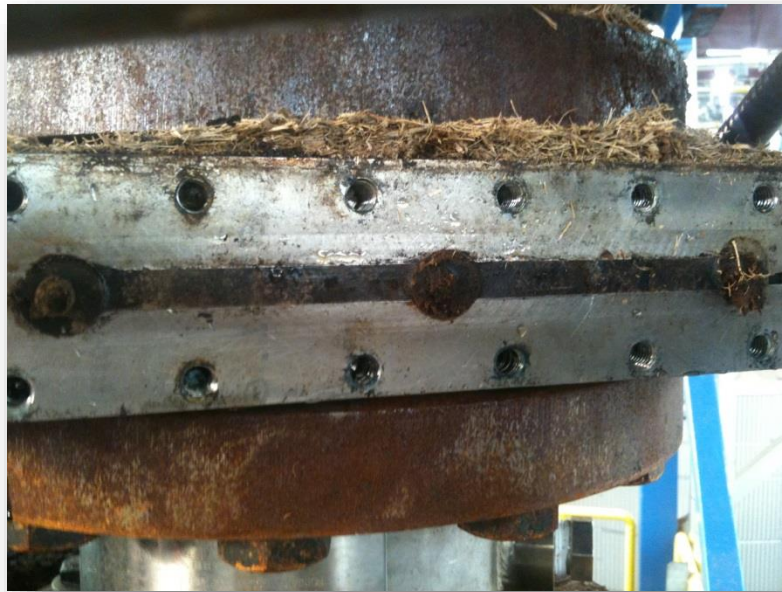
Prior to Campaign 1, the knife gate insertion spaces were frequently clogging with biomass. This led to an incomplete gate closure which allowed for steam leakage.

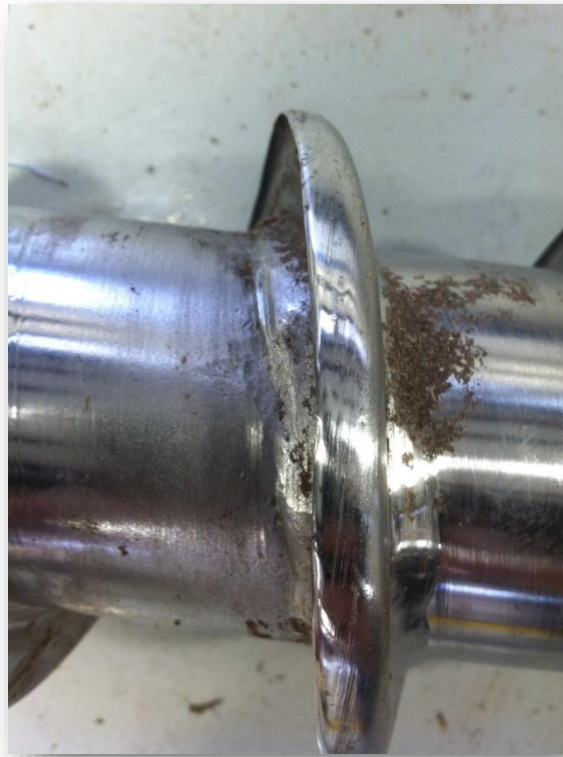
Prior to Campaign 1, the plug screw, which holds back pressure at the inlet of our pretreatment system, wore prematurely. This was due partly to a high blow back dampner pressure setting (60 psi), but more so to the lack of hardening on the screw surface. The evidence of wear came from several random incidents of a lost plug and system depressurization. In the picture below, wear can be seen from the rounded edge on the flight.

Stellite hardening of the plug screw.

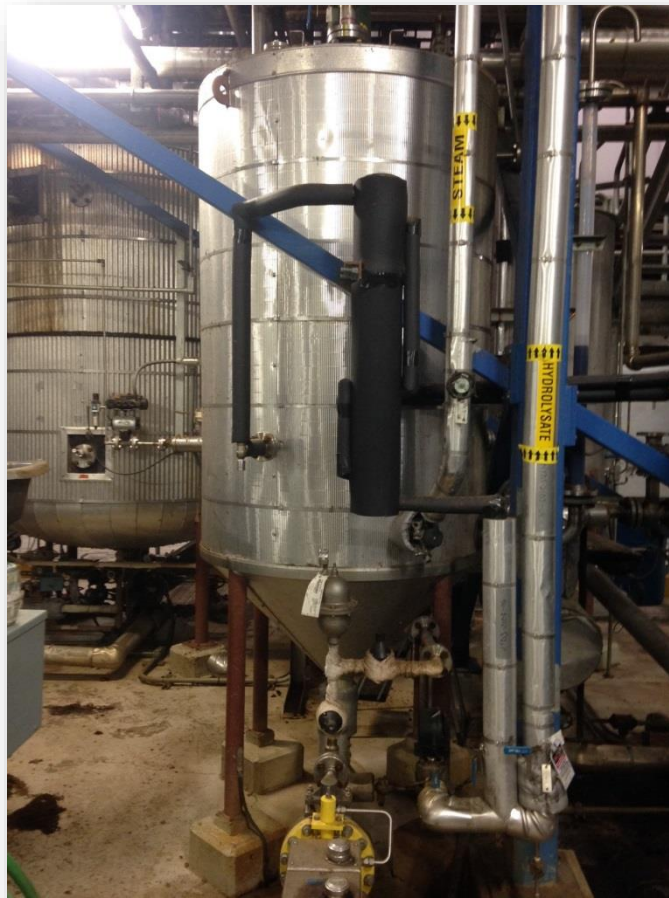
Prior to Campaign 1, the C5 tank which collects hydrolysate from the screw press was maintaining the hydrolysate at a high temp, which allowed for further degradation and increased toxicity.

We took the insulation off the tank and fabricated a shell and tube heat exchanger. The fabrication took some time, so in the meanwhile we kept the hydrolysate cool by diverting it to 300-gallon plastic totes. The heat exchanger was first used in Campaign 3. In the picture below, the heat exchanger is wrapped in black insulation.

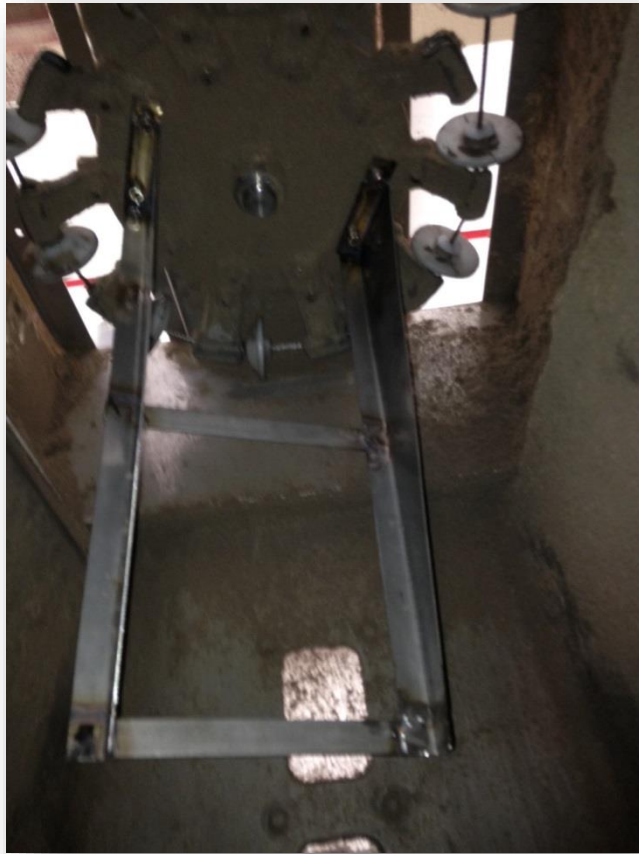
Prior to Campaign 1, we had trouble maintaining a consistent level in the pre-steam bin. The biomass pile within the bin would form a steep slope via the live bottoms, and then at random the top half of the sloped pile would crumble down. This led to inaccurate level readings. Also, if the bin was overfilled, biomass would get in the way of the cablevey discs and cause the cable to hop off track or severely clog the outlet tube which risked snapping the cable.

We found that keeping the level above 50% helped, but level readings would still fluctuate too much. We then designed and fabricated an agitator to help keep the bin at a uniform level.

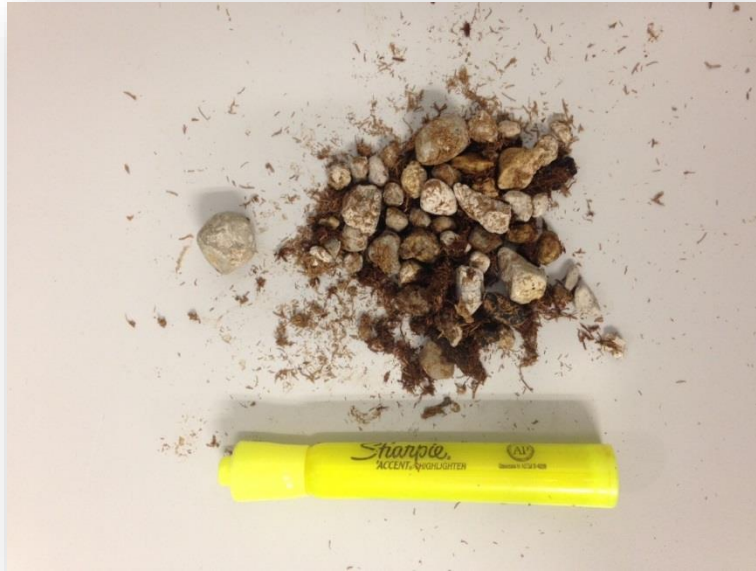
During Campaign 1, we had great difficulty pumping from the bottom of the liquefaction and pH adjustment tank. Loadsure elements within our peristaltic pumps kept rupturing. Most of the trouble arose once the level in the tank started getting low. We eventually drained the remaining contents to the floor, which is when we discovered that rocks were the main reason for clogging.

We decided that pumping from the side of the tank rather than the bottom should help. We planned to incorporate new lines for both tanks which would come from the sample port. We also planned to install a “rock trap” to remove rocks that make their way out the side port. This plan would not be complete until after Campaign 2, before Campaign 3.
