Engineering the Calapooia River for Reduced Streambank Erosion

Presented by Streamlined Designs:

As the final report for BEE 446/546: River Engineering

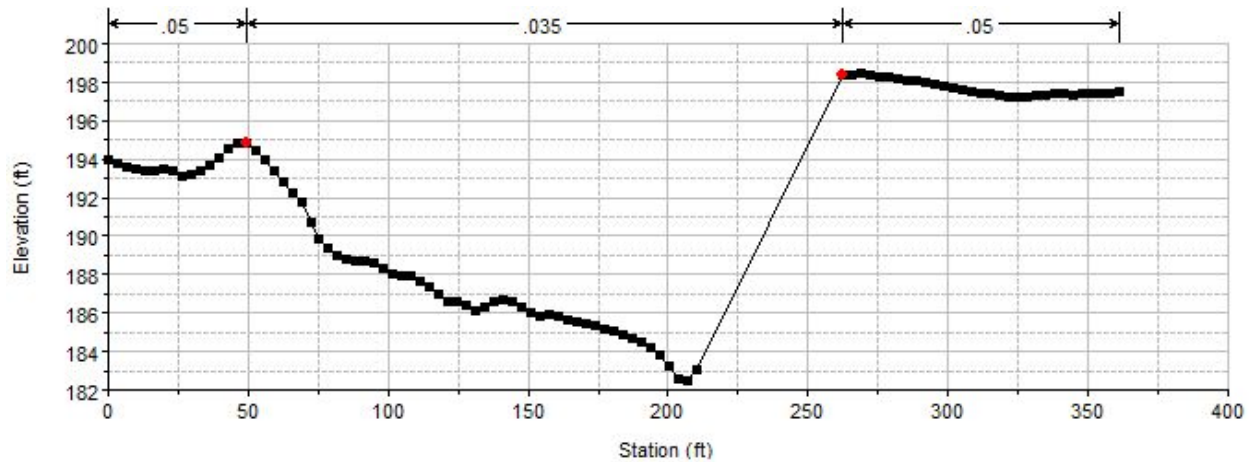
Figure 3 *This cross section, number 3022, depicts a streambank setback as modeled by HEC-RAS.*

Both alternatives, described in detail in “Alternatives Assessment”, included a streambank setback. The streambank setback was modeled in HEC-RAS by laying the slope back at a 3:1 horizontal to vertical ratio, using the toe slope (the deepest point in the channel nearest to the site of erosion) as the start of the setback (Figure 3). This modification was implemented where erosion was deemed the greatest, as determined by the field site visit between the stations 2322 and 3228.

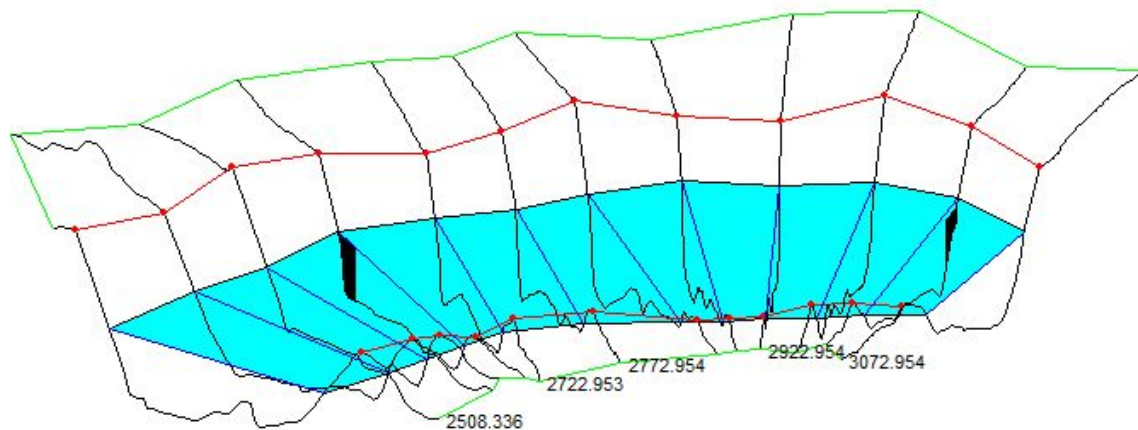
Figure 4 *Cross sections 3022 and 2673 with ELJs included. Obstructions, shown in black, were used in HEC-RAS to represent each engineered log jam.*

The second alternative, which included engineered log jams, was modeled by maintaining the streambank setback as detailed above, and adding obstructed areas at two cross sections, 3022 and 2673 (Figure 4). Section 3022 represents the beginning of the erosion along the bank, and section 2673 lies approximately 350 ft downstream. This spacing was calculated using the recommended length of 3-5 channel widths (Tullos 2017). ELJs extended from the water surface elevation at the calibrated flow and to the base of the hydraulic toe, in order to maximize habitat benefits and energy dispersion, even at base flow.

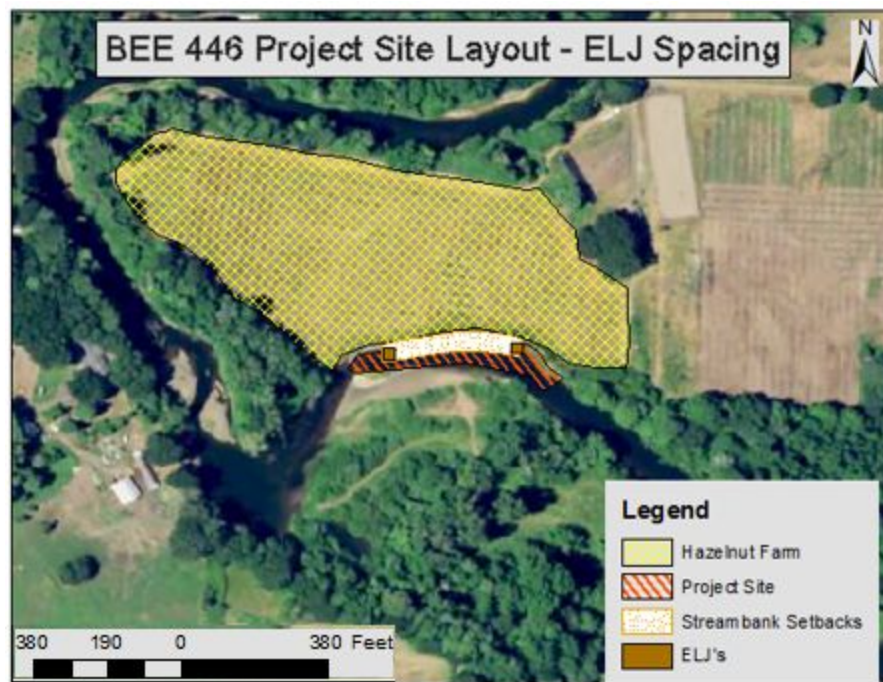
Figure 5 *Site layout of Alternative #2, including ELJ locations and streambank setback.*

Streamlined Designs recommends the installation of two or more engineered log jams in conjunction with a streambank setback (Alternative #2) to maximize social and environmental sustainability, fish habitat, and project longevity. If intervention is deemed appropriate based on social and financial considerations, Alternative #2 provides the best solution for preventing further erosion of the hazelnut farmer's land. Figure 5 shows the recommended site layout.
