UC Berkeley Space Technologies and Rocketry
Post Launch Assessment Review
Project U.R.S.A.¹

April 24, 2017

¹Upright Recovery and Sight Acquisition

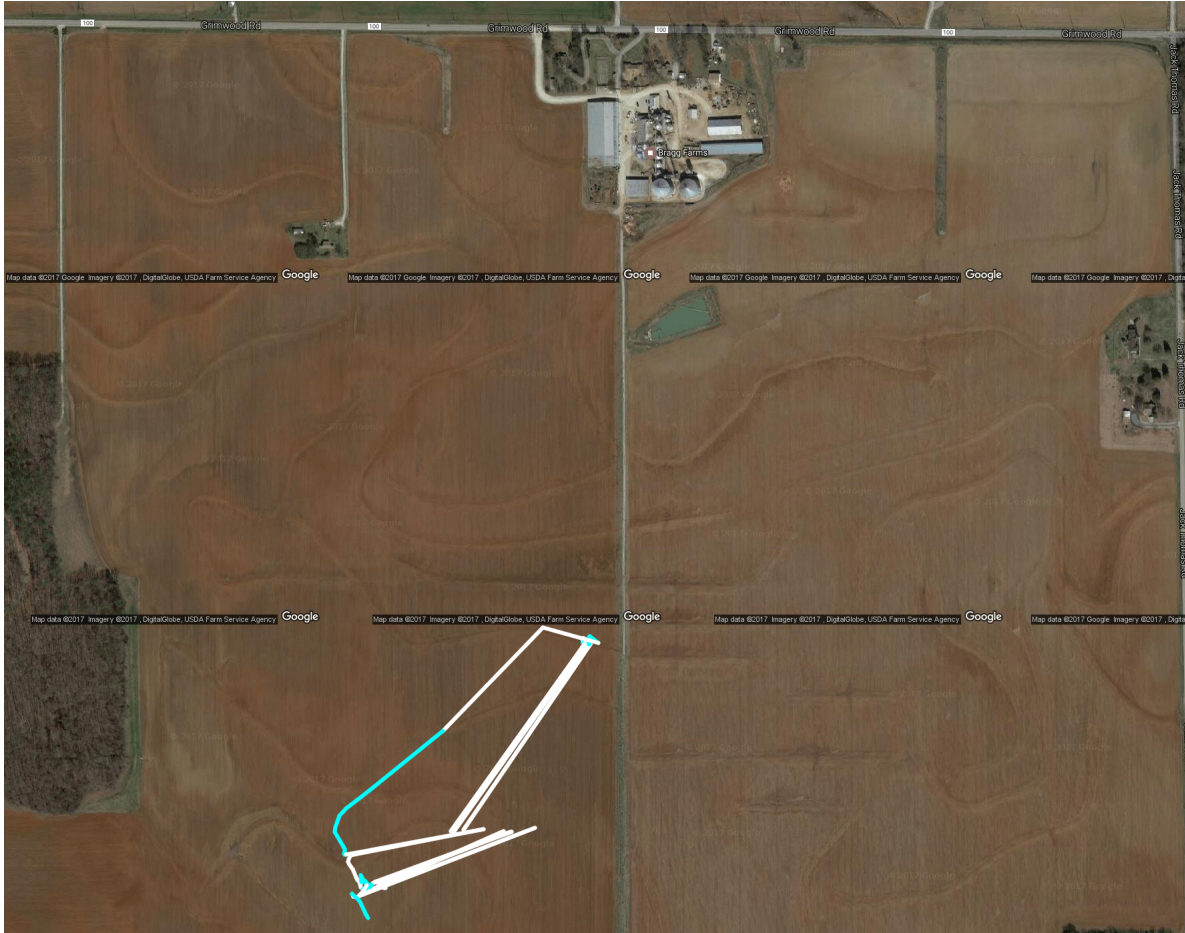
We present below the tracking data from the payload GPS. Note: we were not using the altitude data from the GPS for any purpose.

GPS data do not indicate any in-flight anomalies. The tracking was accurate for the wind drift encountered on launch day. The altitude as recorded by our official scoring flight altimeter was 4530 feet. The resulting altitude was lower than calculated in our models, which can probably be attributed to wind, the launch angle required by the launch provider and launch safety at the range, and an excess of weight due to unforeseen manufacturing discrepancies between the computer model and Ursa Major.

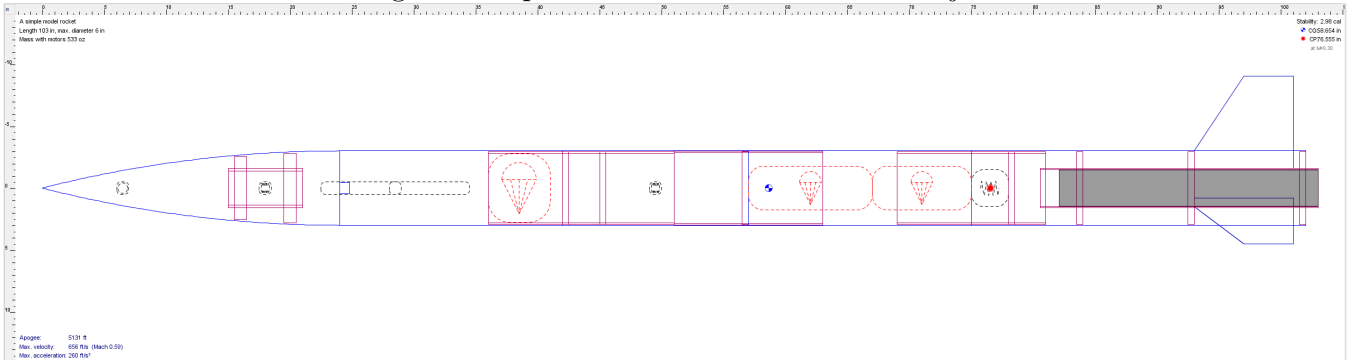
Figure 1: OpenRocket Model of URSA Major

The vehicle airframe was 103 inches long, 6 inches in diameter, and weighed 33 pounds with the motor, an Aerotech L1150. Without the motor, the airframe weighed approximately 25 pounds. The CG was 58.7 inches from the nosecone, and the CP was 76.6 inches from the nosecone, giving the rocket a stability of 2.98 calibers.
