5 MASONRY WALL - REINF.DETAILS
S200

12 CONCRETE WALL ON FOOTING
S200

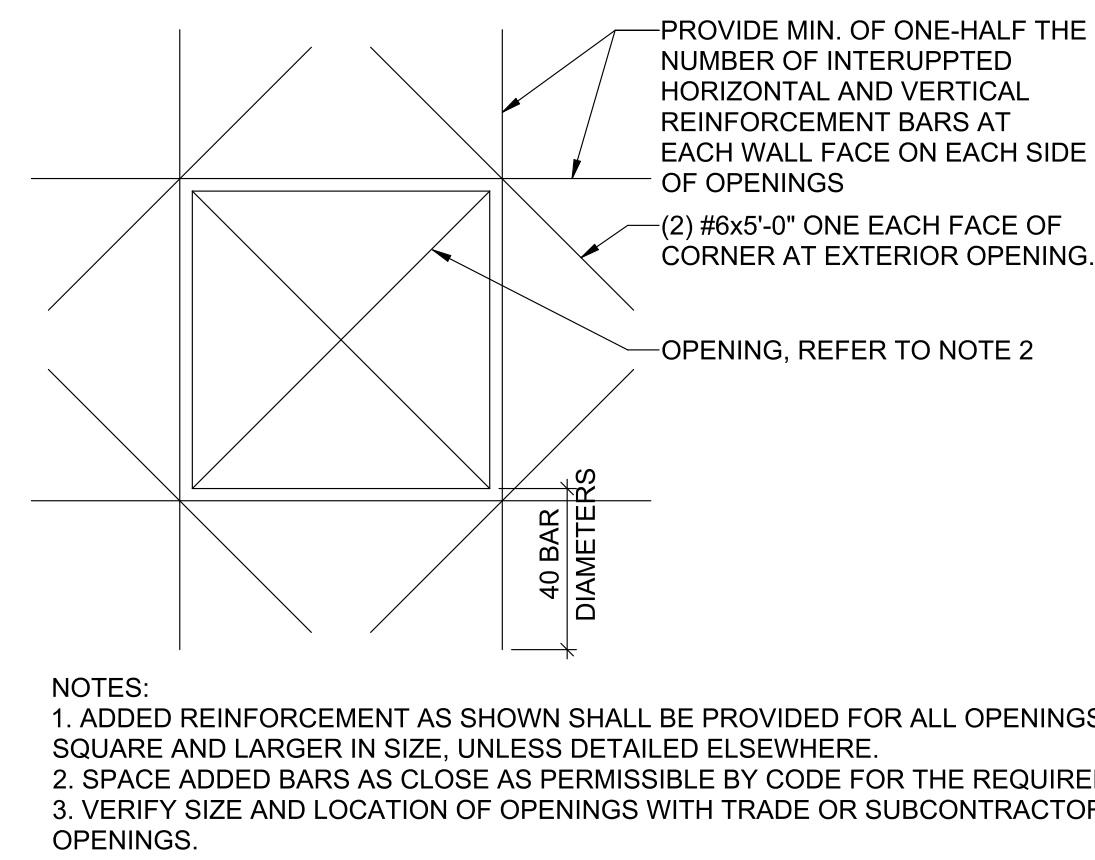
9 REINFORCEMENT AROUND CONCRETE WALL OPENING
\$200

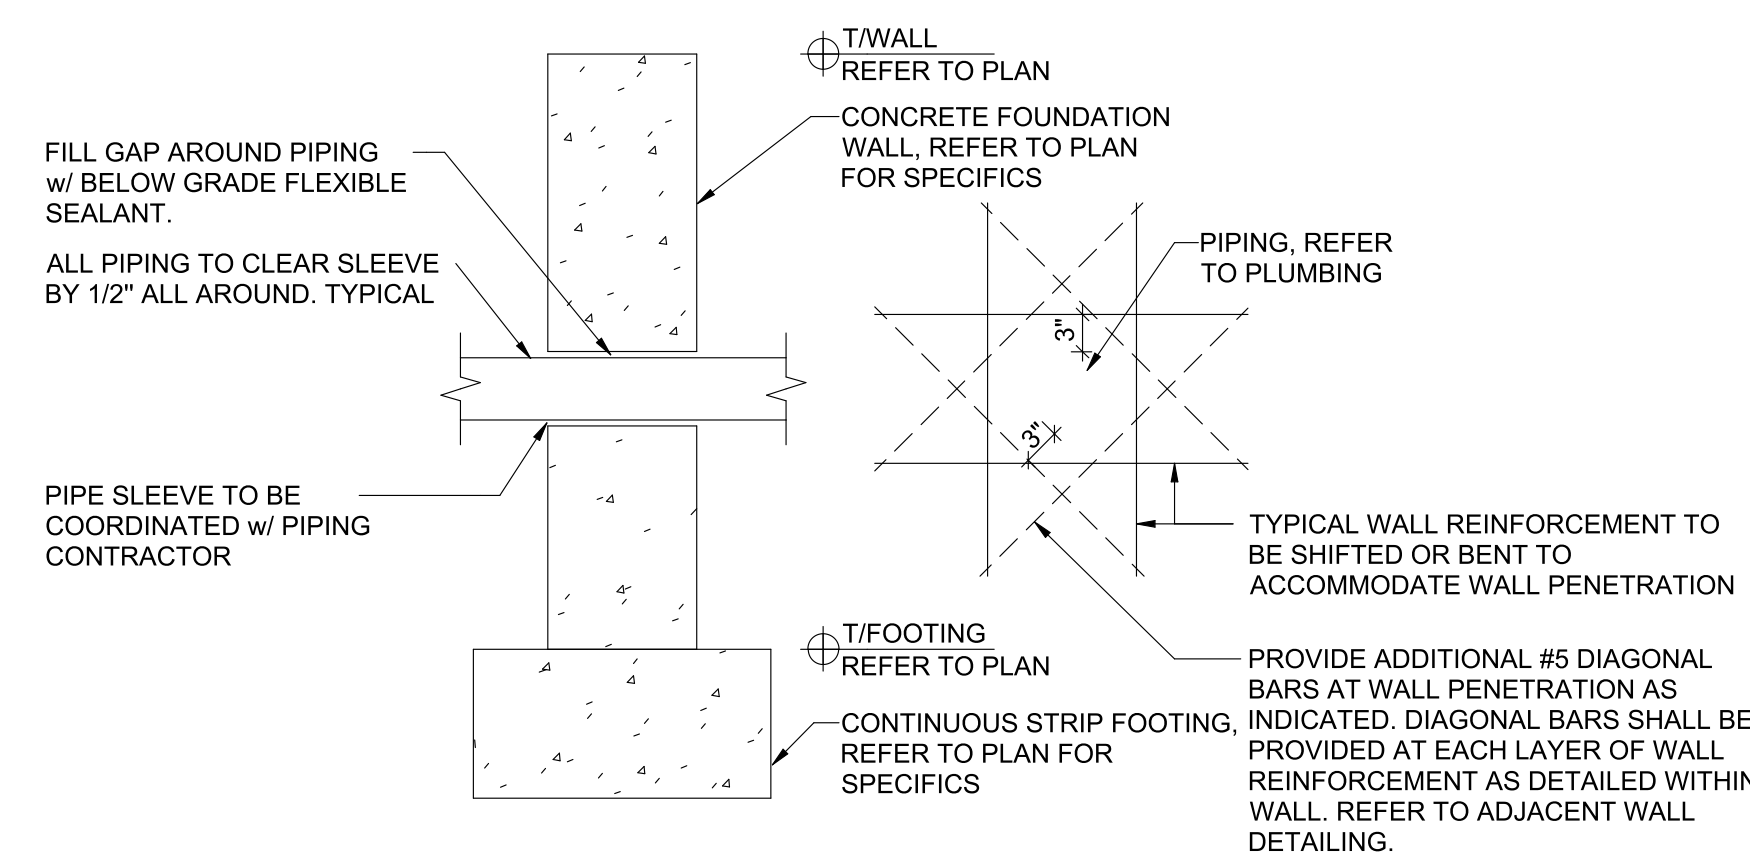
11 PIPE PENETRATION AT FOUNDATION WALL
S200

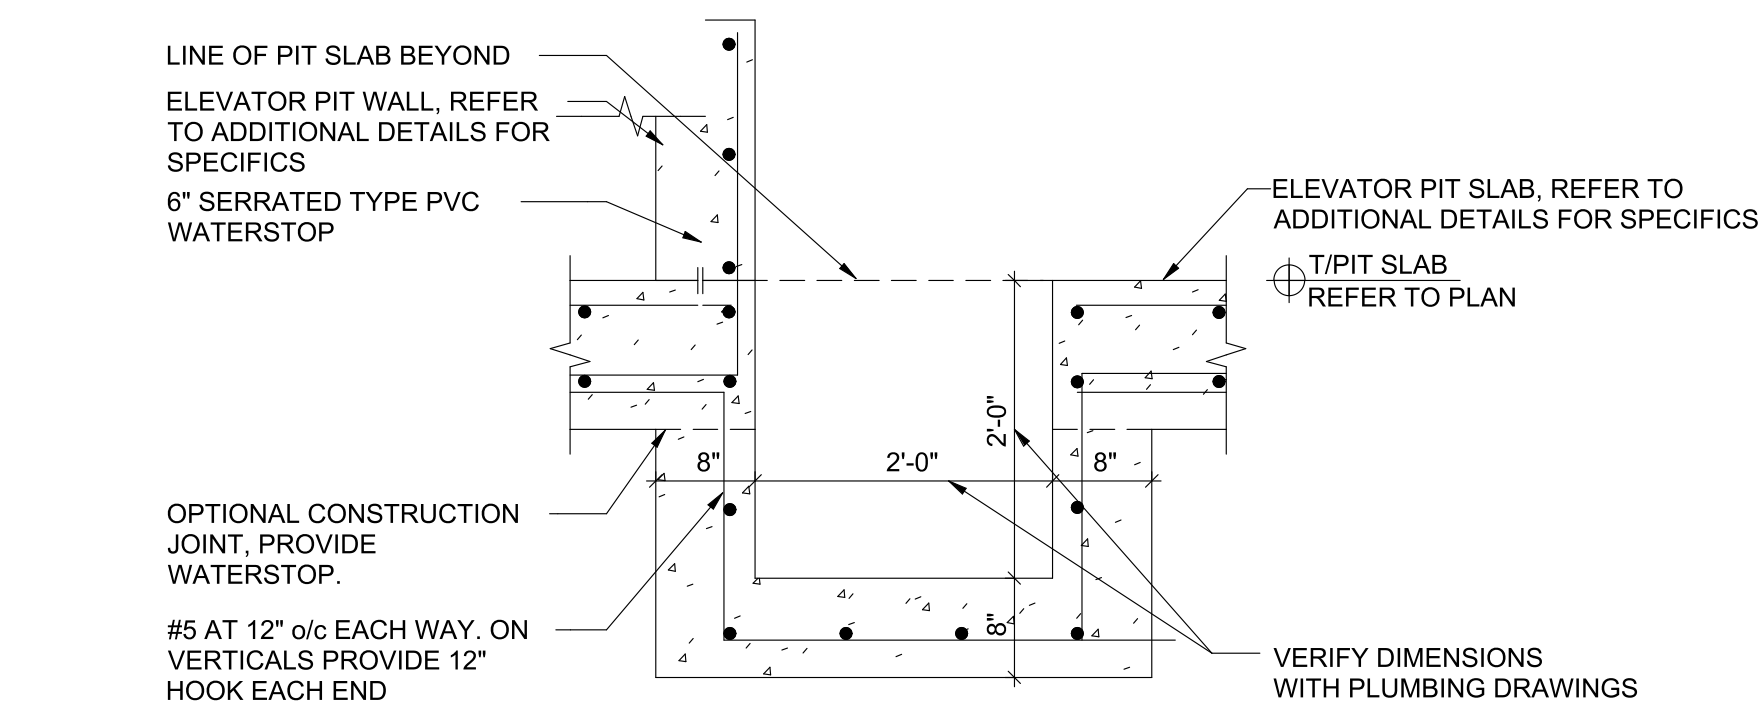
8 ELEVATOR PIT SUMP CROCK
S200

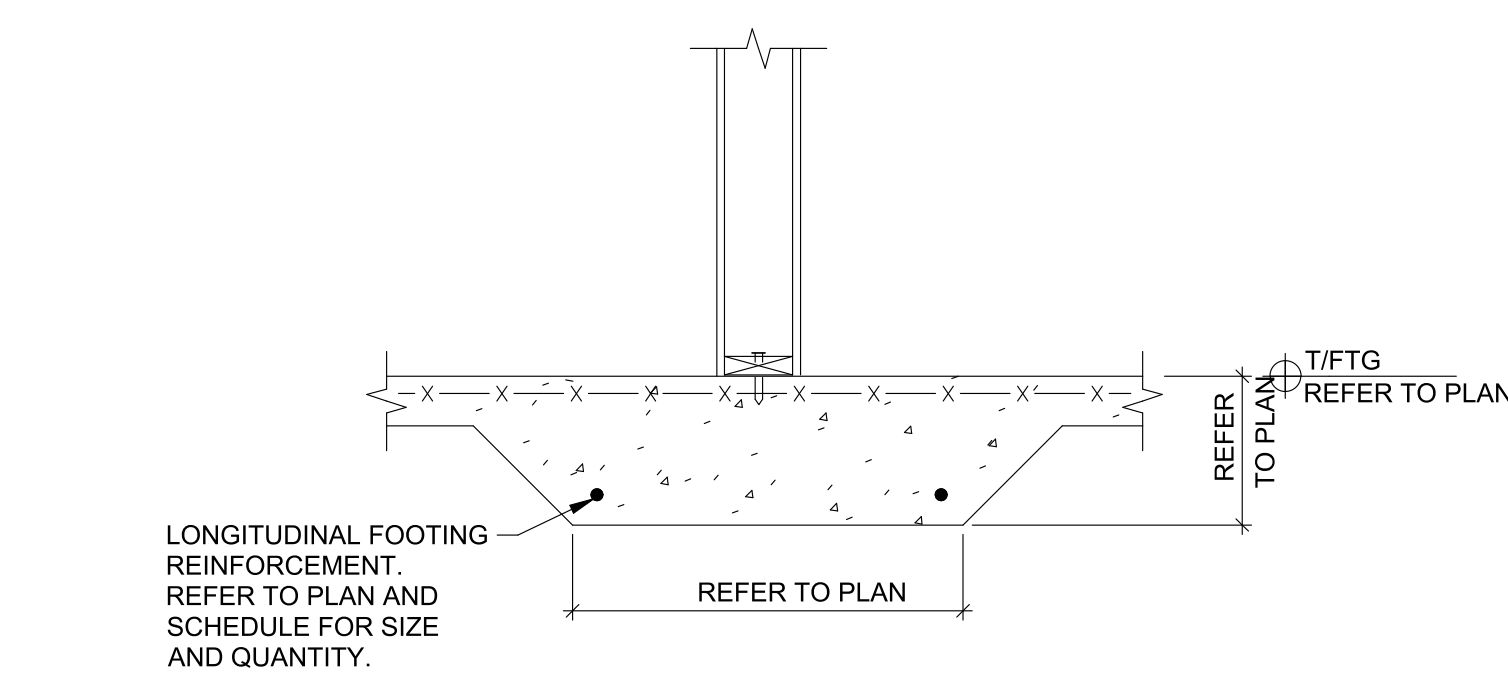
10 INTERIOR STUD WALL ON THICKENED SLAB
S200

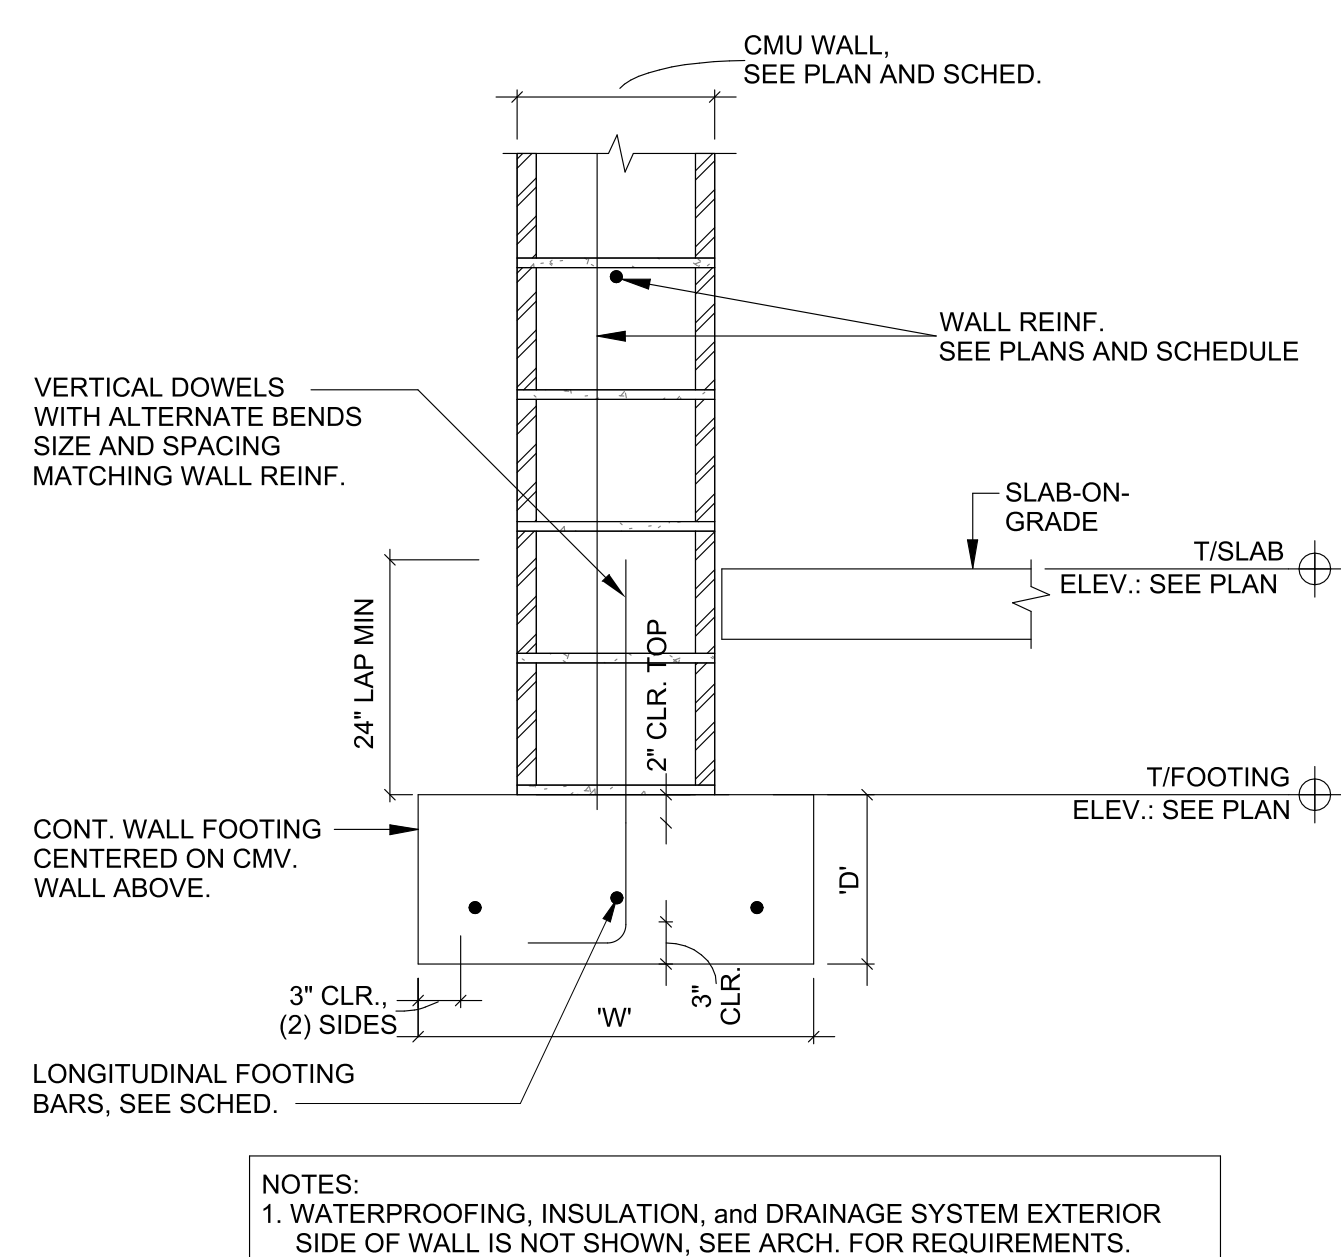
13 CMU WALL ON FOOTING
S200
