**ASTM C 1363-2011 THERMAL PERFORMANCE
TEST REPORT**

SERIES/MODEL: ArcoPlus 547 - Opal

TYPE: Multi-Cell Panel

Report Number: C1826.01-301-46

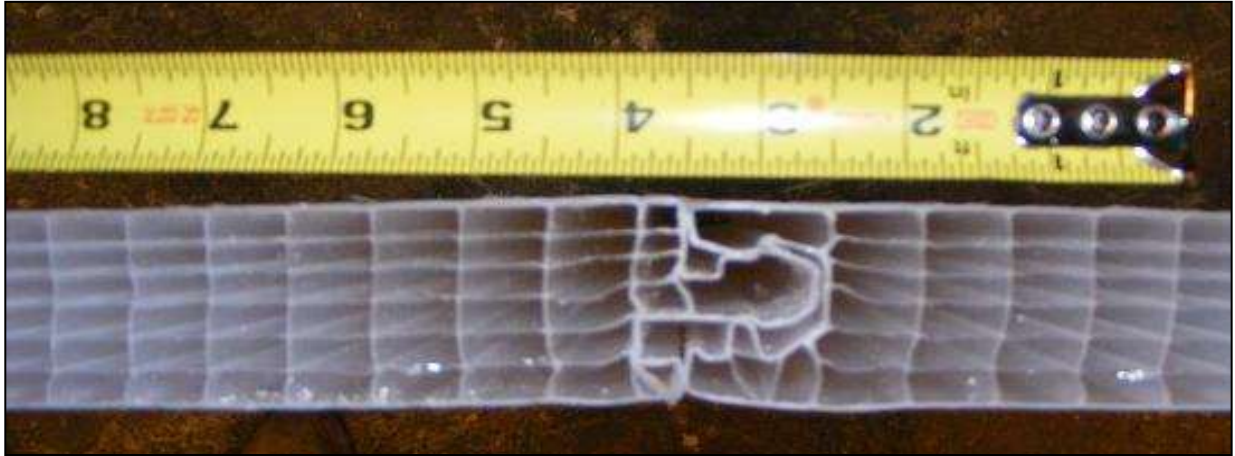
Appendix A: Photographs

The unit consisted of three vertically-oriented multi-cellular extruded panels, snap fit together.

**See Appendix A for Cross-Sectional Picture*
