# Changes in salinity of a clay soil after a short-term salt water flood event

Matthew Taylor \*, Niklas Krüger

Waikato Regional Council, Hamilton, New Zealand

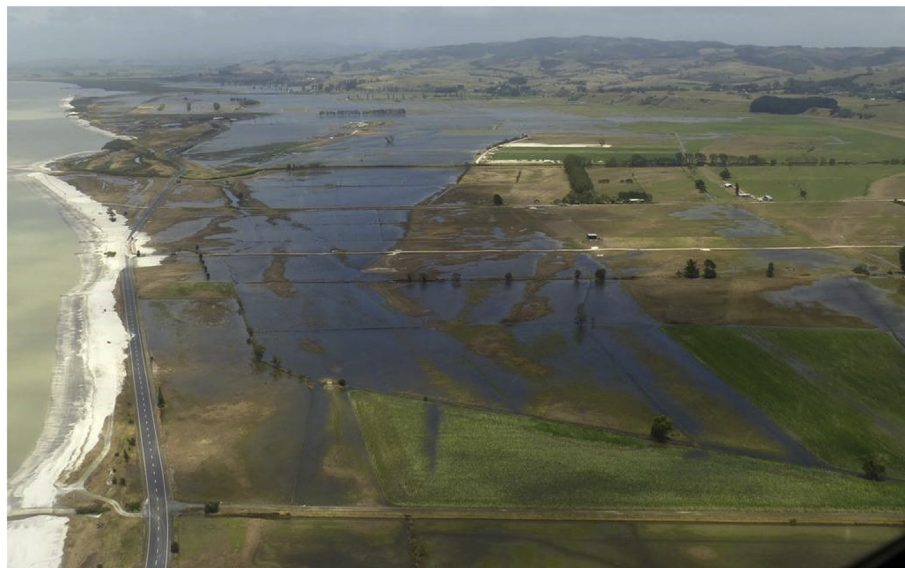
**Fig. 3.** One day after inundation along the Kaiaua/Miranda coast. Overtopping of the coast road is shown by a deposit of white sand in the left middle ground. Relic sand dunes by the road are elevated in the landscape and have already drained.

The pasture at these sites was perennial ryegrass (*Lolium perenne*), which was intensively grazed for dairy production. About 5% of the farmland was maize instead of pasture (Fig. 3) but only sites under pasture were sampled.

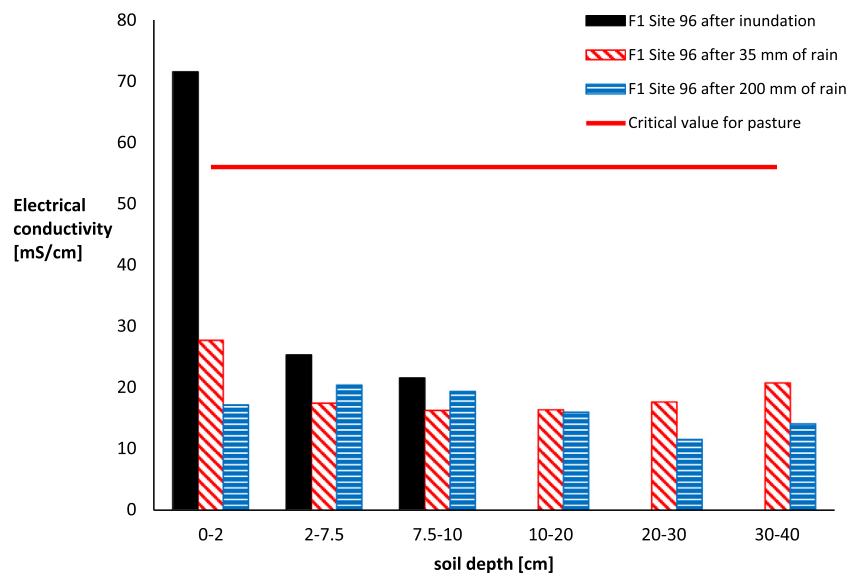
**Fig. 8.** Soil salt content indicated by electrical conductivity (ECe) for seven different soil depths for site F1 96 after inundation (0–2, 2–7.5 and 7.5–10 cm soil depths) and after two rainfall events (0–2, 2–7.5, 7.5–10, 10–20, 20–30 and 30–40 cm soil depths).

Electrical conductivity and SAR in the top 2 cm of soil at inundated sites were considerably lower after 35 mm of rainfall and decreased only slightly more after another 165 mm, a cumulative 200 mm of rain. However, electrical conductivity and SAR did not decrease to the levels present before inundation (Table 1) and remained more than an order of magnitude higher than at the control sites. The salt content at depths deeper than 2 cm decreased only very slightly after rain with minimal difference in salt content below 7.5 cm. Electrical conductivity and SAR in soils at control sites did not change with rainfall. As trends are similar for other inundated sites, only the results for site 96 h are presented in Figs. 8 & 9.

Nevertheless, SAR and electrical conductivity in the soil profiles did not return to pre-flood or control values even after 200 mm rain (Figs. 8 & 9). The electrical conductivity after rain was still  $20 \text{ mS cm}^{-1}$ , which may affect the germination of salt sensitive plants, such as maize. The remaining SAR levels may be further reduced by amendment with gypsum to provide Ca ions to exchange with the Na ions on the soil exchange sites. Released  $\text{Na}^+$  would then be available to leach in soil drainage water. Lime would also supply calcium ions but is not
