" RECONSTRUCTION OF THE 3D CRACK PROFILE IN WOOD BASED STRUCTURES BY X-RAY COMPUTED MICROTOMOGRAPHY"

Résumé :

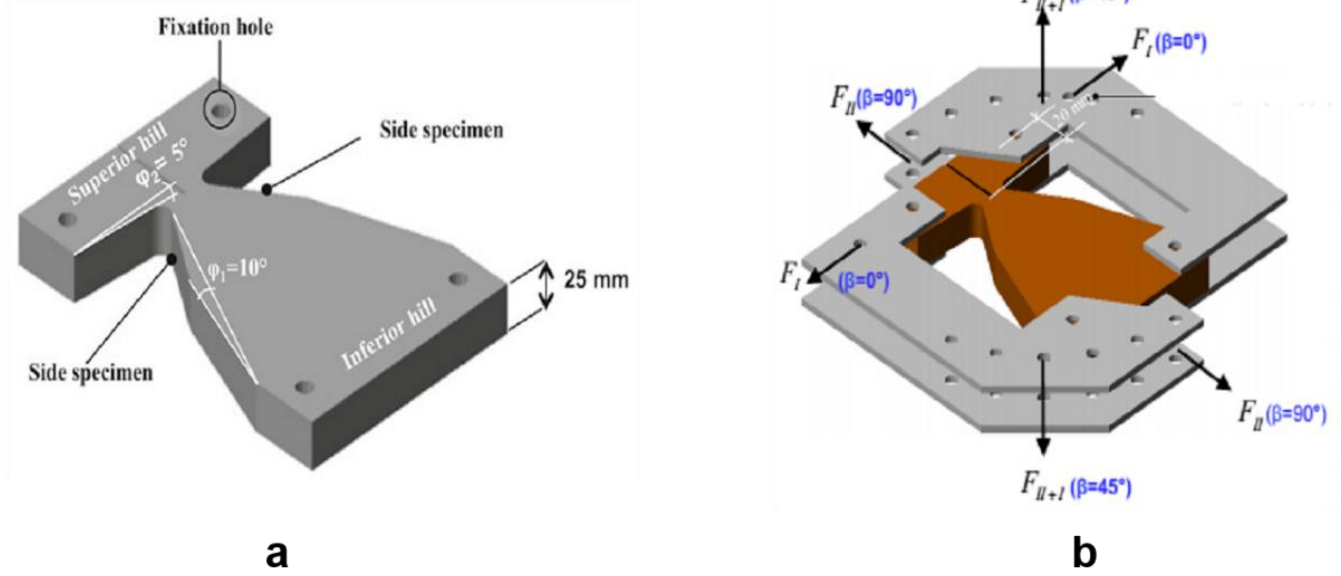
Figure 1. MMCG Padouk wood sample (a), Experimental ARCAN setup (b).

This section presents the experimental setup considered in this study. The tests were carried out on a tropical specie known as Padouk. Figure.1 (a) shows the dimensions of wood specimen, with an overall size 210 x 140 x 25 mm³. The side of the specimen has inclinations with angles of 5° and 10° from the edge and the inferior hill, respectively, as shown in Figure. 1 (b). On both hills, four holes were perforated in order to fix the steel Arcans. The distance between the hole's centers is 110 mm. The steel Arcans, were performed to allow for mixed-mode configurations. An initial crack of 20 mm is machined in the wood specimen in the direction of the fibers.

The MMCG specimen, shown in Figure 1 (b), is defined by the combination of a modified DCB specimen, and CTS specimen, on the one hand, and the observation of stability range of energy release rate versus crack length computed numerically with $M\theta$ [8], on the other hand. The main objective of this specimen is to allow for the decrease in the energy release rate during the tests. The wood specimen presented in Figure. 3 (a), is fixed in a framed structure with Arc-formed handles containing symmetrical holes for load application according to various crack mode ratios β . The application of symmetric loads FI with angle $\beta = 0^\circ$ is equivalent to the opening mode, and the application of FI, with angle $\beta = 90^\circ$ corresponds to the shear mode

as shown in Figure 1 (b). The force F is separated into two forces F_x and F_y corresponding to the axis orientations (x , y) and the mixed-mode ratio in plane configuration. In this work, the mixed-mode fracture tests are obtained by applying the loads F_I and F_{II} with angles $\beta = 45^\circ$.

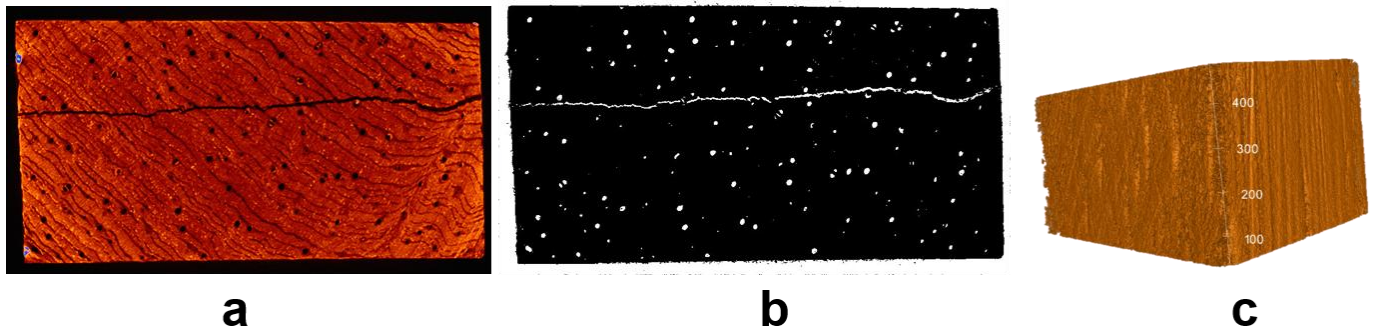
Figure 2. Internal evolution of the crack growth (a), Extraction of porosities by image analysis (b), 3D volume of the cracked Padouk sample (c).

After reconstruction, a 3D volume was obtained in consecutive slices from the 2D cross-sectional images of the investigated sample, as shown in Figure 2(a-c). The entire acquisition process took approximately 120-160 min, with an exposure time of 3 500 ms per projection. Once the region of interest (ROI) of the Padouk sample was chosen (Figure 2 (a)), the fibre elements were then segmented and binary images were obtained (Figure 2 (b)). Three-dimensional rendering of the wood sample, as shown in Figure 2 (c), was used to obtain information regarding the crack orientation, wood porosity, density and size distribution. All the 3D volume-rendered images of the Padouk, carried out along this study, had a fixed size of $900 \times 800 \times 750$ voxels for a specimen with a volume of 33 mm^3 and a voxel size of $6.9 \mu\text{m}^3$.

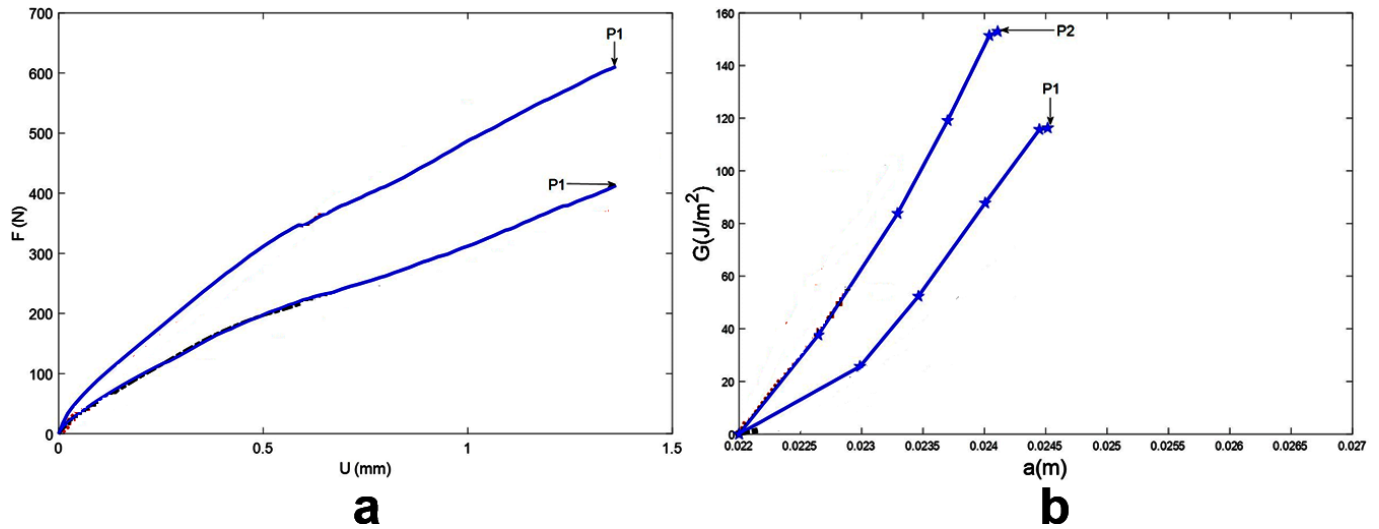
Figure 3. Force versus crack opening evolution (a), Energy release rate evolution according to crack tip advance (b)

In this section, mechanical testing was conducted on two MMCG Padouk (P1 and P2) specimen. Figure .3 (a) present the applied force versus crack opening evolution. Figure .3 (b) illustrate the viscoelastic energy release rate evolution versus crack growth process for mixed mode configuration. The crack growth process can be interpreted as brittle or ductile. If for all cases, the crack growth or damage evolutions in the process zone induce a rigidity decrease, we can note an energy release rate increase during the crack growth advance. With these considerations, for mixed mode configurations, Figure .3 (b) shows a progressive growing of the process zone (phase of energy release rate increasing) and, in the other hand, Figure .3 (a) a stationary phase with a stabilization of its evolution. More precisely, we can observe, for the second Padouk (P2) specimen, a greater energy release rate then the first Padouk (P1) specimen, which correspond on brittle crack tip advance with an approximately peaks values around 120 J/m² for P1 and 157 J/m² for P22. Energy steady state evolution after these peaks illustrate crack growth stabilities for mixed mode.

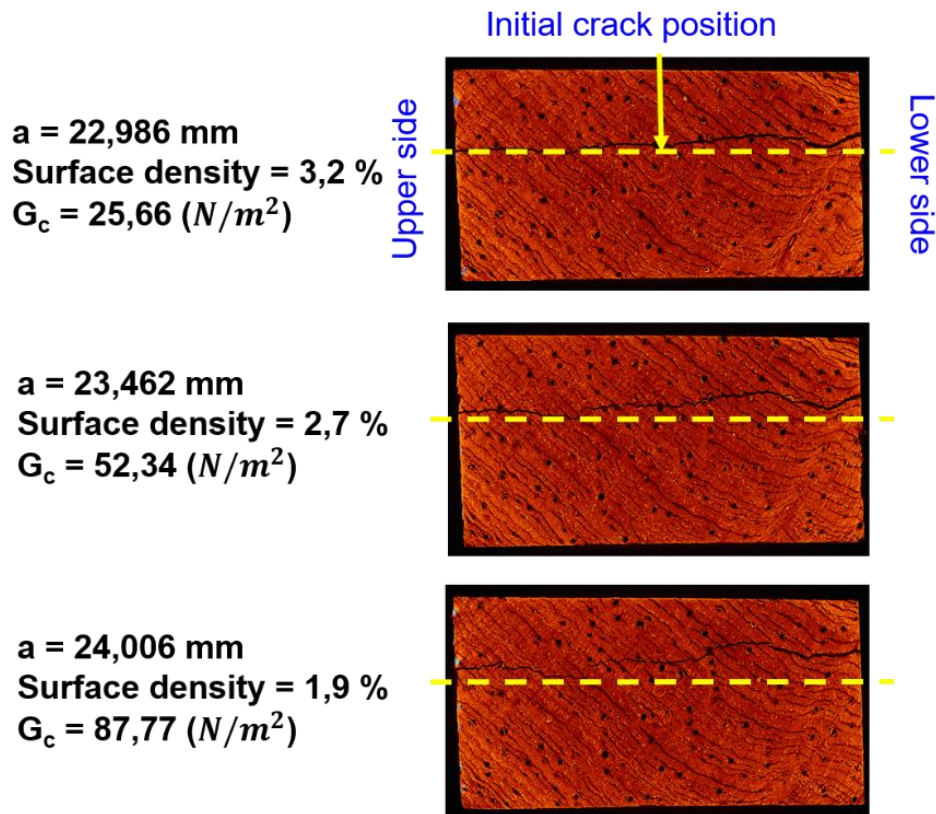
Figure 4. Crack growth path according to surface density of Padouk sample: 2D Cross sectional images extracted from 3D volume of Padouk P1 sample.

indicator of the damage level on MMCG wood samples, which is suitable for comparing the values obtained using different methods. Comparison of individual crack-based measurements is possible by relying on segmented images correlated by the surface density of the analyzed samples, as shown in Figure 4.

The volume-weighted crack length distribution of the analyzed tropical wood samples is calculated from 2D cross images (see Fig. 4). The results showed that crack progress continues inside the MMCG wood samples most likely after this progress ends in the surface of the specimens. In addition, we notice in first hand, that the surface density distribution inside a specific Padouk sample is not homogenous, which tends to accelerate the crack growth speed. In the other hand, X-ray CT showed that Padouk wood presents a high surface density. This can be explained by, the fact that Padouk wood fibers and particles diameters, estimated using the X-ray CT method (Figure 2b), showed a dispersion smaller than 60 μm and larger than 800 μm . Indeed, the conditions of fiber repartition inside the wood material affects the crack growth speed and direction as depicted in Figure. 4. The observation using the 3D scanning method showed that the crack tip progress tends to move towards larger fibers porosity all along crack path.
