AIR QUALITY ANALYSIS

Group 01:
Fábio Costa - 108090
Francisco Pereira - 98628
Joaquim Monteiro - 96254
Pedro Manuel - 96303
Sara Aymerich - 100689

Prof. Marta Almeida
& Associates

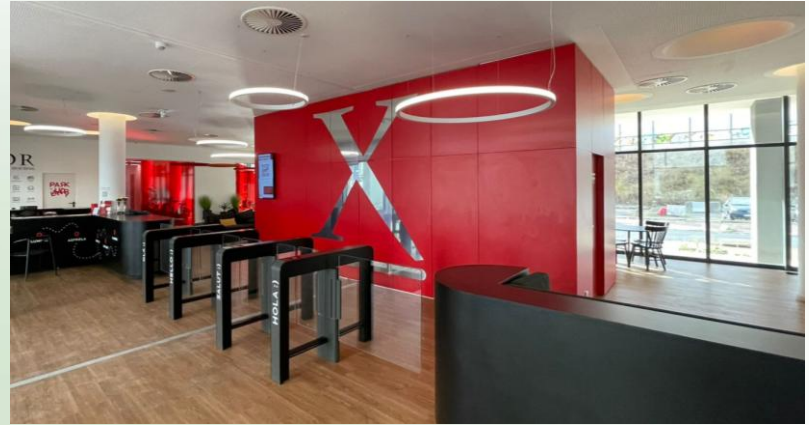
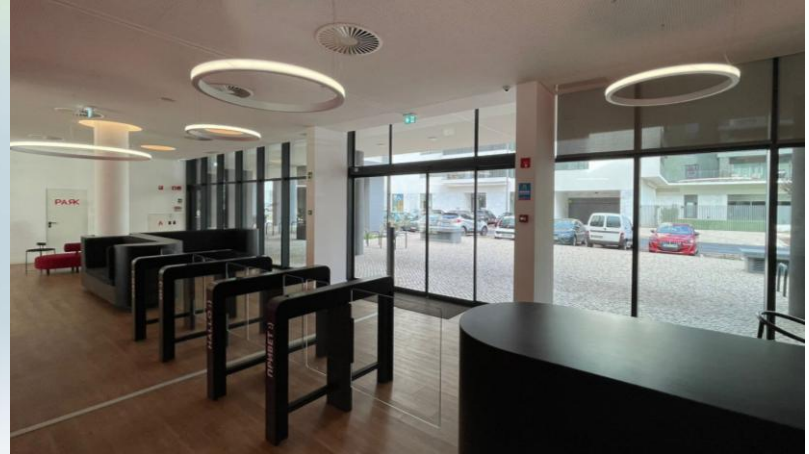
- **Occupancy:** two receptionists during the day and passing occupancy.
- **Activity:** Sedentary
- **Measurement duration:** 1 hour
- **Space characteristics:**
 - **Cleaning habits:** One per day
 - **Ventilation:** Mechanical ventilation, HAVC, Doors to the exterior;
 - **There is furniture inside and a road outside.**
- **Predictions.**

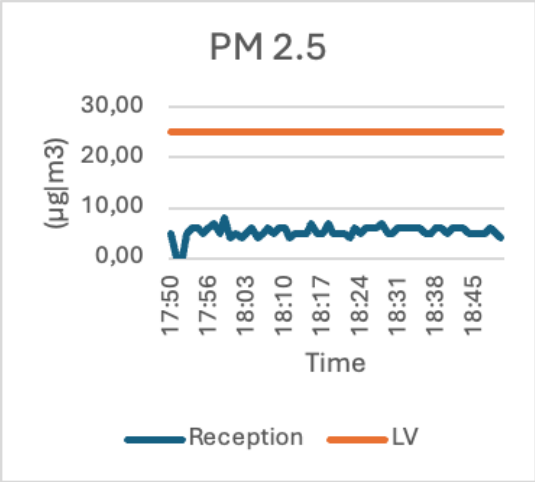
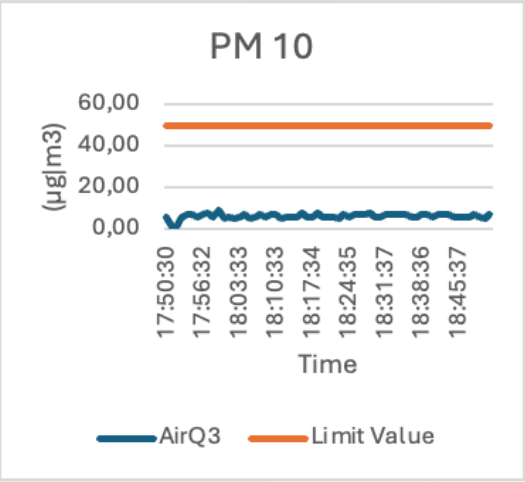
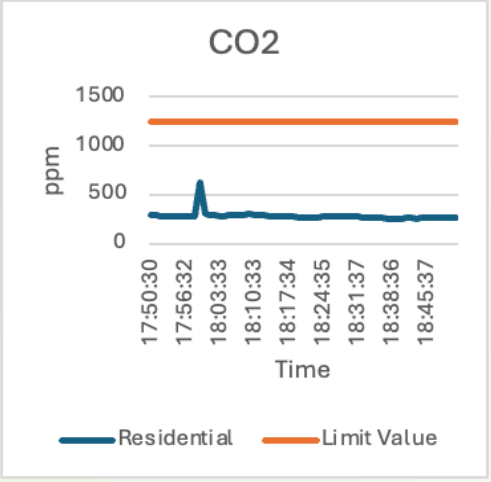
Reception of a student dorm

Pollutant	CO2 (ppm)	PM2.5 ($\mu\text{g}/\text{m}^3$)	PM10 ($\mu\text{g}/\text{m}^3$)
LV	1250	25	50
MAXIMUM	621	8,00	9,00
Complies	OK	OK	OK

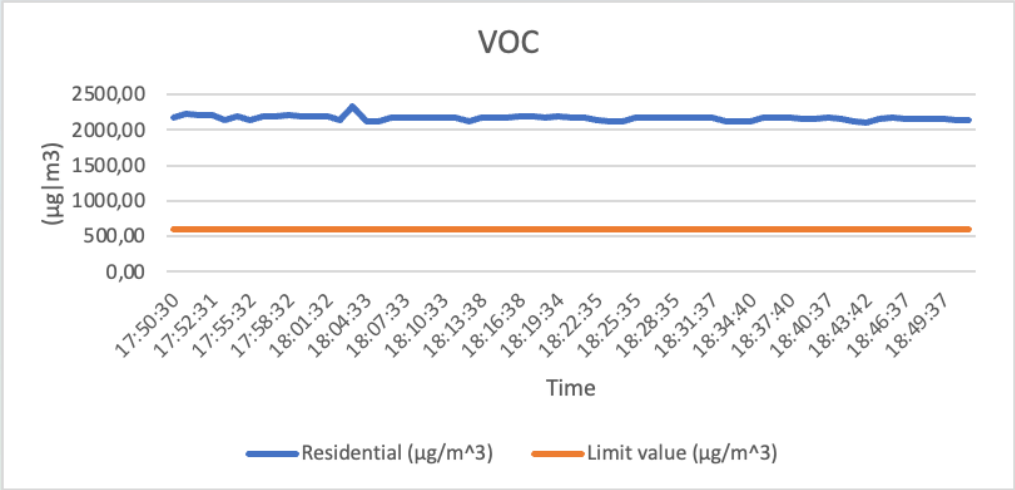
Reception of a student dorm

Pollutant	VOCs (µg m3)
LV	600
MAXIMUM	2338,21
Complies	NOT OK

Possible Causes	Corrective Measures
Emissions from furniture	Use low-VOC or VOC-free furniture. Regularly air out the space.
Frequent automatic door openings	Increase ventilation rates to mitigate outdoor pollutants.
Proximity to road and vehicle emissions	Install double doors with an airlock system.
Cleaning products containing VOCs	Switch to eco-friendly, low-VOC cleaning products. Ensure proper ventilation after cleaning.

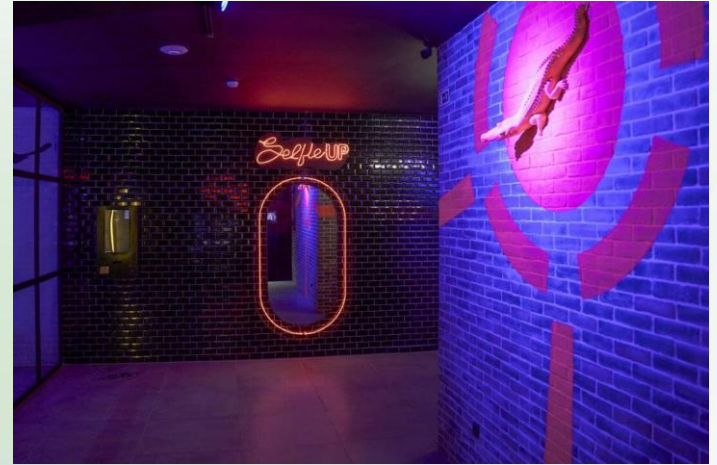
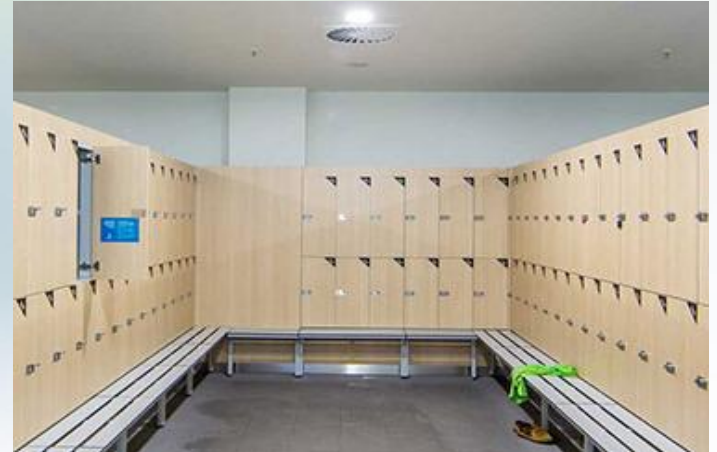
- **Occupancy:** Receptionists and high density of people;
- **Activity type:** High
- **Measurement duration:** 10 minutes
- **Space characteristics:**
 - **Cleaning habits:** High cleaning habits;
 - **Ventilation:** Mechanical ventilation, no windows, HVAC
 - **Furniture:** Tables, lockers
- **Predictions:**

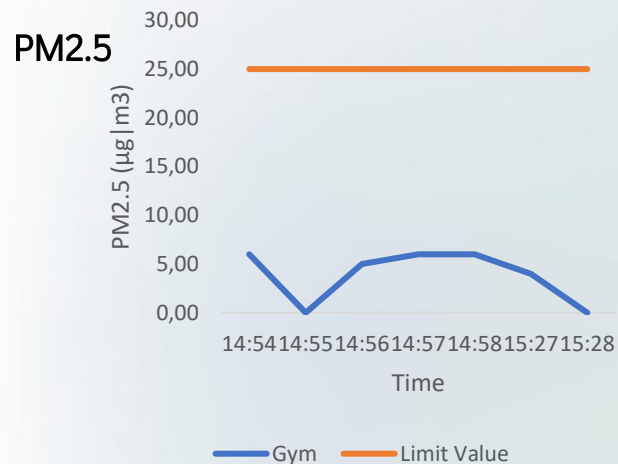
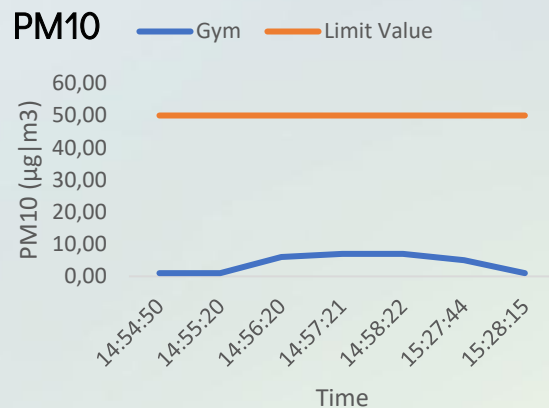
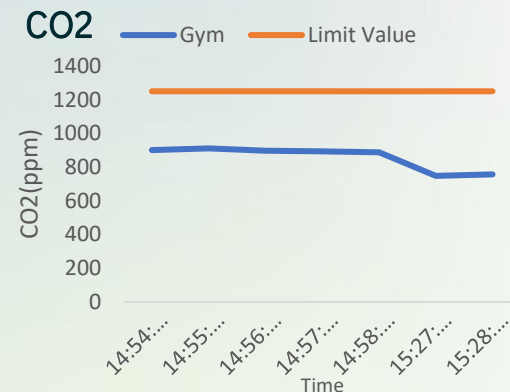
Entrance & locker room of a gymnasium

Pollutant	CO2 (ppm)	PM2.5 ($\mu\text{g}/\text{m}^3$)	PM10 ($\mu\text{g}/\text{m}^3$)
LV	1250	25	50
AVERAGE	852	3,86	4
MAXIMUM	911	6	7
Complies	OK	OK	OK

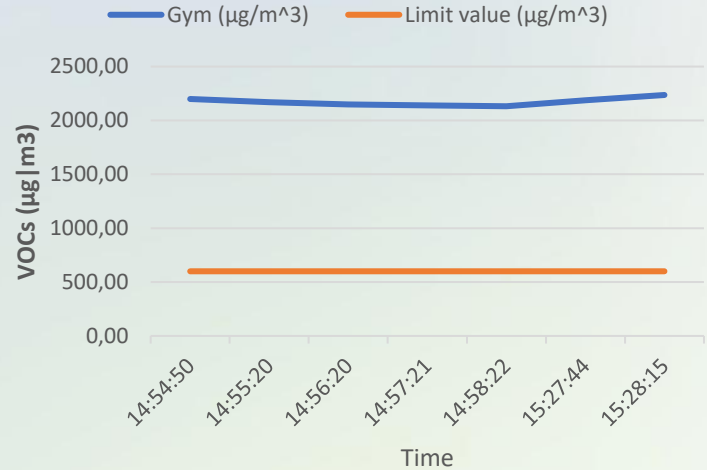
Entrance & locker room of a gymnasium

Pollutant	VOCs ($\mu\text{g}/\text{m}^3$)
LV	600
MAXIMUM	2236,17
Complies	NOT OK

Possible Causes	Corrective Measures
Emissions from furniture	Use low-VOC or VOC-free furniture. Regularly air out the space when possible.
Mechanical ventilation without windows (HVAC)	Regularly maintain and clean HVAC systems. Increase fresh air intake to reduce VOCs.

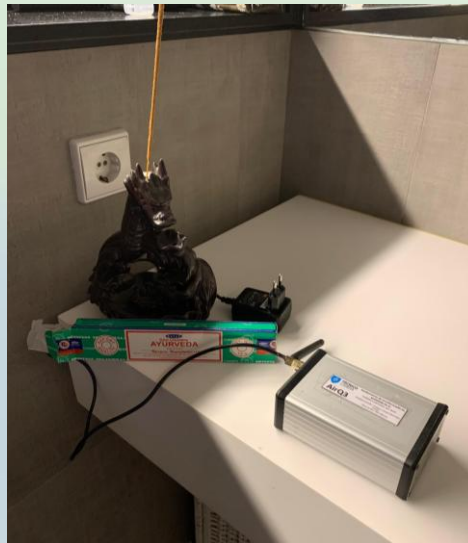
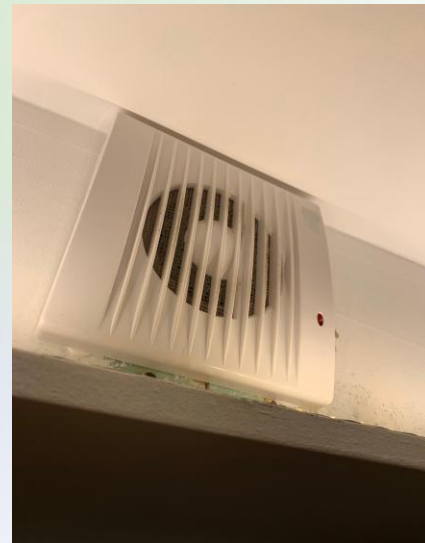
- **Occupancy:** 0 people
- **Area:** 5 m^2
- **Measurement duration:** 29 minutes
- **Space characteristics:**
 - **Cleaning habits:** Weekly
 - **Ventilation:** Mechanical ventilation

Measurement procedure	
Time	Test steps
02:32	Beginning of test, with close door
03:32	Light the incense
12:32	Turn on exhaust fan
21:32	Open the door
29:41	End of test

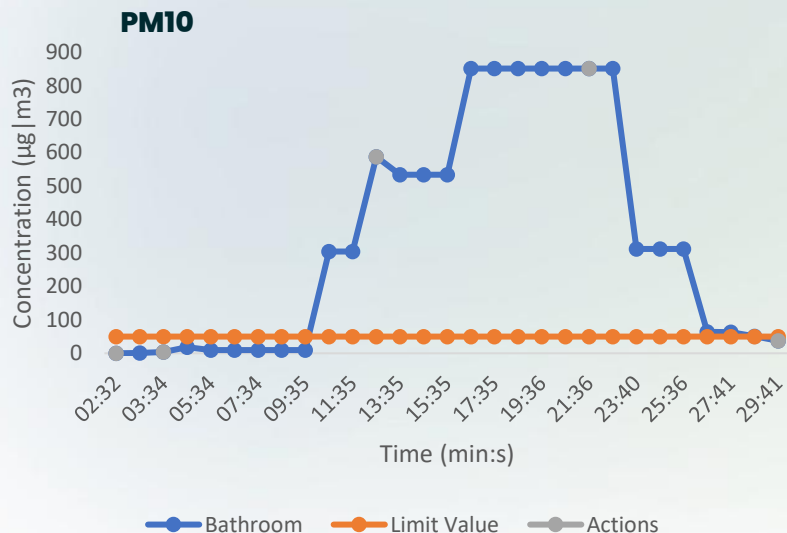
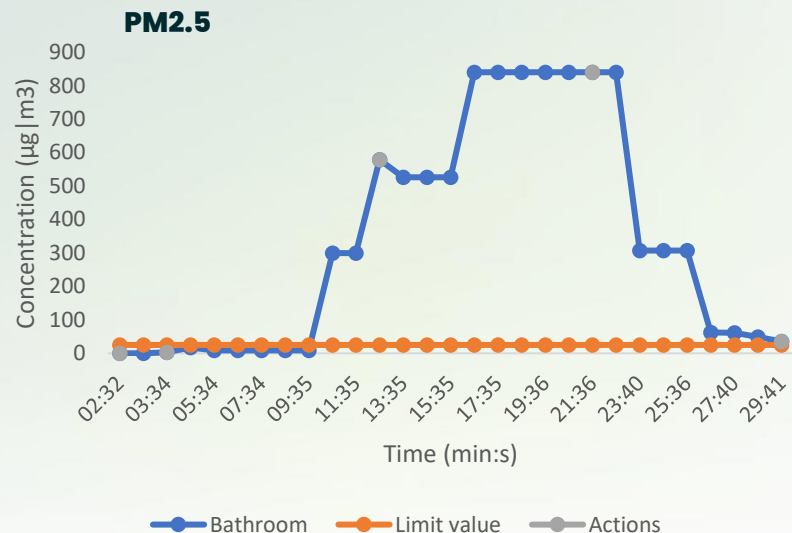
Use of incense in a bathroom

Pollutant	PM10	PM2.5
Limit Value ($\mu\text{g}/\text{m}^3$)	50	25
MAX ($\mu\text{g}/\text{m}^3$)	851	840

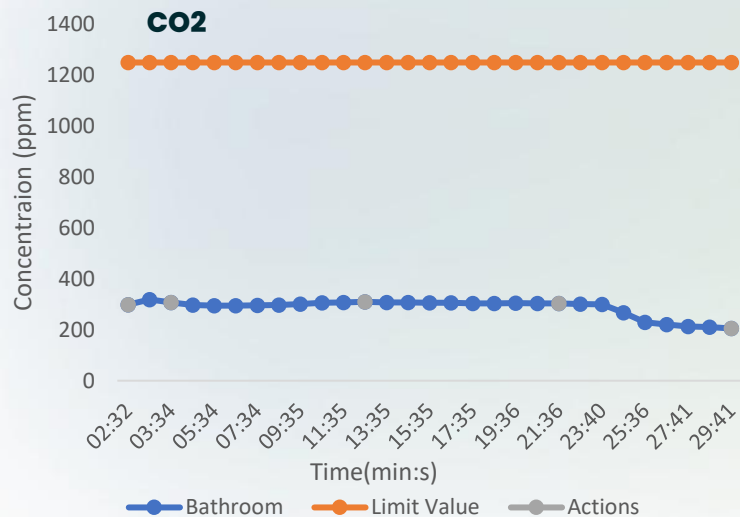
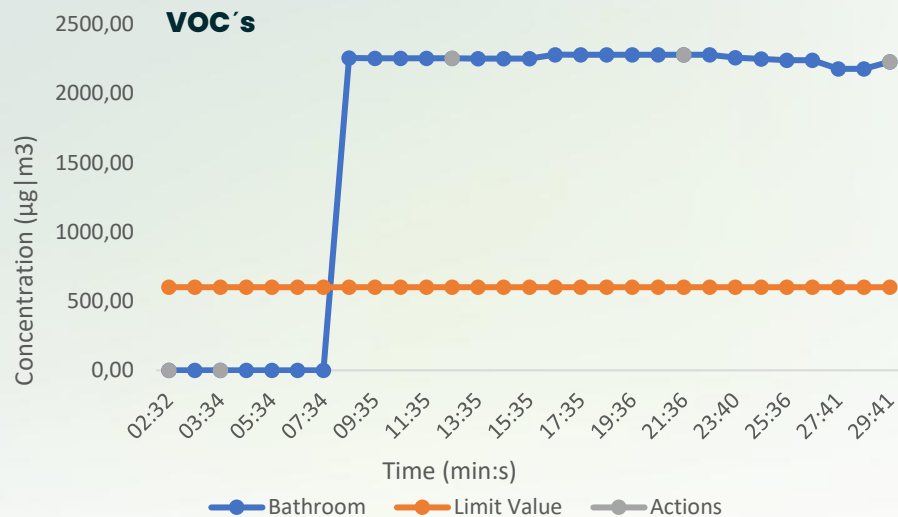
Use of incense in a bathroom

Pollutant	CO2	VOC
Limit Value ($\mu\text{g}/\text{m}^3$)	1250	600
MAX ($\mu\text{g}/\text{m}^3$)	287	2279
