HOME INSPECTION REPORT

5742 Timberline Drive, Layton, UT 84021

Inspection prepared for: Sample Report

Date of Inspection: 11/10/2017

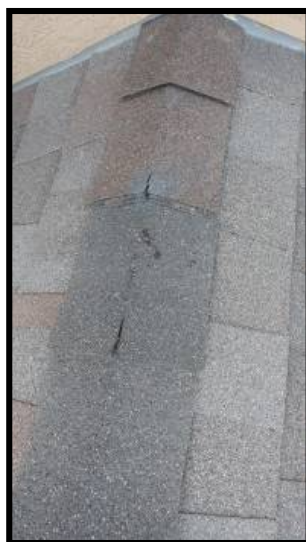
- No major system safety or function concerns observed at the readily accessible areas.
- Typical ridge shingle cracks observed.

Typical ridge shingle cracks observed.

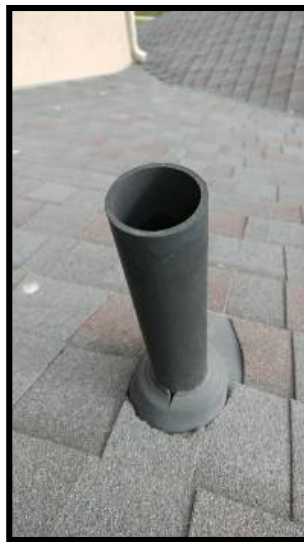
- **Damaged- Vent boot is damaged. Potential water intrusion.**

Vent boot cracked.

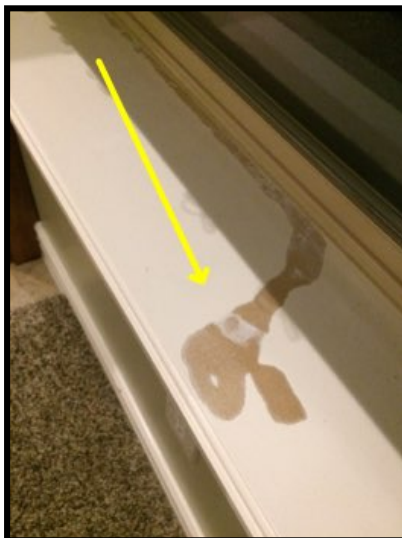
2. Windows Interior Condition

Roof		
Page 4 Item: 5	Plumbing Vents	• Damaged- Vent boot is damaged. Potential water intrusion.
Exterior Areas		
Page 8 Item: 15	Dryer Vent Cover Condition	• Missing- The dryer vent is missing the exterior cover.
Electrical		
Page 15 Item: 5	Breaker Condition	• One and only one 20amp breaker is serviced by 14 gauge branch wire. Should be addressed and switched to a 15amp service breaker by a certified electrician.
Room(s)		
Page 29 Item: 6	Wall Condition	• Missing/damaged drywall observed.
Page 30 Item: 8	Windows Interior Condition	• Large tare in living room window screen.

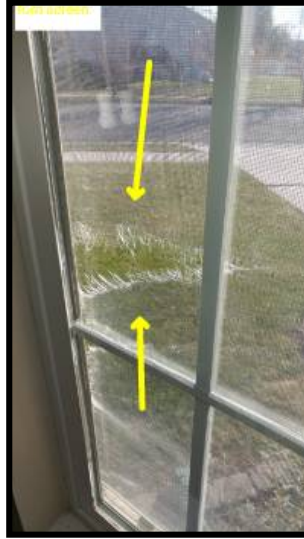
- **Large tare in living room window screen.**
