# Car Damage Detector & Reporter

## Damage Analysis Report

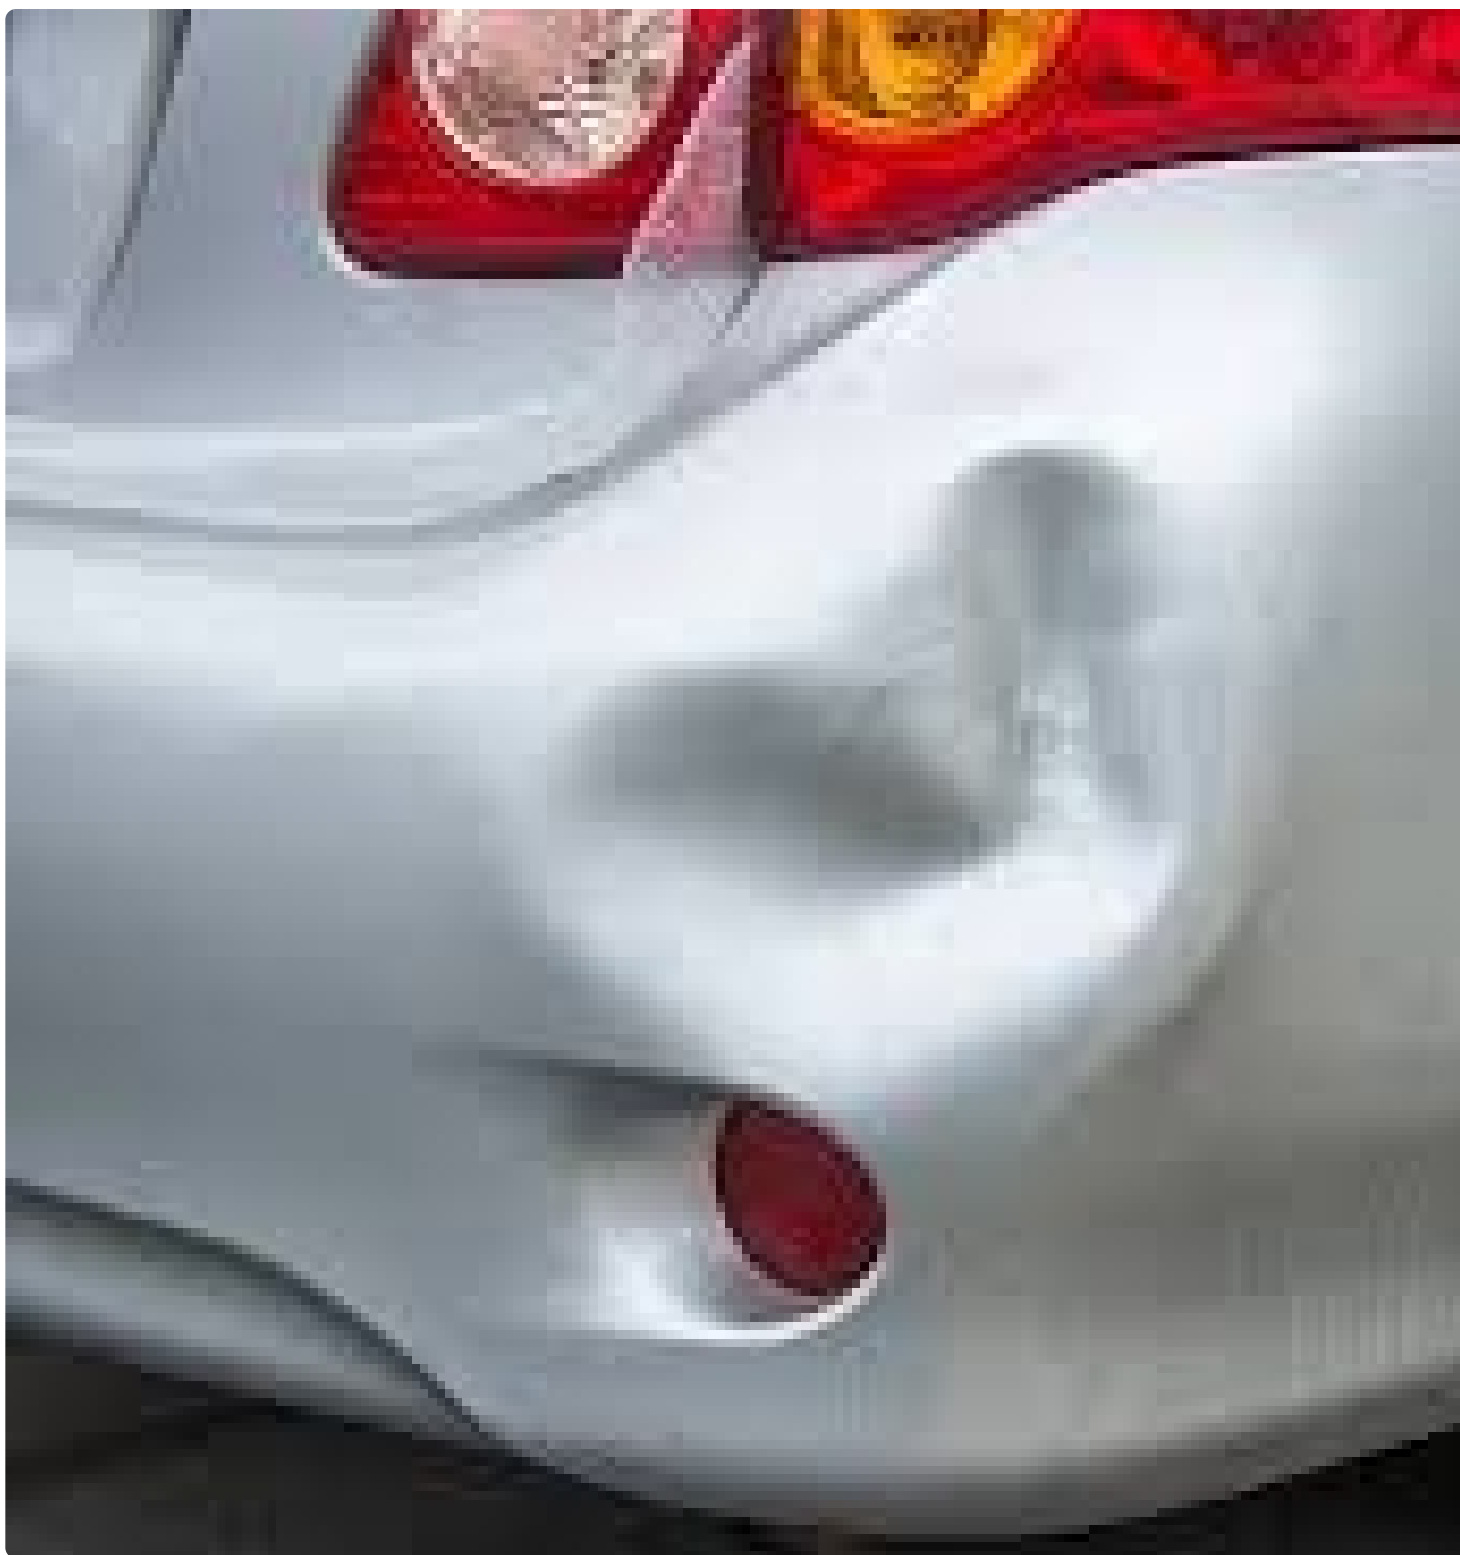
## Original Image

Detected Damage Highlighted

- **Part:** The primary damage is a significant deformation to the rear bumper of the vehicle. Specifically, it appears to be the lower portion of the bumper, likely the p
- **Severity:** The damage is *severe*. The bumper cover has been severely crushed inwards, creating a pronounced concave shape. This indicates a substantial impact

- There is visible paint damage around the impacted area.

- The rear light is intact, indicating the damage didn't extend to the light assembly itself.

This damage requires extensive repair. It's highly likely that the bumper cover needs to be replaced, and potentially the surrounding body filler as well, to properly res
