Field Service Action 22B44

SUBJECT: 22B44 - MONDEO - FRONT BRAKE FLEXIBLE HOSE REPLACEMENT

22B44: Mondeo/S - Front Brake Flexible Hose Replacement

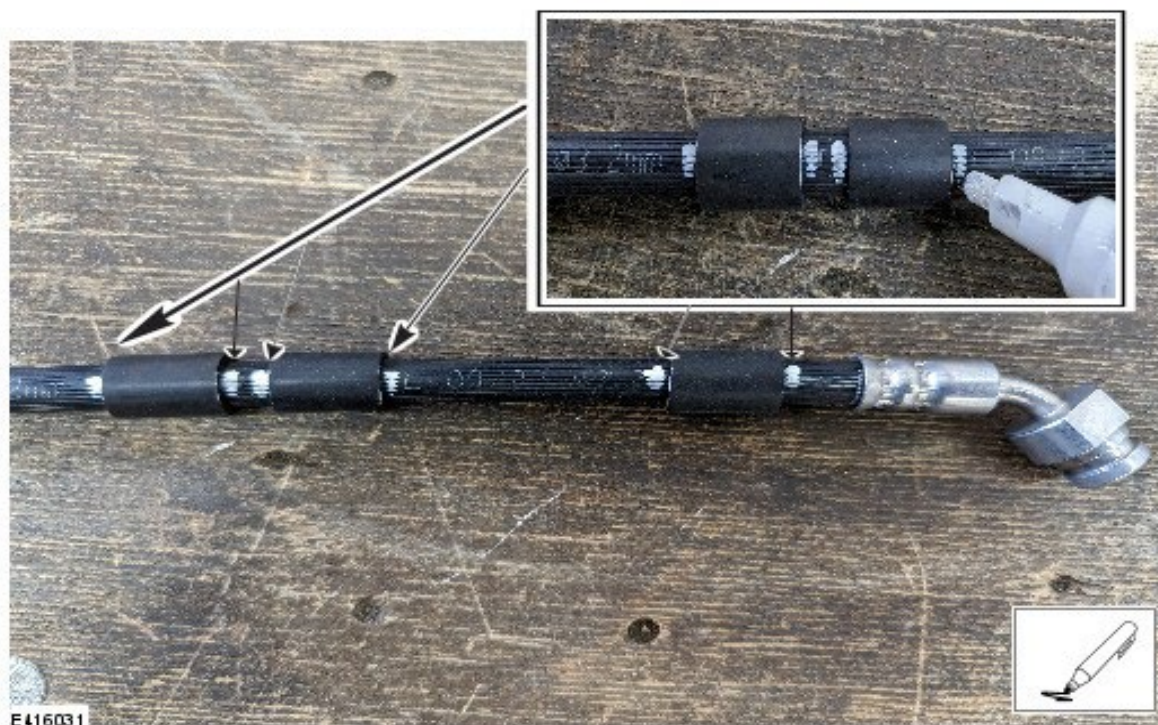
FIGURE 1

1. Mark brake hose bumper positions prior to fitting the new brake hoses to the vehicle. See Figure 1.

NOTE: The three (3) brake hose bumpers shown in step 1 may move during fitting due to brake fluid seepage. These bumpers must be checked and relocated after completing both Right Hand (RH) and Left Hand (LH) front brake replacements.

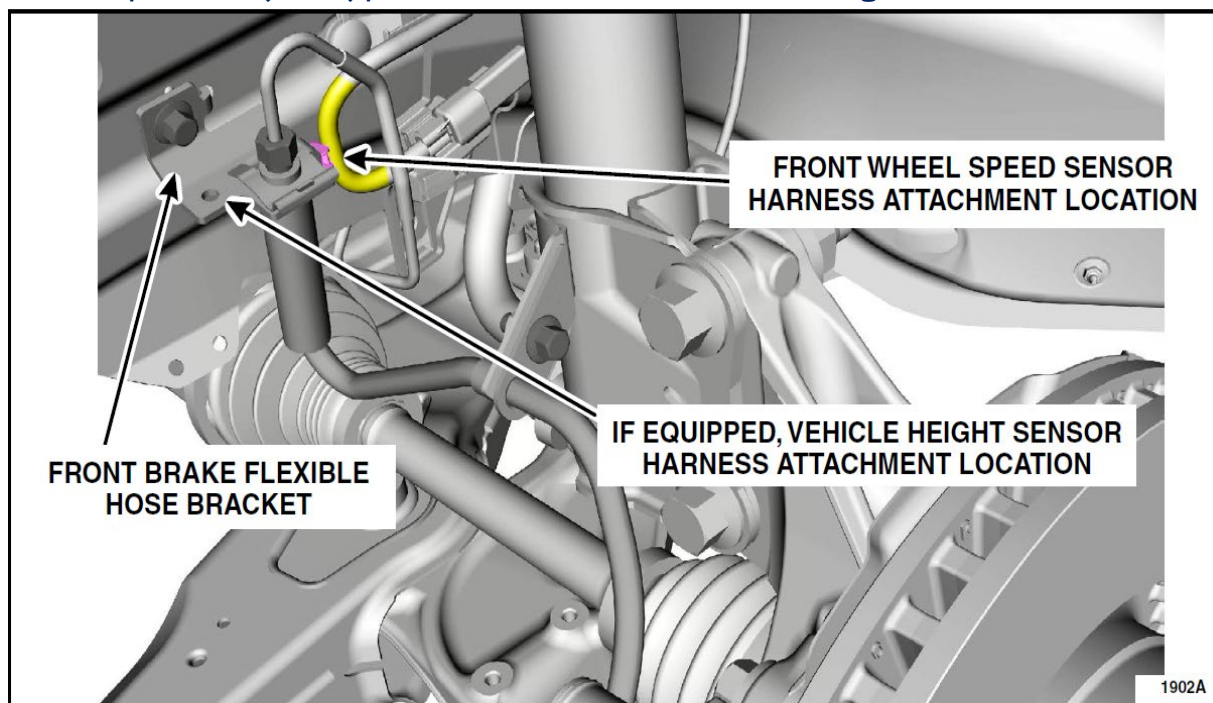
FIGURE 2

2. Replace the Right Hand (RH) and Left Hand (LH) front brake flexible hoses. Please follow Workshop Manual (WSM) procedures in Section 206-03. See Figure 2

3. Check both brake hoses for bumper movement and relocate to original positions as marked in step 1.

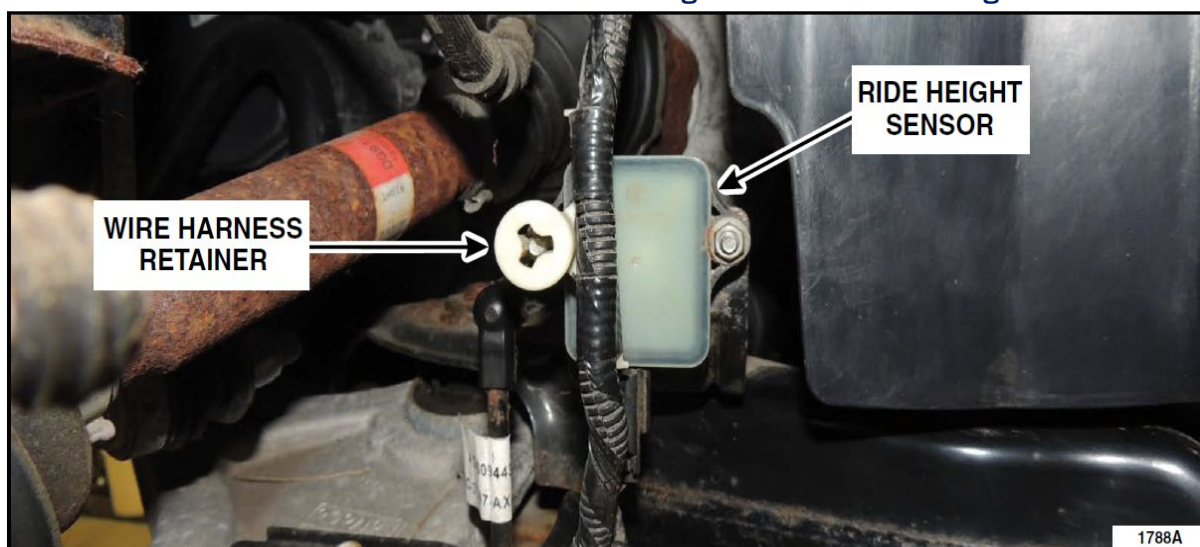
FIGURE 1

4. Remove the wire harness retainer from the ride height sensor stud. See Figure 1.

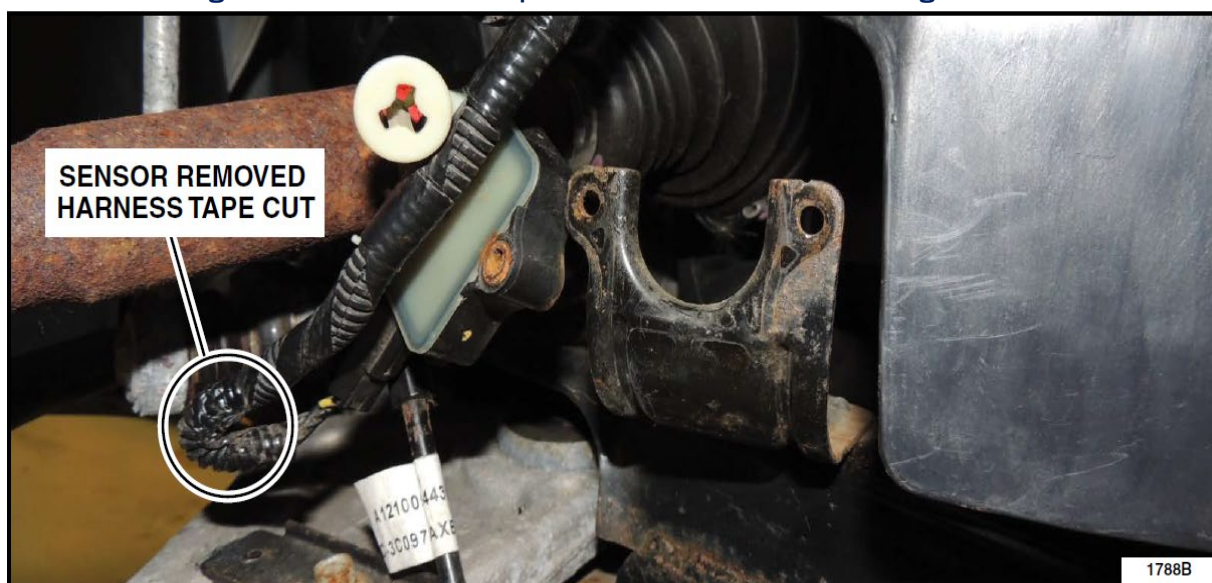
FIGURE 2

5. Remove the nuts and bolts from the ride height sensor and position aside. See Figure 2.
6. Cut the ride height sensor's harness tape at the harness bend. See Figure 2.

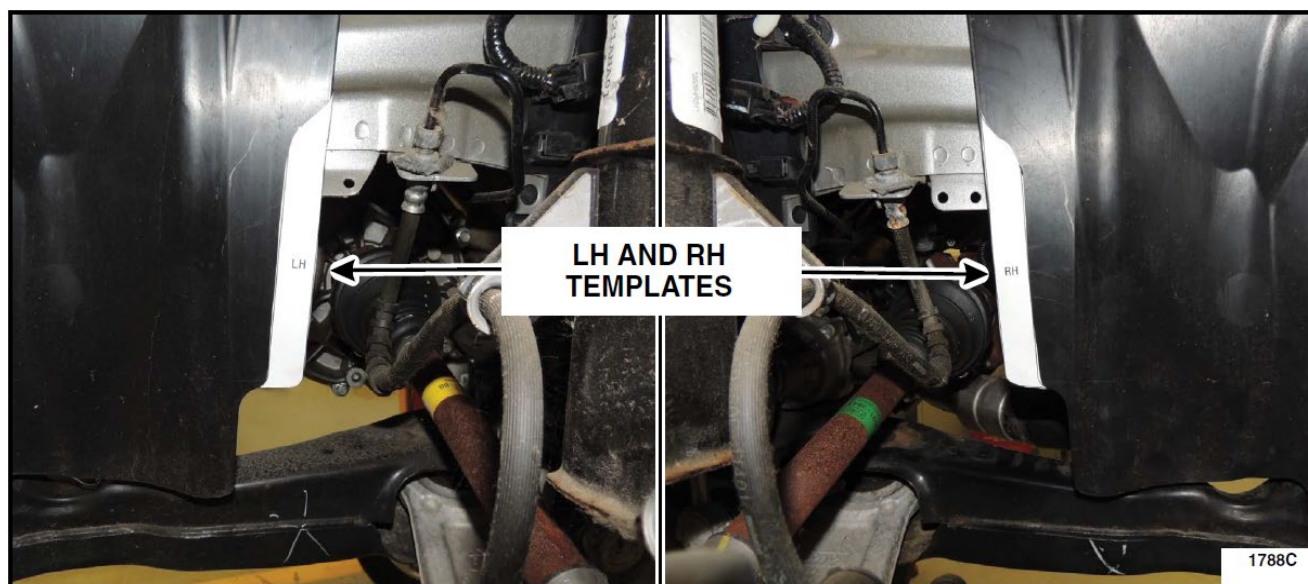
FIGURE 3

7. Attach the cut-out templates (See Attachment IV) to the RH and LH front fender splash shields. Using a suitable cutting tool, cut the front fender splash shields at the locations shown. See Figure 3.

NOTE: Remove any burrs or sharp edges.

NOTE: Some vehicles may already be fitted with front fender splash shields that include the cut outs. If the cut-outs are present, please proceed to step 8, if not continue with step

NOTE: The front fender splash shields should remain on the vehicle during cutting.

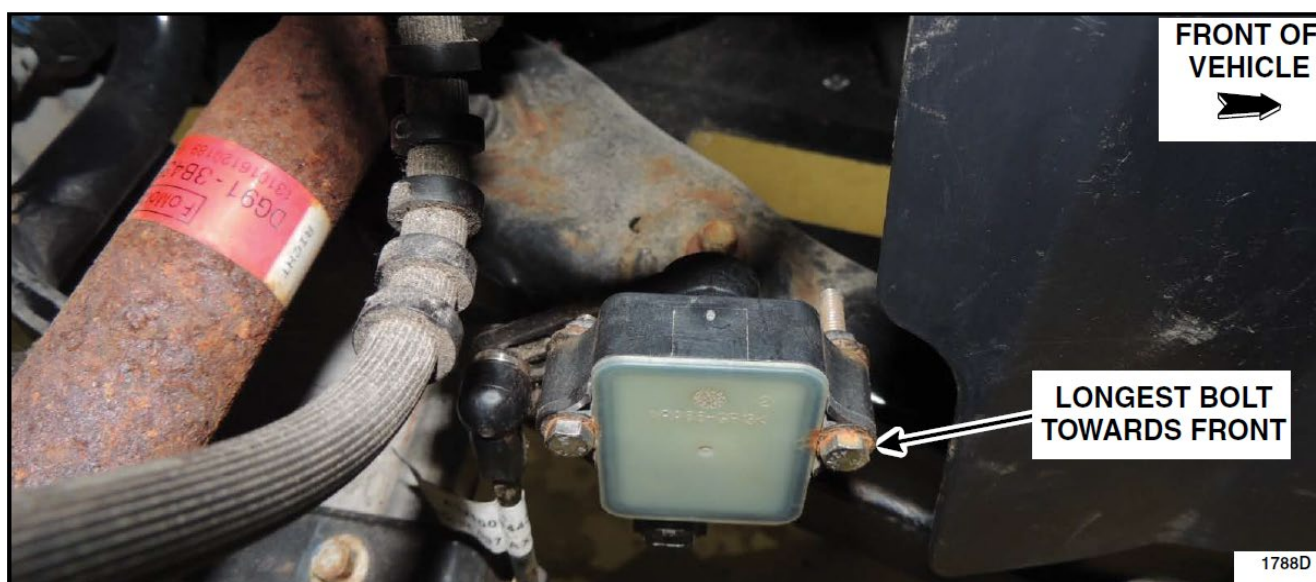
FIGURE 4

8. Position the ride height sensor back onto the brackets and install the nuts and bolts with the long bolt in the front bracket hole. See Figure 4.
 - Tighten bolts to 9 Nm.

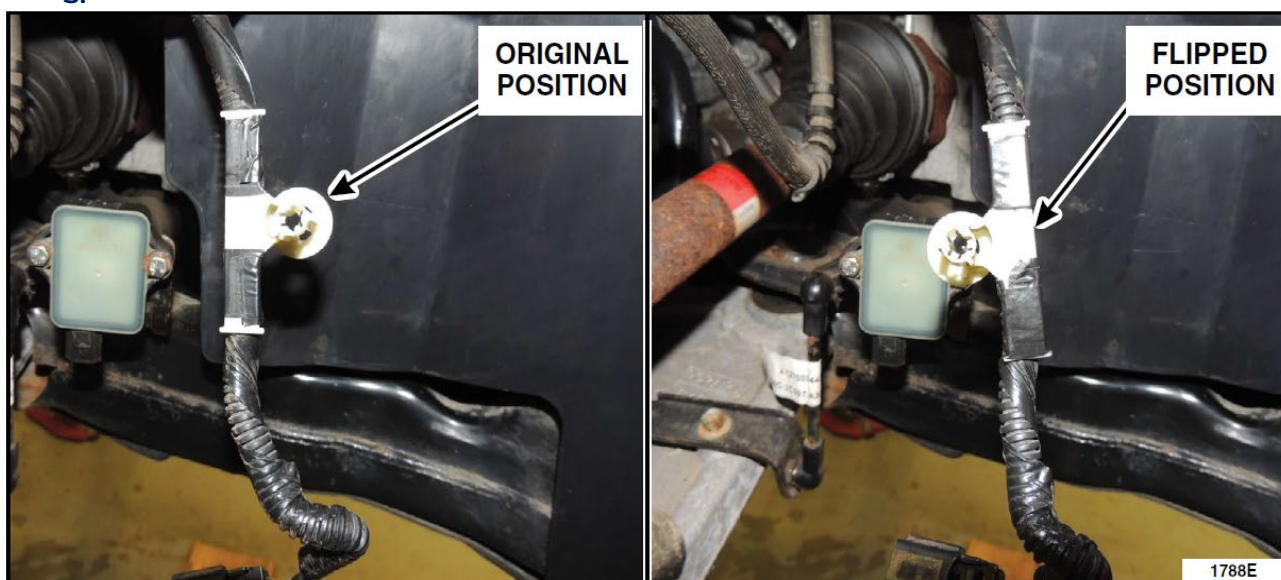
FIGURE 5

9. Mark the location of the clip on the ride height sensor's wire harness. See Figure 5.
10. Remove the tape and clip from the ride height sensor's wire harness. Rotate the clips 180 degrees and reinstall onto the ride height sensor's wire harness with electrical tape. See Figure 5.

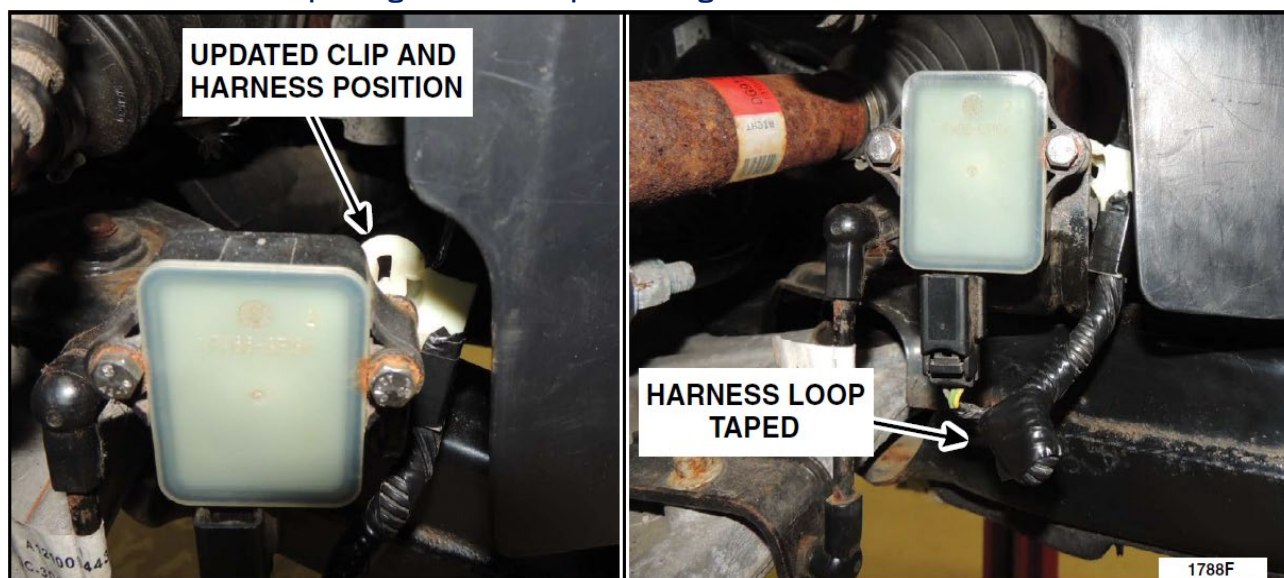
FIGURE 6

11. Attach the ride height sensor's wire harness clip to the front bracket bolt (long bolt) and secure the harness loop using electrical tape. See Figure 6.

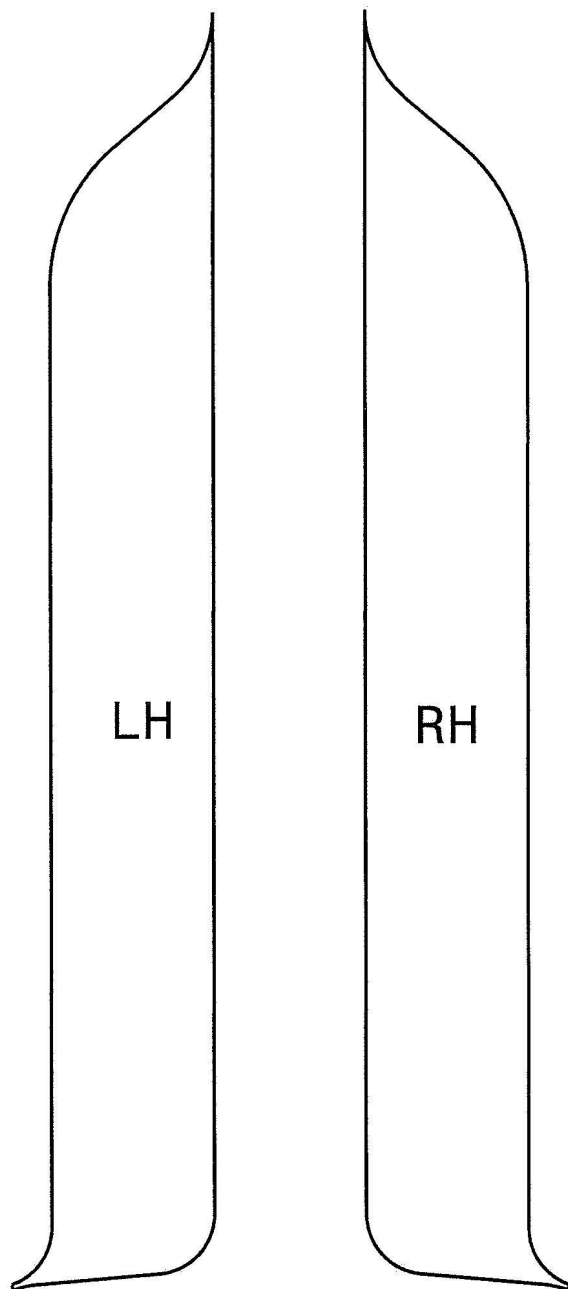
Front Fender Splash Shield Templates

Print on A4 paper in portrait orientation only
