# FCSD Field Service Action 16S38S2

**Subject: 16S38S2- SAFETY RECALL - Focus Fuel Tank Purge Vent**

### **RECOMMENDED REWORK PROCEDURES (updated)**

Certain 2011 through 2015 Model Year Focus Vehicles — Fuel Tank Purge Vent

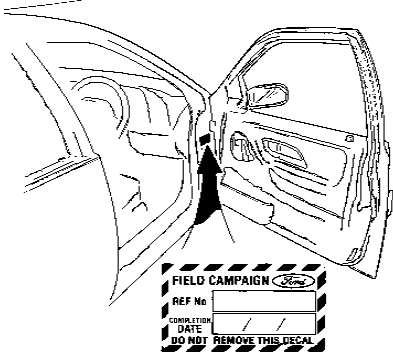
**NOTE:** When rework is completed, fit campaign completion decal to the right hand (drivers) side A Pillar and return the vehicle to service.

<p>Enter campaign number and date of repair using a permanent marker pen.</p> <p>Ensure area of application is thoroughly clean and dry before applying decal.</p>
---	--

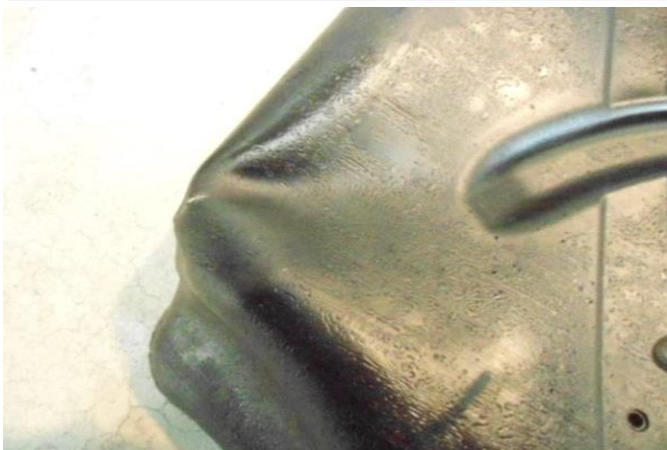
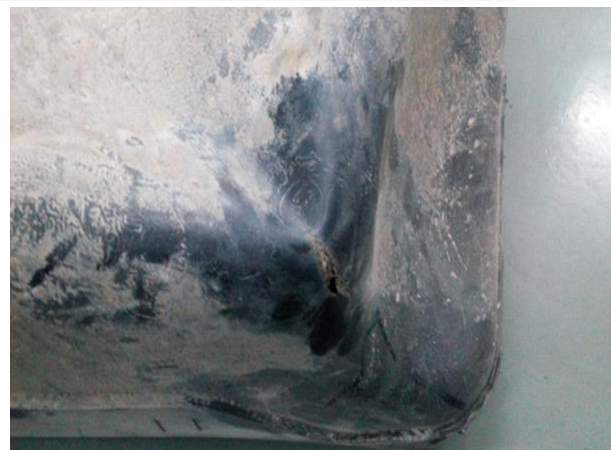
2. Feel the front left hand corner of the fuel tank for any distortion. Examples of distortion are shown below.

Is the corner of the fuel tank distorted?

Yes	<p>The fuel tank has failed the inspection. Replace the following components:</p> <ul style="list-style-type: none"> <li>• Fuel Tank – Refer to <b>SECTION E</b>.</li> <li>• Evaporative Emissions Canister – Refer to <b>SECTION F</b>.</li> <li>• Fuel Tank Vent Line – Refer to <b>SECTION H</b>.</li> <li>• Fuel Filler Nozzle Inhibitor (Capless Filler) – Refer to <b>SECTION I</b>.</li> </ul> <p><i>For vehicles built in Thailand with the Early Type Capless Filler, claim PDR FSA16S3811 for this repair.</i></p> <p><i>For vehicles built in Thailand with the Later Type Capless Filler, claim PDR FSA16S3812 for this repair.</i></p> <p><i>For vehicles built in Germany, claim PDR FSA16S3813 for this repair.</i></p>
No	<p>The fuel tank has passed the inspection, but other components must be replaced. Replace following components:</p> <ul style="list-style-type: none"> <li>• Evaporative Emissions Canister – Refer to <b>SECTION F</b>.</li> <li>• Fuel Tank Vent Line – Refer to <b>SECTION H</b>.</li> <li>• Fuel Filler Nozzle Inhibitor (Capless Filler) – Refer to <b>SECTION I</b>.</li> </ul> <p><i>For vehicles built in Thailand with the Early Type Capless Filler, or vehicles built in Germany claim PDR FSA16S3809 for this repair.</i></p> <p><i>For vehicles built in Thailand with the Later Type Capless Filler, claim PDR FSA16S3810 for this repair.</i></p>

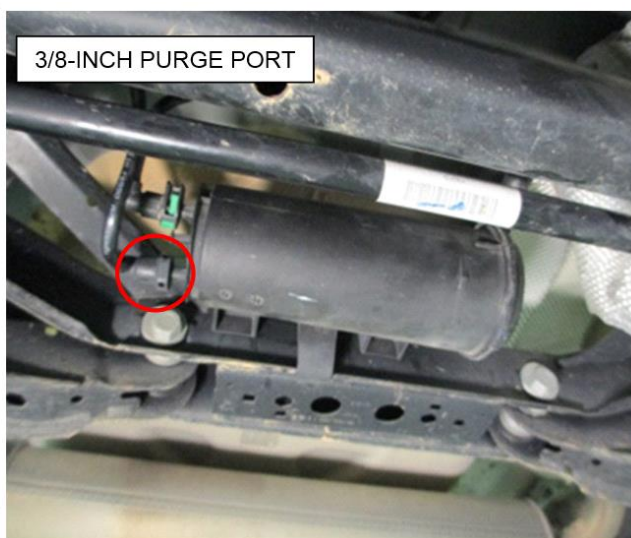
1. Fit a load restrictor to the 3/8-inch purge port.

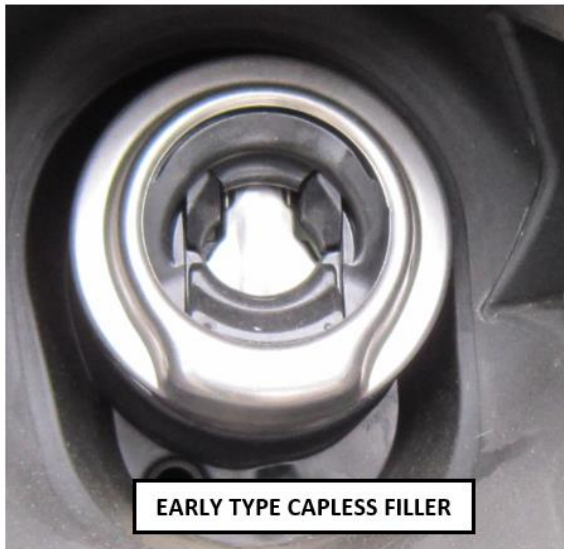
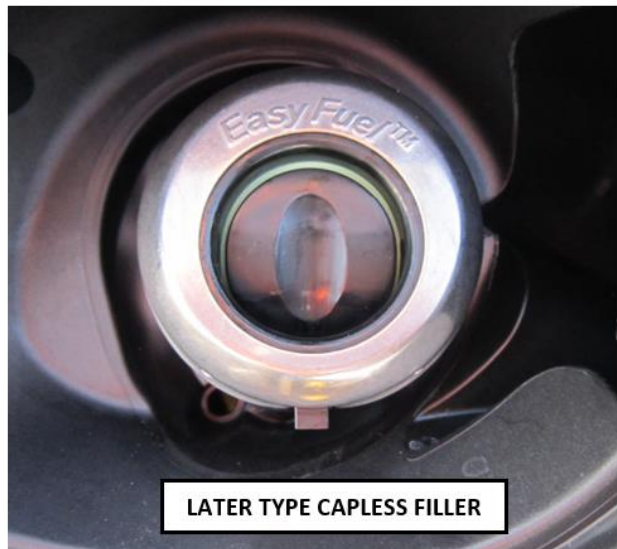
**NOTE:** There are two types of Capless filler assemblies depending on build date of the vehicle. Determine the type of Capless filler fitted to the vehicle to ensure that the correct PDR is claimed.

1. Determine the type of Capless filler fitted to the vehicle.

2. Replace the fuel filler nozzle inhibitor (Capless filler).

**NOTE:** Replace the Capless filler with the same type of design (early/late type) shown above.
