Model Group	Model Code	Model Year
CIVIC	FC1 / FC6	2016-2019
CIVIC	FK4 / FK5	2017-2019
CR-V	RW1	2018-2019
CR-V	RW2	2018-2019
CR-V	RW3	2018-2019

Authorized by Honda Australia Pty Ltd – Ownership Experience Division – Technical Department

WARRANTY EXTENSION: ABNORMAL NOISE FROM STEERING WHILE TURNING (6G1)

ASH-TI420210060

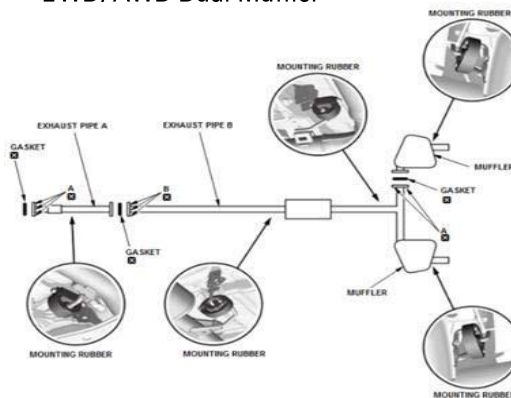
2WD, AWD Dual Muffler

10. Exhaust Pipe A - Remove.

Item		Torque
	A	54 N·m (5.5 kgf·m, 40 lbf·ft)
	B	33 N·m (3.4 kgf·m, 24 lbf·ft)
