Detailed Project Report for Climate Change Action Programme Support

Title of Project: Enhancing Adaptive Capacity to Climate Change through Conservation of Traditional Water Supply Sources (Wells and Bawdies) of Indore City

Environmental Planning & Coordination Organisation (EPCO)

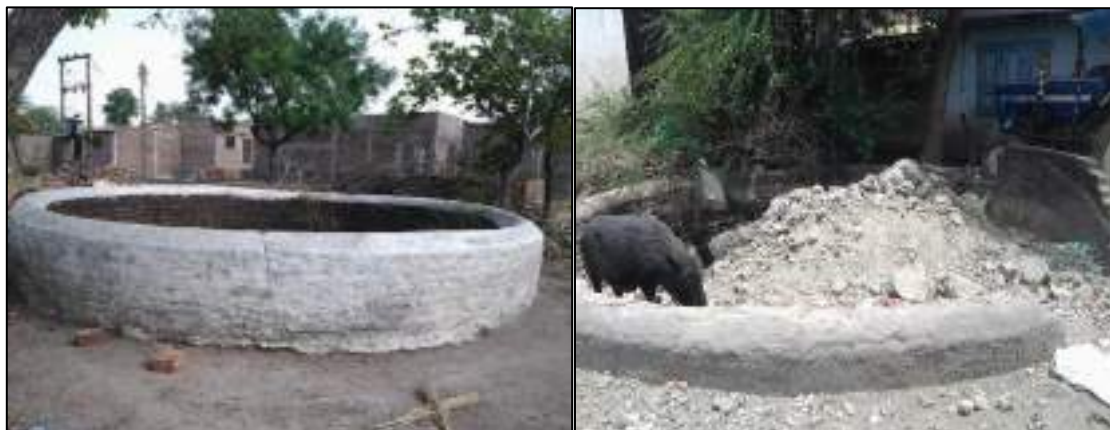
Figure 9: Open Wells

The top layer of soil is prevented from collapsing by providing a lining up to the entire thickness of the soil profile/loose and weathered material. A parapet wall is also built around the open well above the ground level as a protection measure.

In some open wells platforms have been provided for miscellaneous uses. The parapet wall, now-a-days serves as a base for fixing cover over the open well.

The construction materials of open wells included stone masonry for the older wells while the modern construction used bricks and reinforced cement concrete.

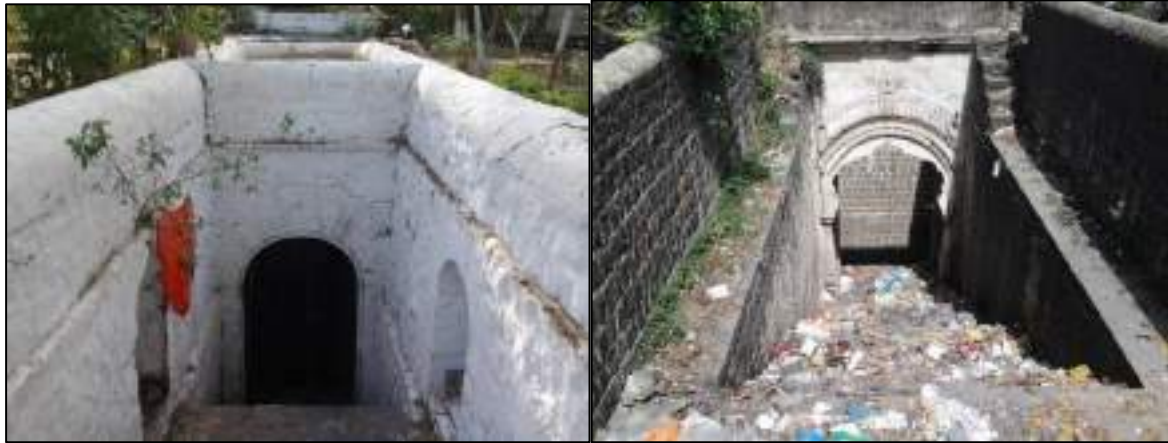
Figure 10: Step Wells

Step wells were mostly constructed in earlier days with large plan area and generally in square-rectangle shaped. It is very convenient structure to fetch or use water through steps as the seasonal water level goes down. These wells were large in size because of the old construction technology which required bigger plan areas to excavate to deeper levels. Since most of these step wells are old creations they have been built with stone masonry.

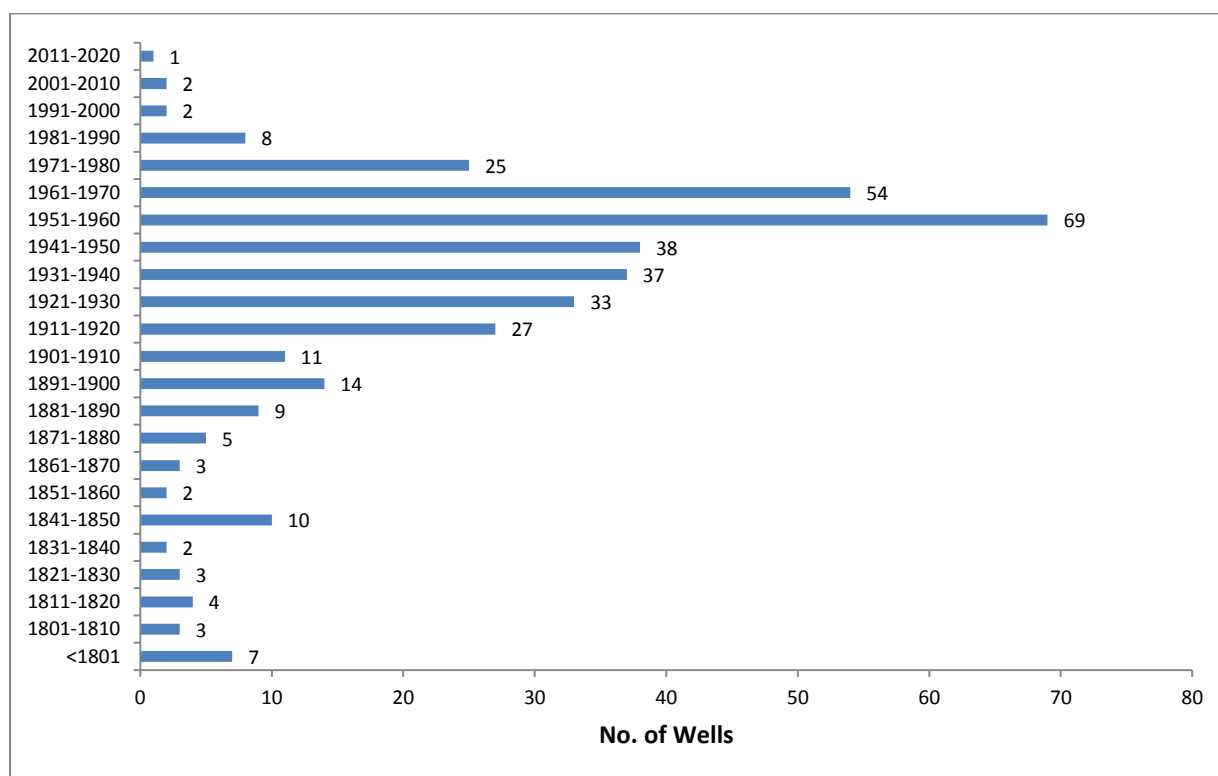
Figure 11: Time of construction (Decade wise) of Open-wells in Indore

Maximum numbers of sources, 124 were developed in the period of 1941 to 1960 and out of which 121 are open wells and 3 are step wells. The construction activity seemingly declined with construction of 81 wells between years 1961 and 1980, out of which 79 are Open wells and 2 are Step wells. It is to be noted here that the construction of step wells declined sharply

The material used also changed with time and the stone masonry gave way to bricks and concrete. After 1981 the technology of well creation changed dramatically with advent of mechanized drilling machines and bore wells replaced open wells. Hence 12 wells were constructed between years 1981 and 2000, out of which 11 are Open wells and 1 is Step well. From 2001 to recent only 3 wells were constructed and all are Open wells, not constructed any Step well in these period. The data is presented in Table-6 with graphically presentation in Annexure-1 as Figure numbers 27 to 32.

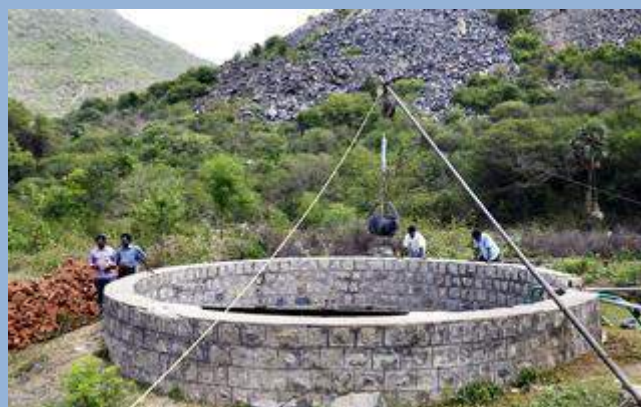
Traditional sources in drought situation: cleaned, deepened to augment drinking water supply
