Fire & First Flush Effects on Salmonid Habitat in a Coastal Watershed

Marelle Arndt¹, Rosealea Bond^{2,3}, Adrienne Chenette¹, Cynthia Kern^{2,3}, Joseph Kiernan^{3*}

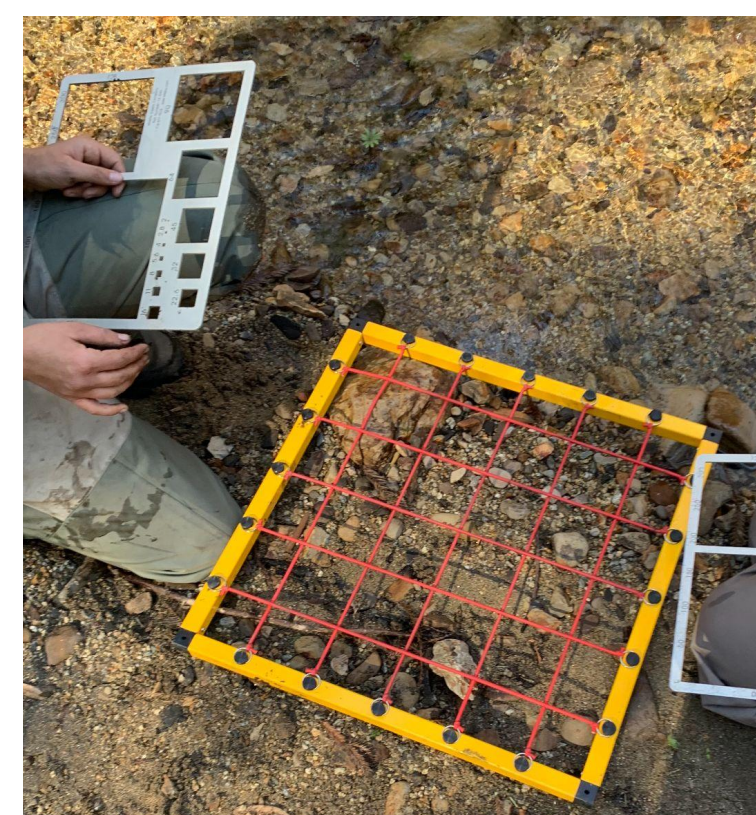
Figure 3: Sampling frame (0.5 m²) and gravelometer used during pebble count data collection.

- Salmonid abundance (3-pass depletion eFishing)
- Basal carbon sources (leaf litter)
- Pebble counts (Fig. 3)
- Habitat typing
- % shade

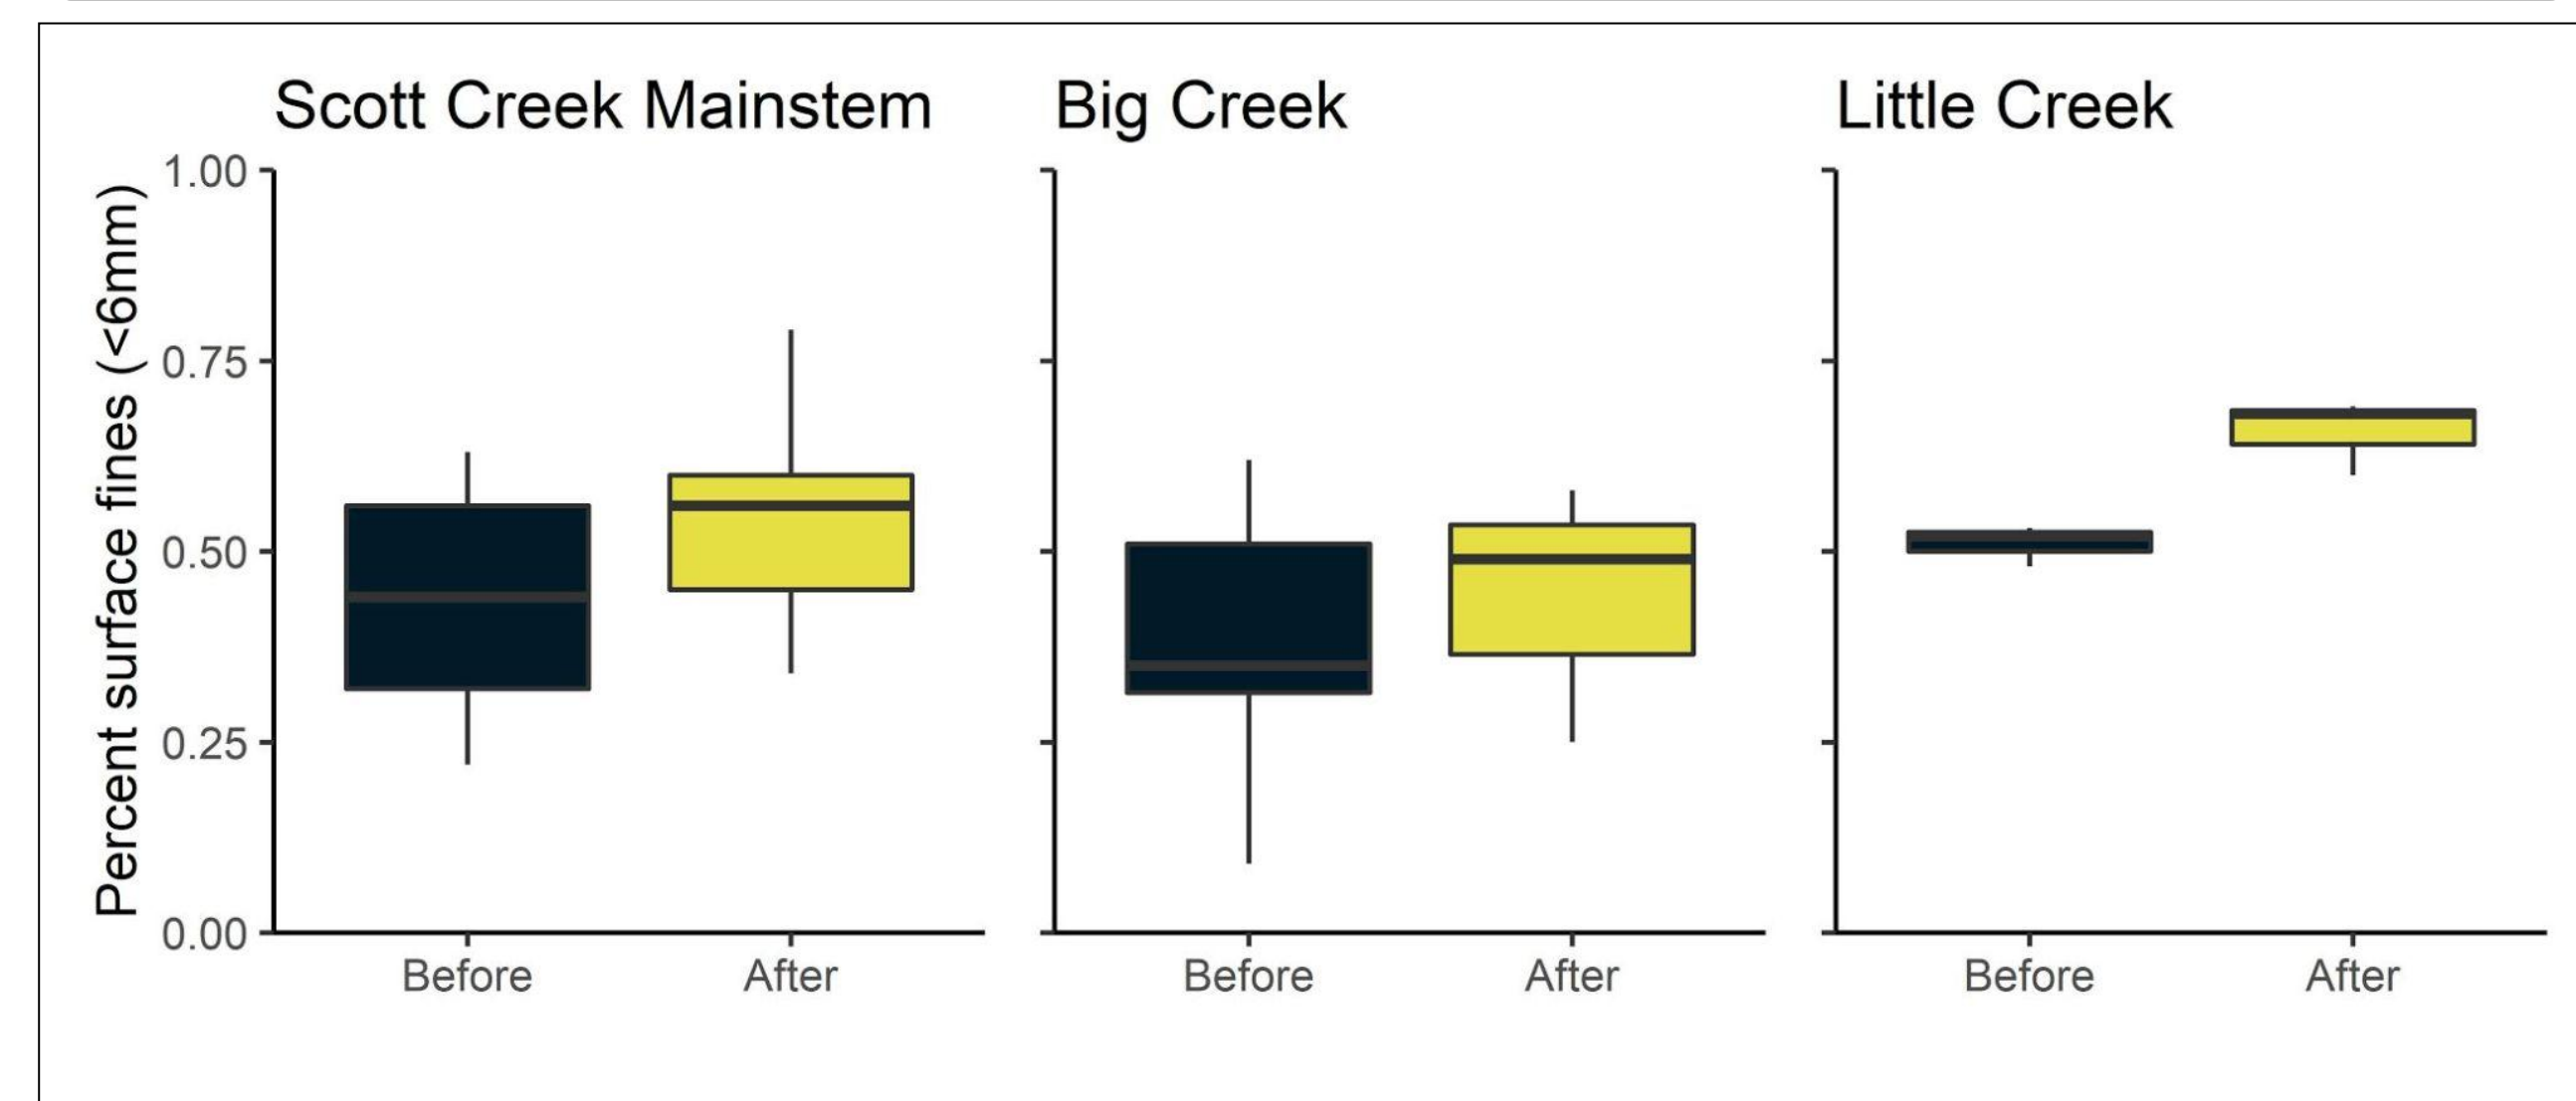
Figure 4: Box-and-whisker plot showing percent surface fine-sediment (<6mm) increase after the first major post-fire rain event, measured from February 24, 2021–March 4, 2021. Horizontal lines in boxes are medians, box-ends are quartiles, whiskers are 5% and 95% confidence intervals. Before data measured from October 21, 2020–November 23, 2020.

- Even the smallest rain events are mobilizing fine sediment
- Overall % surface fines (<6mm) increased across all sampling locations (Fig. 4)
- Sediment deposition (Fig. 6) → habitat degradation¹ → fills in pools, fills in cobbles
- Sediment suspension (Figs. 9 & 10) → blocks fish gills, decreases oxygen for fish redds⁴, increases invertebrate drift⁵

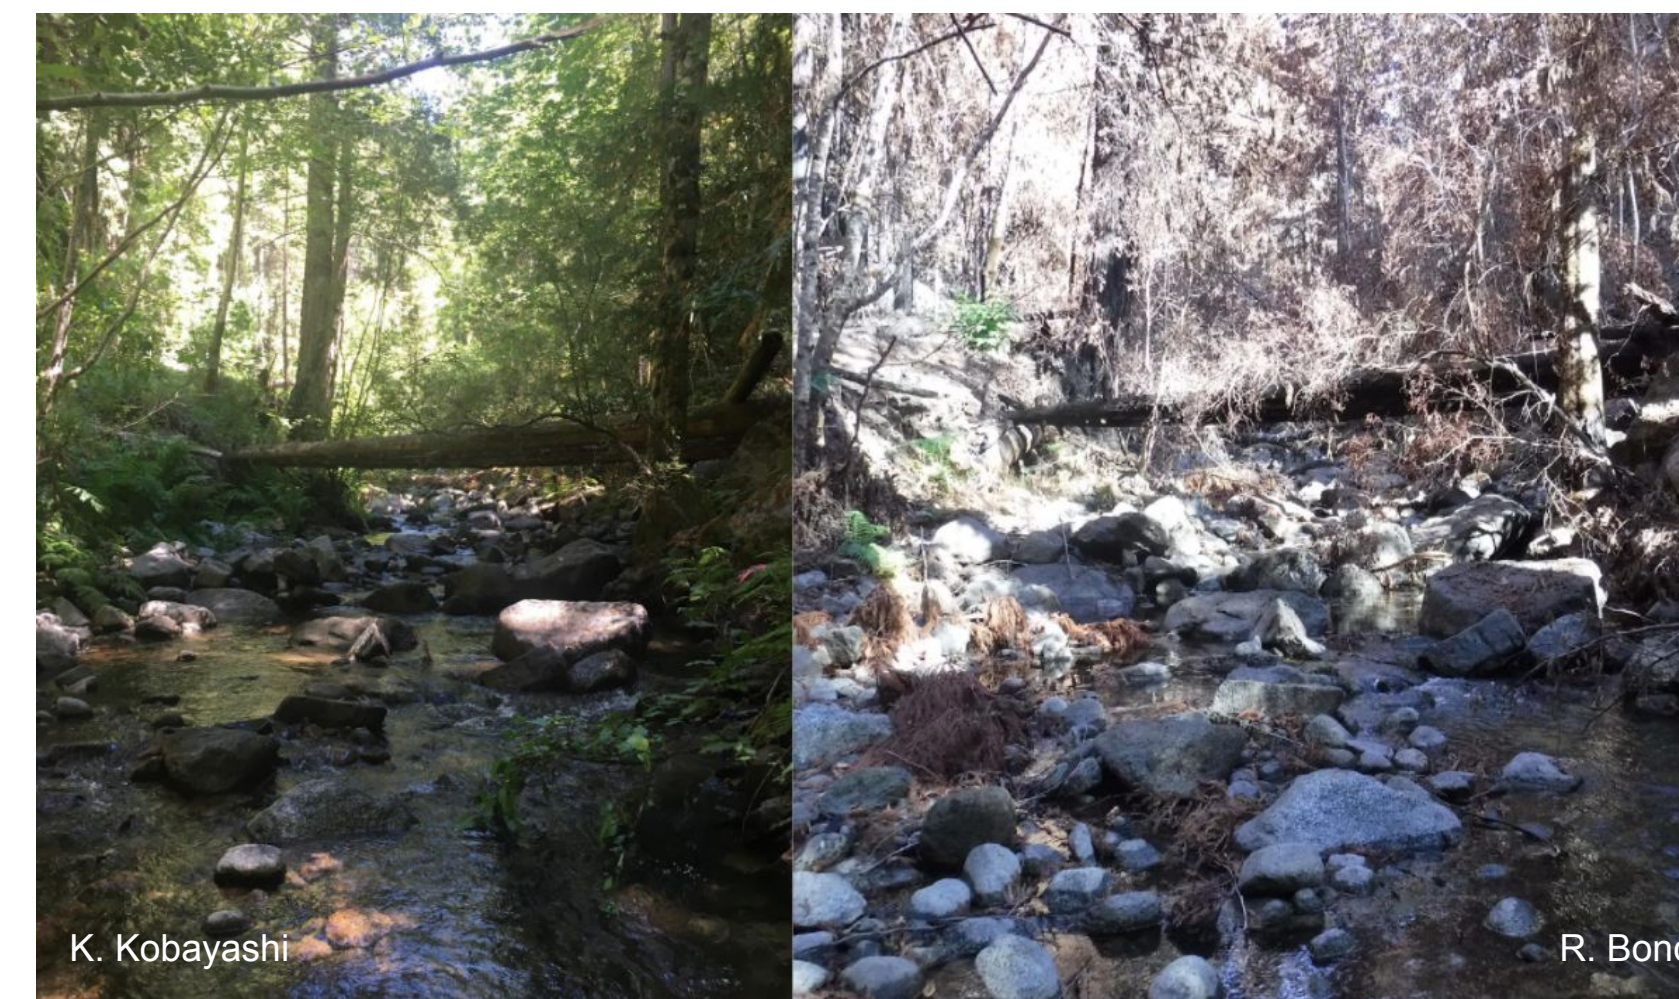
Figure 5: Severe wildfire damage in the riparian zone on Big Creek tributary before (left photo; September 2017) & after fire (right photo; November 2020), looking upstream.

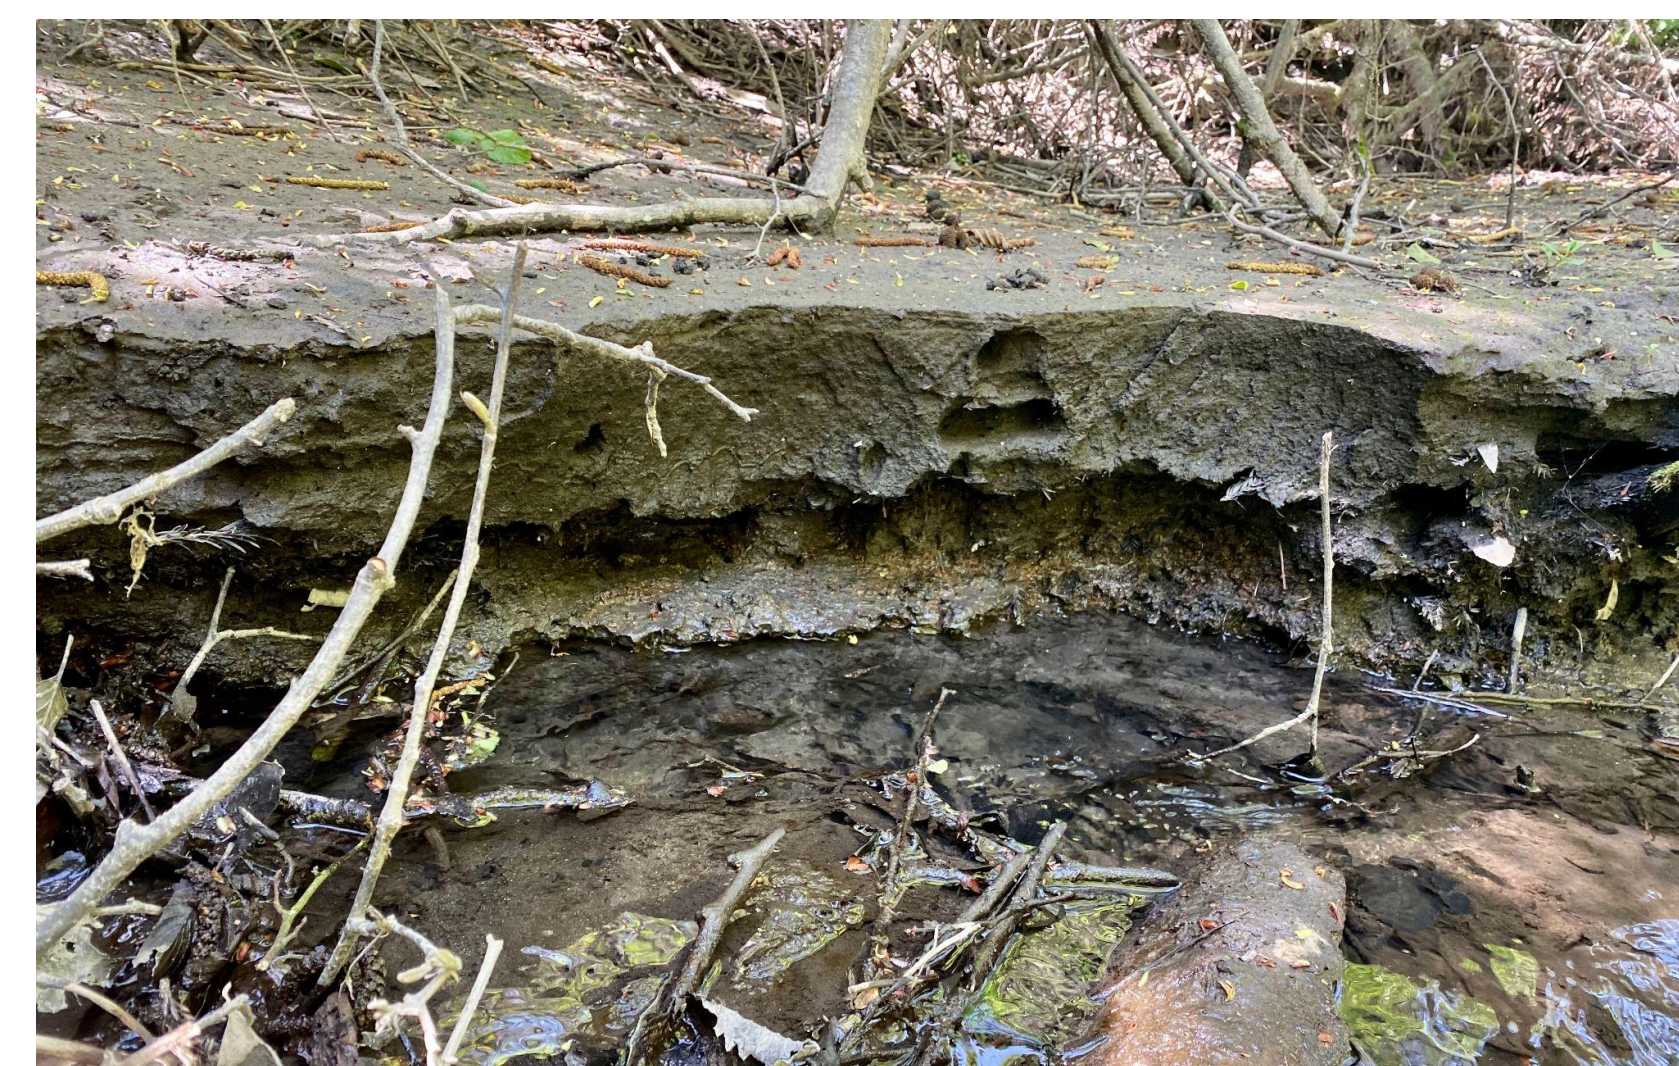
Figure 6: Substantial fine sediment deposit on upper Scott Creek mainstem following winter storm event, photo taken on April 8, 2021.

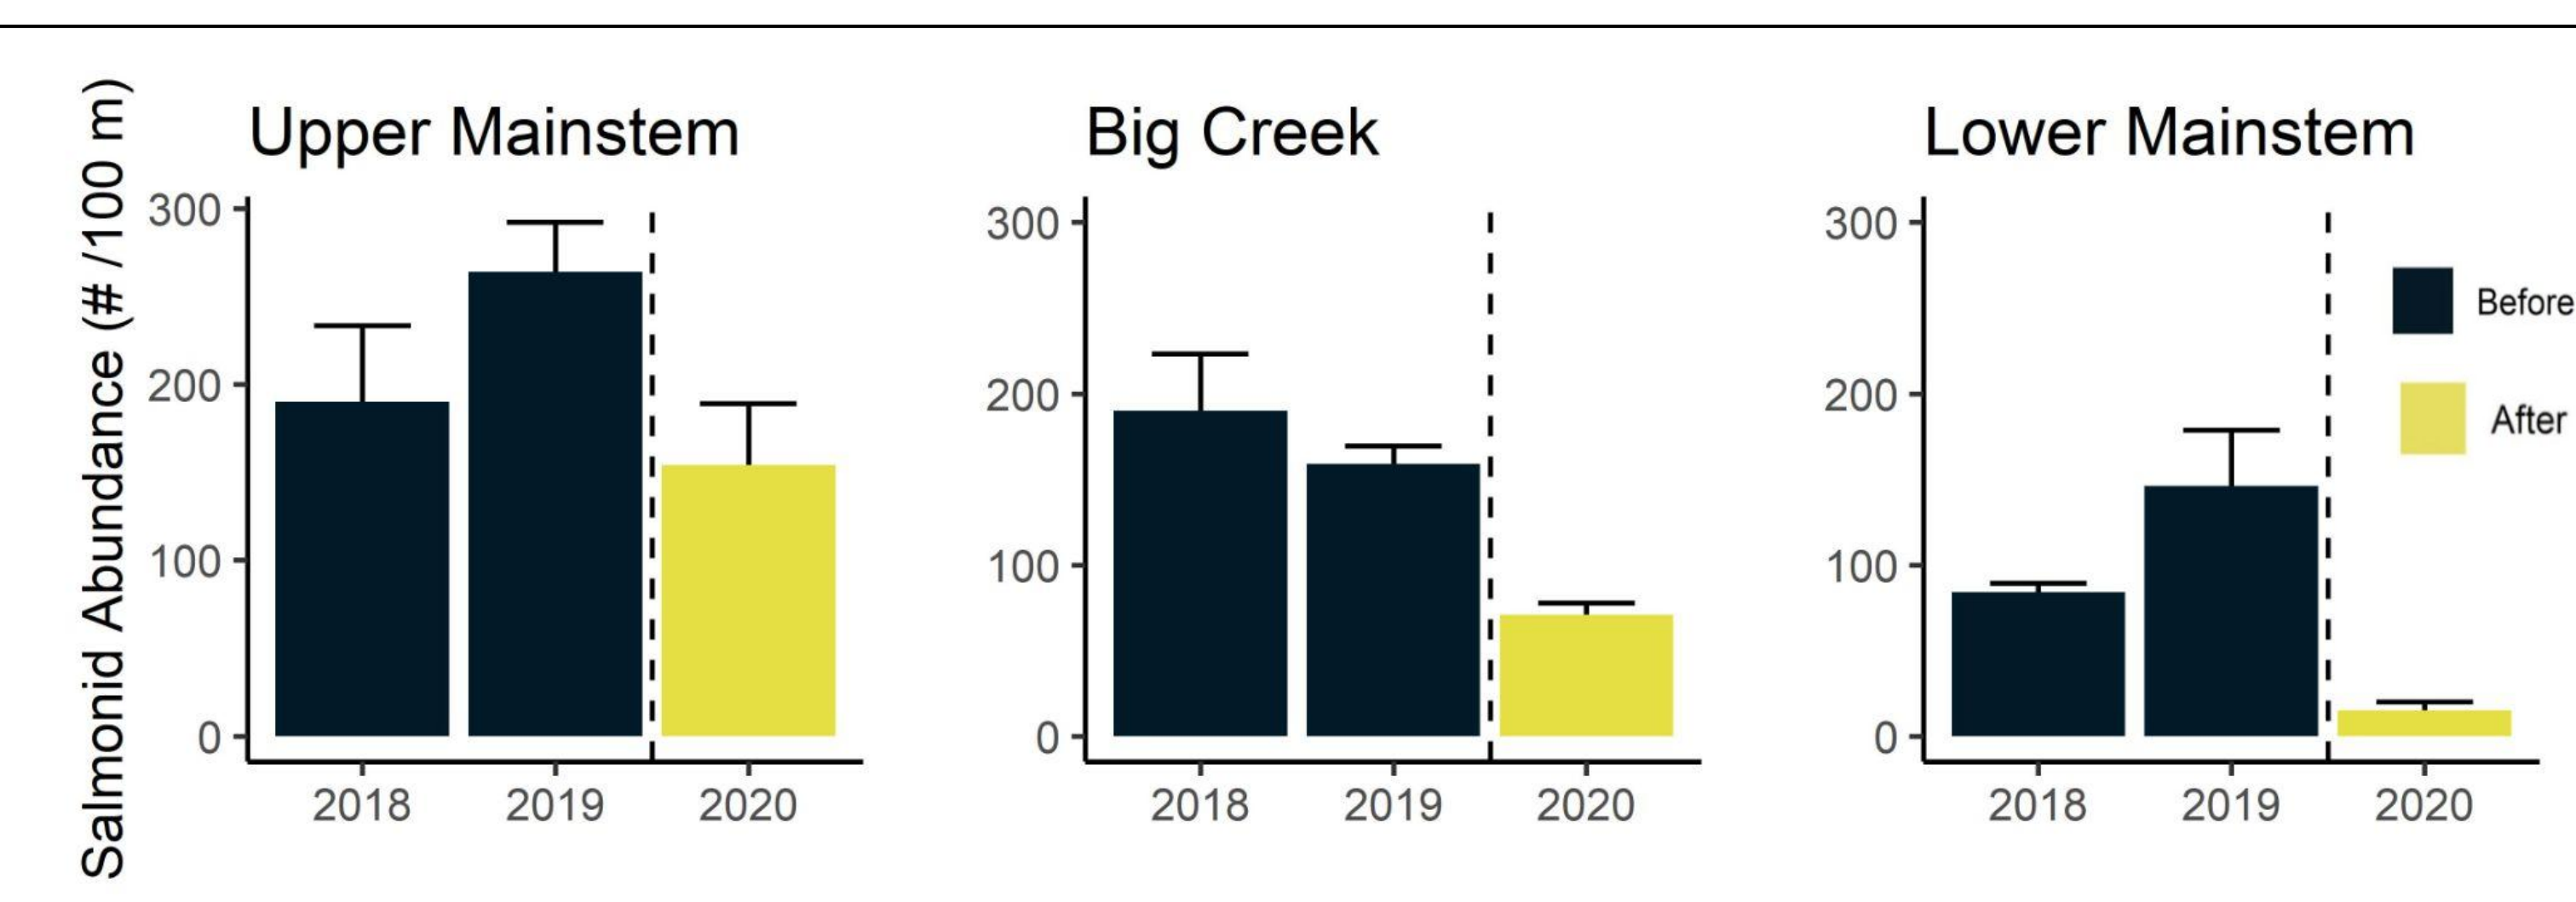
Figure 8: Bar graph showing general decline in total salmonid abundance (+ 95% CI). Data were derived from three-pass depletion electrofishing in three reaches (Upper mainstem, Big Creek, and Lower mainstem) during autumn. 2018 and 2019 data represent pre-fire conditions, whereas 2020 represents post-fire and pre-rainfall.

- Salmonid abundance declined following the fire but before any rain event (Fig. 8)
- Smoke and ash fallout have immediate effects on stream water quality. Concentrations of ammonium, nitrate, and phosphate can increase immediately following ash input²
- The Scott Creek system may have experienced increased exposure to these nutrients for at least over one month while the fire burned
- Prolonged exposure to these nutrients can lead to food web disturbances and fish toxicity³
- More data is needed to understand the impacts of ash input on riverine organisms

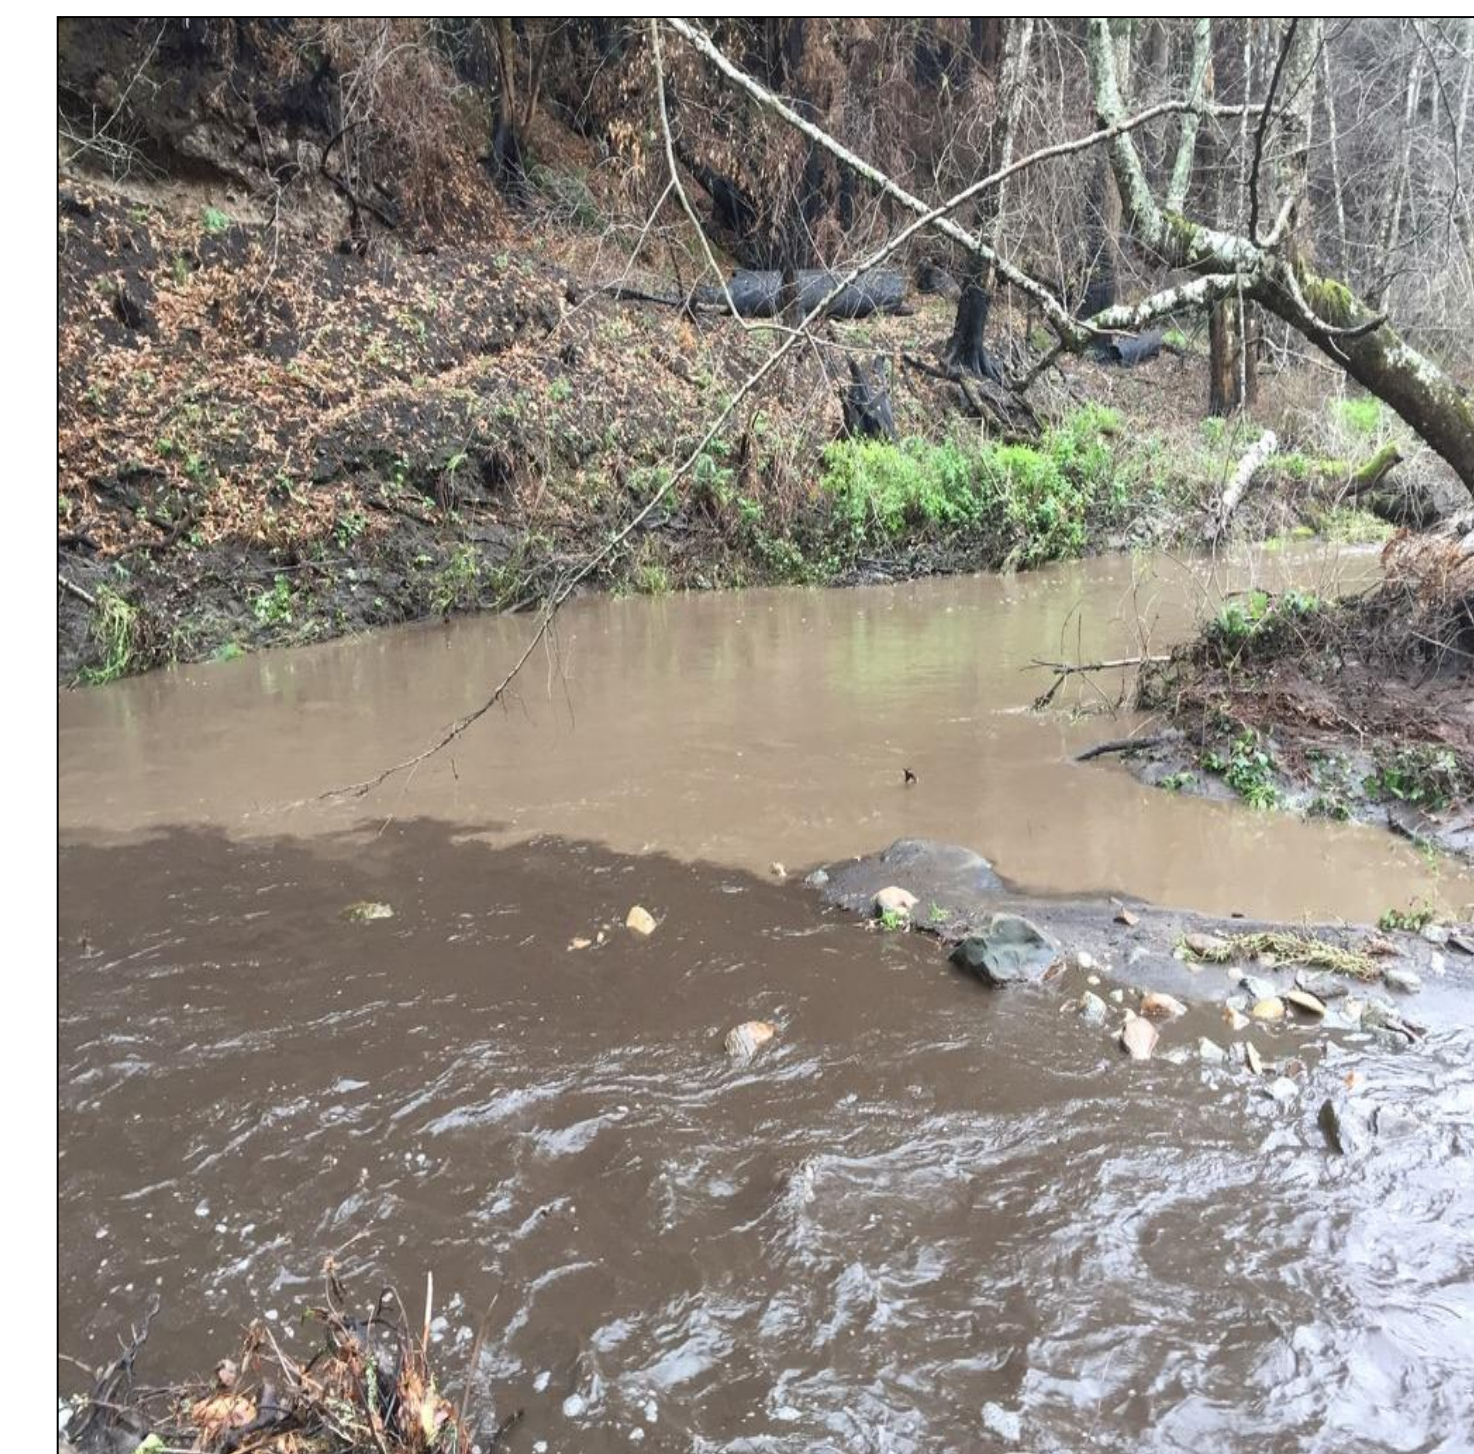
Figure 10: Extensive sediment flow at the confluence of Big Creek (foreground) and Scott Creek mainstem (background) following the first major post-fire rain event (January 27, 2021).
