Grounding Caption

This localization caption provides multi-dimensional spatial analysis of anatomical structures and pathological findings for this panoramic dental X-ray image, including:

Oral Radiological Examination Report

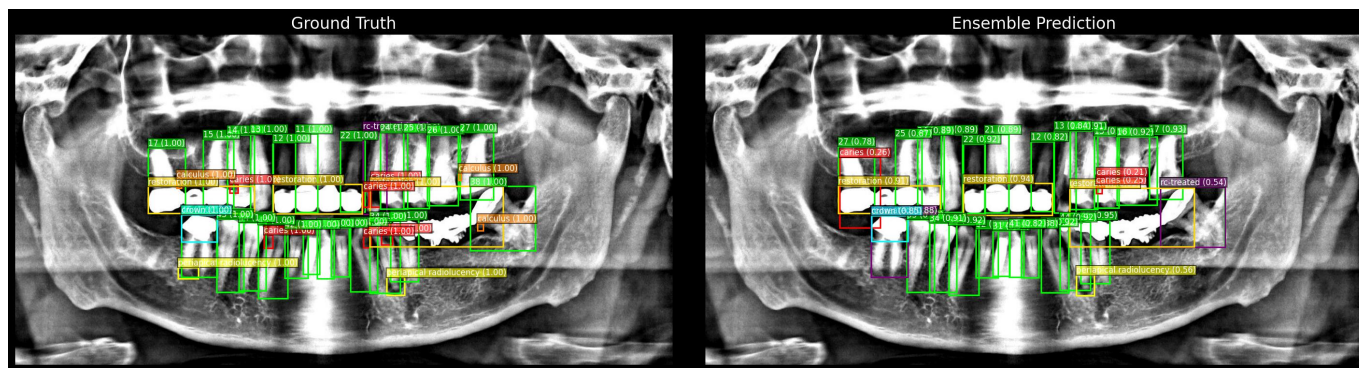
A total of 23 teeth are visualized with acceptable clarity. The lower right wisdom tooth (#48) is fully erupted and non-impacted. No evidence of congenital absence or supernumerary teeth is observed.

- Tooth #27:** Suspected carious lesion noted.
- Near tooth #15:** Areas of concern for carious demineralization at the distal surface.
- Near tooth #44:** Periapical radiolucency observed, suggesting possible apical periodontitis or inflammatory changes.

- Tooth #48:** Root canal-treated tooth with definitive radiographic evidence.
 - Near tooth #21:** Presence of a composite restoration.
 - Near tooth #16:** Amalgam restoration detected.
 - Near tooth #25:** Indirect restoration (inlay/onlay) noted.
 - Near tooth #35:** Combination of a root canal-treated tooth and a full-coverage crown.
-

- Suspected caries on #27** requires urgent evaluation for restorative intervention.
- Demineralization near #15** necessitates further diagnostic imaging (e.g., bitewing) to confirm extent.
- Periapical radiolucency near #44** warrants endodontic assessment to rule out apical pathology.

- Reinforce meticulous oral hygiene practices, particularly interproximal cleaning around #15 and #27.
- Monitor suspicious areas for progression of demineralization.
- Advise dietary counseling to minimize cariogenic risks.

- **6-month recall** for re-evaluation of carious lesions and periapical changes.
 - **Referral to endodontist** for #44 and #15 to confirm diagnosis and treatment planning.
 - **Referral to restorative specialist** for permanent restoration of #27 if caries is confirmed.
-
