Grounding Caption

This localization caption provides multi-dimensional spatial analysis of anatomical structures and pathological findings for this panoramic dental X-ray image, including:

Medical Report

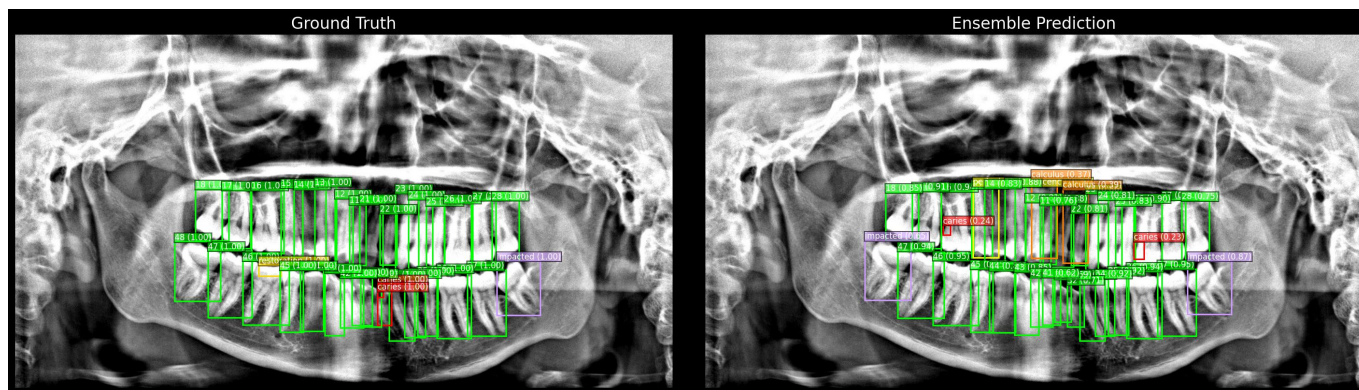
```
[
{'box_2d': [708, 401, 775, 589], 'tooth_id': '15', 'label': 'periapical radiolucency', 'score': 0.32},
{'box_2d': [946, 408, 1012, 602], 'tooth_id': '22', 'label': 'calculus', 'score': 0.39},
{'box_2d': [863, 380, 930, 590], 'tooth_id': '11', 'label': 'calculus', 'score': 0.37},
{'box_2d': [1275, 598, 1392, 739], 'tooth_id': 'unknown', 'label': 'impacted', 'score': 0.87, 'near_tooth': '37'},
{'box_2d': [421, 544, 543, 702], 'tooth_id': 'unknown', 'label': 'impacted', 'score': 0.65, 'near_tooth': '47'},
{'box_2d': [629, 503, 647, 529], 'tooth_id': 'unknown', 'label': 'caries', 'score': 0.24, 'near_tooth': '16'},
{'box_2d': [1133, 546, 1160, 593], 'tooth_id': 'unknown', 'label': 'caries', 'score': 0.23, 'near_tooth': '26'}
]
```

- A total of 30 teeth are visualized, with complete dentition except for unerupted or missing posterior teeth.
- Wisdom teeth (#18 and #28) are present and **not impacted**.

- **#15**: Suspicious for periapical radiolucency, suggesting potential apical pathology.
- **#11 and #22**: Areas of concern noted for calculus deposits.
- **Near #37**: Clear indication of impacted tooth (likely #38) adjacent to the lower left first molar.
- **Near #47**: Suspicious for impacted tooth near the lower right second molar.
- **Near #16**: Suggests carious lesion in proximity to the upper left first molar.
- **Near #26**: Suggests carious lesion in proximity to the upper right first molar.

- No prior restorations, crowns, root canal treatments, or implants observed.
-

- Impacted tooth near #37 requires evaluation for potential surgical removal or orthodontic planning.
- Monitor suspicious carious lesions near #16 and #26 for progression.
- Address suspected calculus on #11 and #22 via professional cleaning and hygiene counseling.

- Reinforce oral hygiene practices, emphasizing interproximal cleaning for areas with calculus risk.
- Advocate for fluoride application and dietary counseling to mitigate caries susceptibility.

- Immediate referral to an oral surgeon for assessment of the impacted tooth near #37.
- Schedule a 6-month recall for reassessment of pathological findings and calculus management.
- Consider endodontic evaluation for the suspicious periapical radiolucency at #15 if symptoms arise.
