Grounding Caption

Medical Report

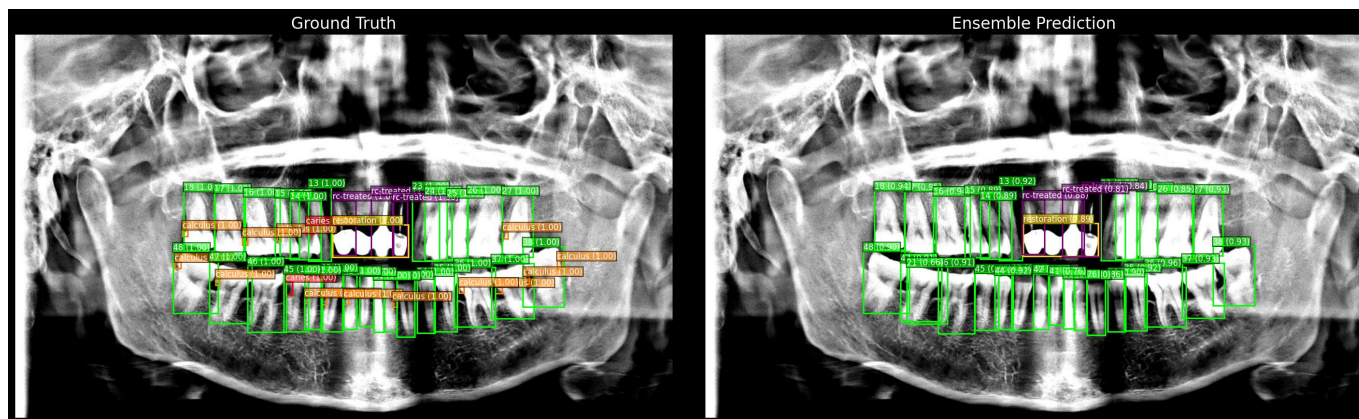
A total of 28 teeth are visualized within the panoramic image. All detected wisdom teeth (FDI #18, #38, and #48) are present and not impacted. No radiographic evidence of impaction or partial eruption is noted for these teeth. The remaining dentition demonstrates normal spatial alignment and anatomical relationships.

No pathological findings were identified in this examination.

- A restoration is evident near FDI #13.
- Root canal-treated (RCT) modifications are observed near FDI #13 and #23.

No significant pathological findings are detected. However, ongoing monitoring of previously treated teeth (#13 and #23) is advised to ensure long-term stability of root canal therapy and adjacent restorative work.

- Reinforce comprehensive oral hygiene practices to prevent secondary caries or periodontal complications around restored and RCT-treated teeth.
- Emphasize regular interdental cleaning to maintain periodontal health in the absence of pathological findings.

- Schedule a 6-month recall for routine evaluation of existing restorations and RCT-modified teeth.
- If not already completed, consider a separate evaluation for the absence of FDI #28 (right lower third molar) to confirm its anatomical status.
- No immediate referral is required for this examination.
