## Grounding Caption

This localization caption provides multi-dimensional spatial analysis of anatomical structures and pathological findings for this panoramic dental X-ray image, including:

## Medical Report

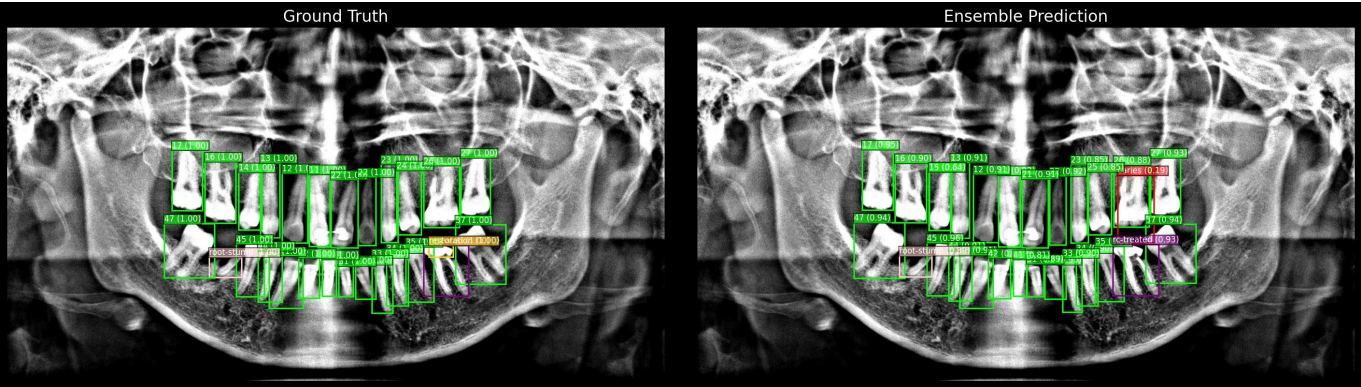
Teeth visibility with center points (total: 25):

Dental Pathological Findings (total: 2):

```
[
  {'box_2d': [1111, 389, 1208, 567], 'tooth_id': '26', 'label': 'caries', 'score': 0.19},
  {'box_2d': [534, 601, 620, 658], 'tooth_id': 'unknown', 'label': 'root-stump', 'score': 0.89, 'near_tooth': '45'}
]
```

Historical Treatments (total: 1):

```
[
  {'box_2d': [1099, 572, 1221, 708], 'tooth_id': 'unknown', 'label': 'rc-treated', 'score': 0.93, 'near_tooth': '35'}
]
```

A total of 25 teeth are visualized within the panoramic field. No wisdom teeth (third molars) are present or impacted. The overall dental arch alignment and spacing appear within normal limits.

1. **Tooth #26:** Suspicious for caries in the proximal region. The low confidence score necessitates further clinical evaluation to confirm lesion extent.
2. **Near tooth #45:** A root stump is present with radiographic features suggestive of incomplete extraction or residual root fragment.

1. **Near tooth #35:** A root canal-treated tooth is identified, evidenced by radiopaque filling material within the root canal system.
-

1. **Tooth #26:** Requires immediate assessment for caries progression and potential restoration.
2. **Tooth #45:** Presence of a root stump warrants evaluation for infection risk or need for surgical removal.

1. Reinforce oral hygiene protocols, emphasizing interproximal cleaning for high-risk areas (#26).
2. Monitor radiographic changes in the apical region of #35 during subsequent visits to ensure long-term success of root canal therapy.

1. Schedule a 6-month recall for re-evaluation of #26 and #45.
2. Refer to an endodontist for advanced management of #26 caries and surgical consultation for the root stump near #45 if symptomatic.
