Grounding Caption

This localization caption provides multi-dimensional spatial analysis of anatomical structures and pathological findings for this panoramic dental X-ray image, including:

Medical Report

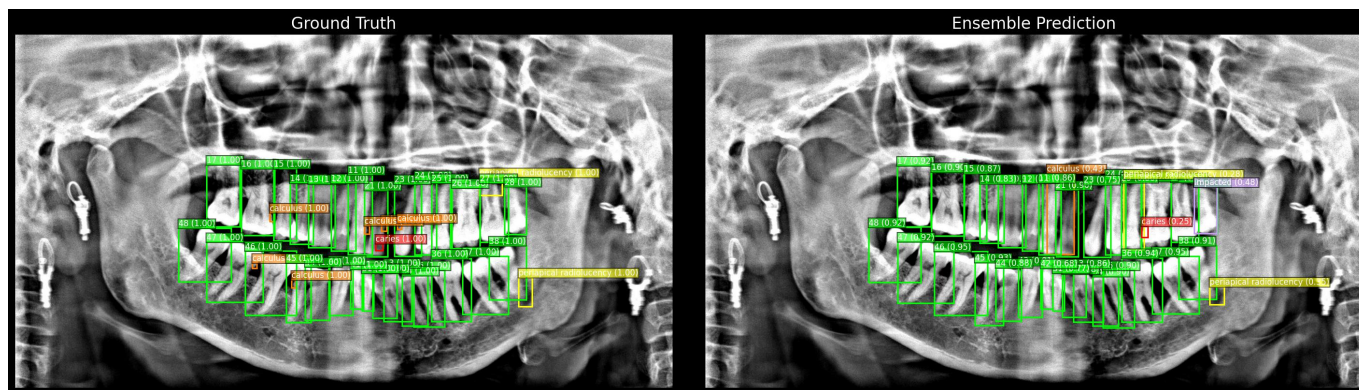
A total of 29 teeth are visualized within the panoramic field. Wisdom teeth include #48 (non-impacted), #38 (non-impacted), and #28 (impacted). All detected teeth demonstrate normal anatomical alignment and root morphology.

- #21: Suspicious for supragingival/subgingival calculus.
- #25: Suspicious for periapical radiolucency, potentially indicative of apical pathology.
- #28: Impacted wisdom tooth with limited radiographic visibility.
- Near #38: Suspicious for periapical radiolucency involving adjacent apices.
- Near #25: Areas of concern for carious lesion involvement.

No prior restorative interventions (e.g., fillings, crowns, root canal treatments, implants) are evident on this examination.

- Impacted wisdom tooth (#28) requires evaluation for extraction due to potential risk of pericoronitis or adjacent molar compromise.
- Periapical radiolucency near #38 and #25 necessitates endodontic assessment to rule out apical periodontitis or non-vitality.
- Suspected carious lesion near #25 warrants clinical correlation and preventive intervention.

- Reinforce plaque control measures to address calculus accumulation on #21.
- Educate on interdental brushing and flossing near impacted #28 to mitigate periodontal risks.
- Schedule regular recall for monitoring of suspect caries and periapical lesions.

- Refer to endodontist for #38 and #25 within 2 weeks to evaluate periapical radiolucency.
- Radiographic and clinical re-evaluation in 6 months for impacted #28 and suspicious lesions.
- Consider prophylactic extraction of #28 if radiographic progression or symptomatic involvement is observed.
